# CR QUALITY HOME INSPECTIONS

## RESIDENTIAL INSPECTION

1234 Main St. Lena Illinois 61048

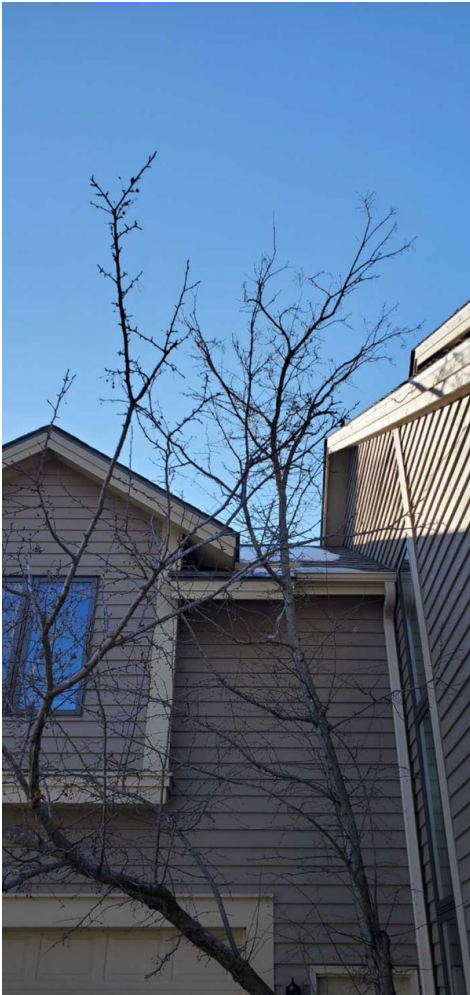
I observed indications that tree branch's are overhanging the roof and maybe in contact with the roof . Trim the branches back so nothing hangs over the roof.

Further evaluation by a qualified tree trimmer is recommended.

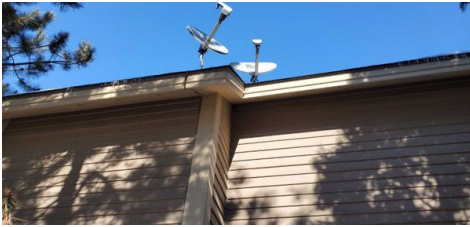
West West

### **GUTTERS MISSING IN ONE OR MORE AREAS.**

Gutters are necessary to properly collect rain water from the roof, control it, divert it, and discharge that water away from the house and its foundation. A missing gutter is a defect. This is a defect that should be corrected by a professional contractor if so desired but is recommended.

Water may seep into basement and cause water damage, mold, mildew some of which may possibly be present already

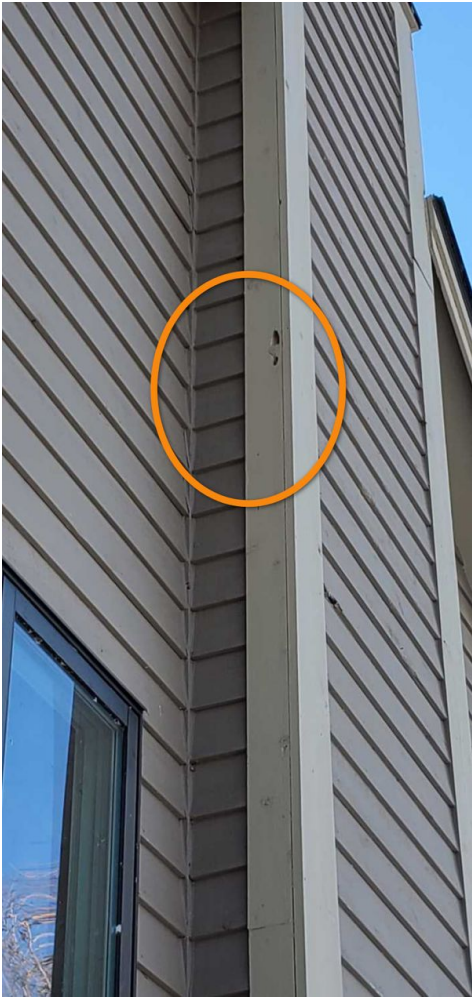
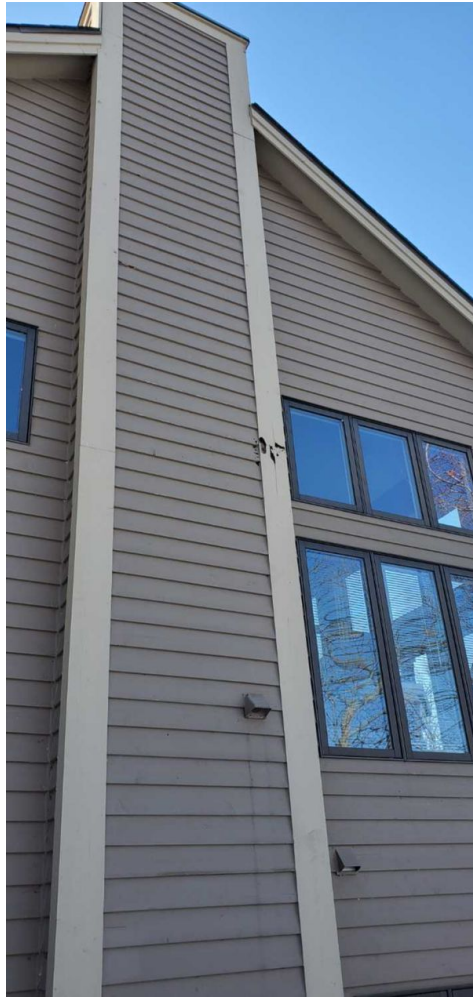
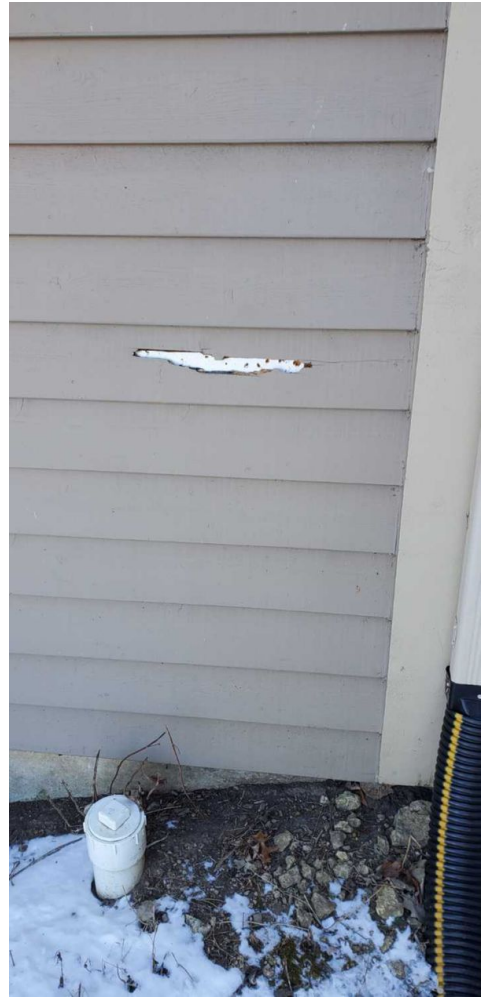
North Basement

### **DAMAGED WALL-COVERING/TRIM MATERIAL**

I observed indications of a defect at the exterior wall-covering material.

Holes and cracks should be sealed shut or siding replaced to protect against the element's from getting into the wall cavities.

Correction and further evaluation is recommended by a qualified contractor

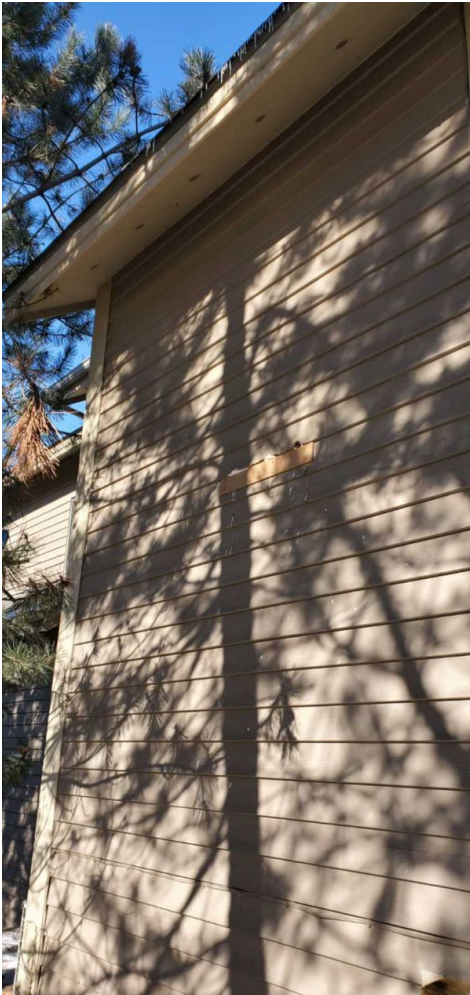
West

3.3.2 Wall-Covering, Flashing & Trim

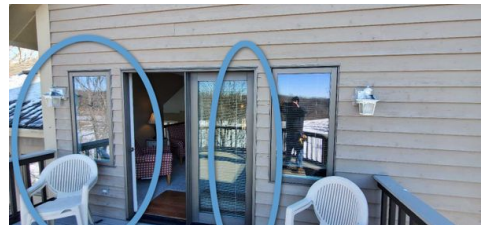
2nd Floor North

**CRACKING - SPLITTING SIDING OR TRIM**

Siding showed cracking in one or more places. Recommend monitoring, repair or replace as needed . Consult a qualified contractor .

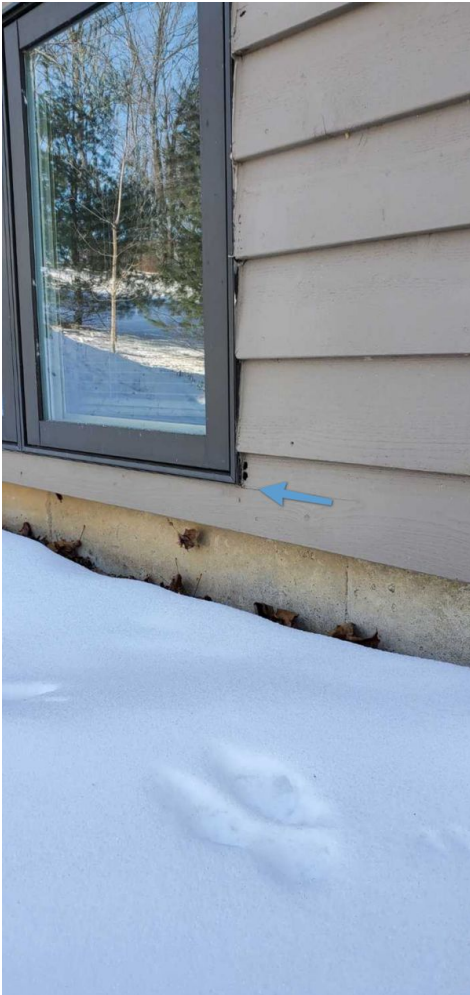
Basement East

Be and sure to check all doors , windows and joints for missing or deteriorated caulking .

Check annually for deterioration and replace as needed to preserve the integrity of the materials and to prevent moisture intrusion .

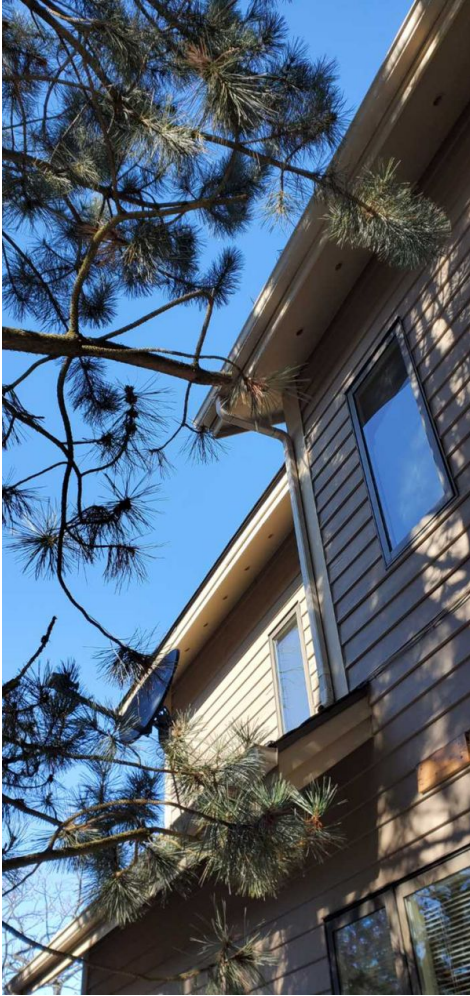
West

Keep the vegetation trimmed back to prevent rubbing and holding moisture and possible creating rot.

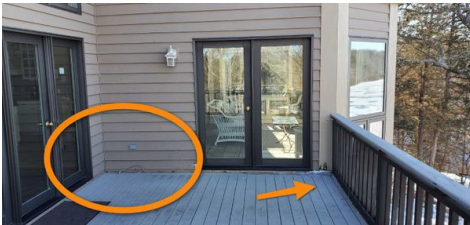
1st Floor North

3.4.1 Vegetation, Surface Drainage, Retaining Walls & Grading

**NEGATIVE GRADING AROUND THE DWELLING**

The ground around a house should slope away from all sides, ideally 6 inches for the first 10 feet from the house foundation perimeter. Downspouts, surface gutters and drains should also be directing water away from the foundation.

I highly recommend further evaluation is recommended by a qualified contractor /landscaper

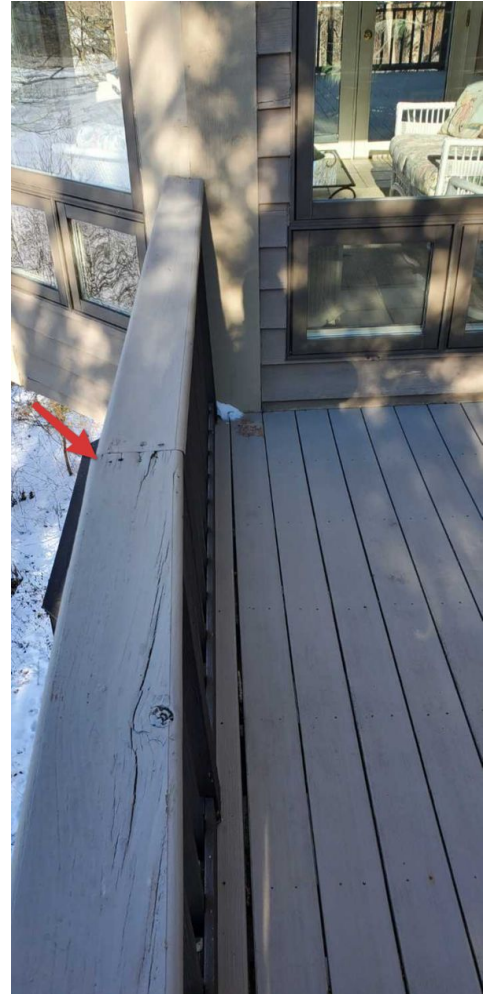
1st Floor Bedroom deck

Monitor yearly for deterioration. Keep all wood surfaces sealed and protected.

Repair and replace as needed

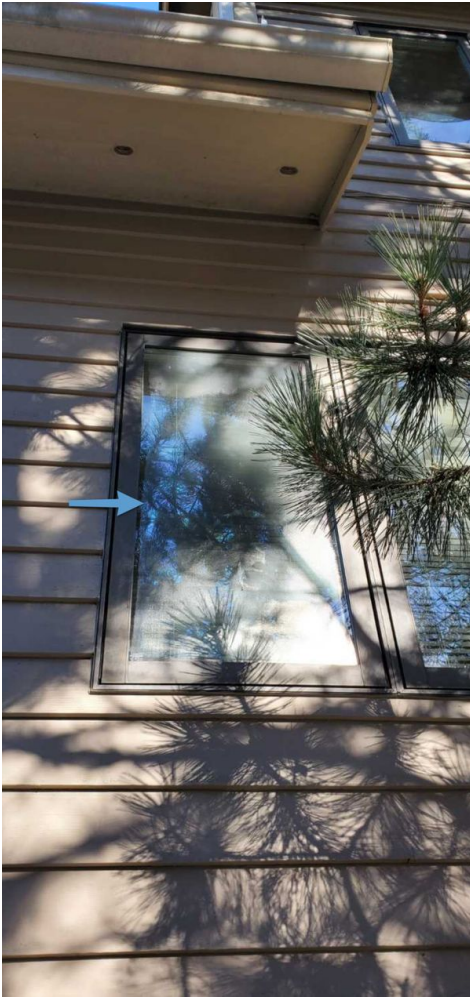
1st Floor West Bathroom

If multiple-pane windows appear misty or foggy, it means that the seal protecting the window assembly has failed, and condensation has formed in between the two panes of glass. Condensation in double-paned windows indicates that the glazing assembly has failed and needs repair or replacement. Visible condensation can damage glazing and is the main indication of sealant failure. Condensation is not always visible. If the failure is recent, a failed window may not be obvious, since condensation doesn't usually form until the window is heated by direct sunlight. Windows in the shade may show no evidence of failure, so it is nearly impossible to observe and report all failed double-paned windows.

I recommend having a glass company further evaluate .

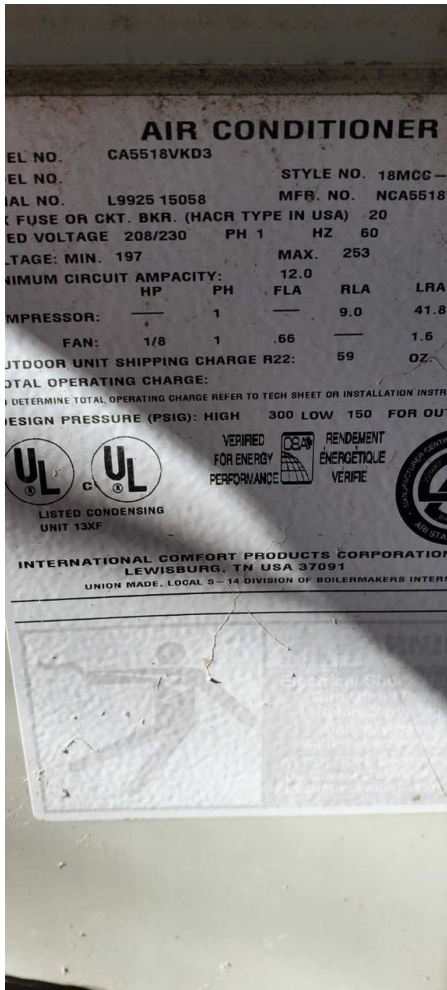
Due to the low temperature i was not able to run the air-conditioner.

I recommend further evaluation by a qualified HVAC for repairs and maintenance on yearly schedule

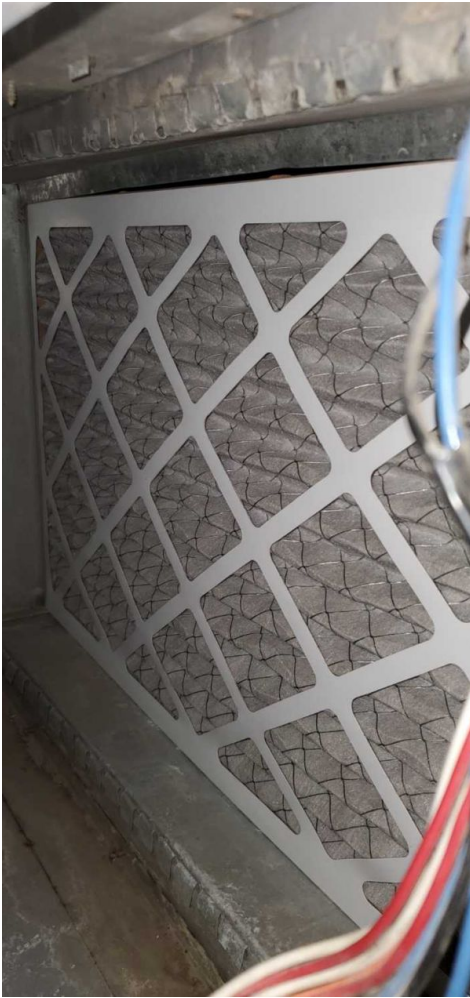
The furnace filter is dirty and needs to be replaced every 1-6 months. Monitor monthly and change as needed . A dirty filter makes the air handler work harder and less efficient .

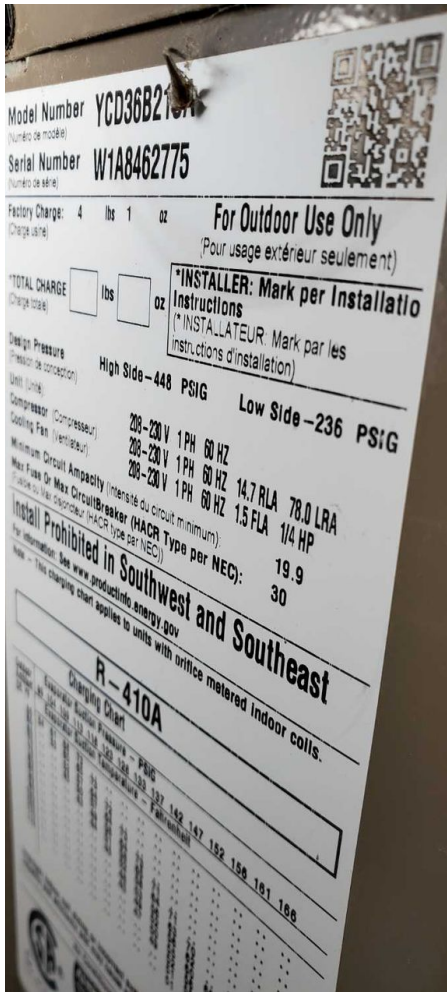
Due to the low temperature i was not able to run the air-conditioner.

I recommend further evaluation by a qualified HVAC for repairs and maintenance on yearly schedule

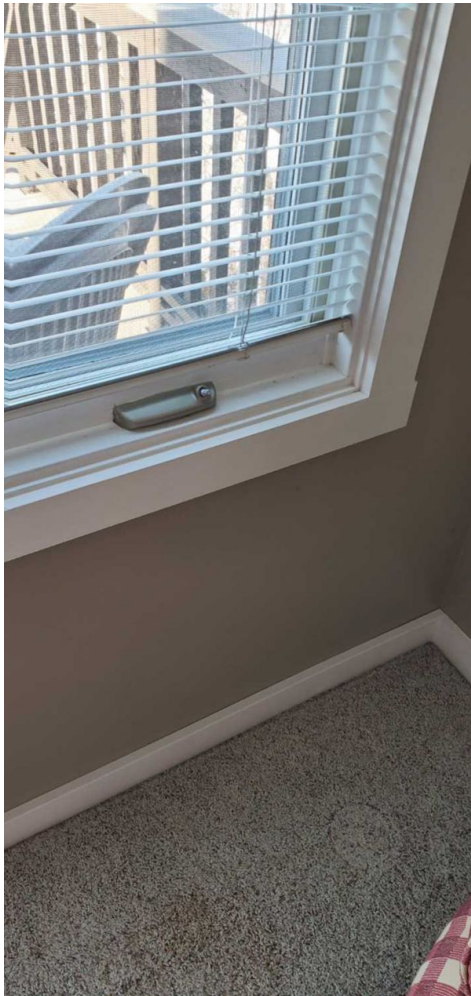
2nd Floor North

I observed damage to the hardware at a window and its operation.  
Window would not open, It was either missing a handle to the crank or the crank did not function  
Further evaluation by a qualified contractor is recommended

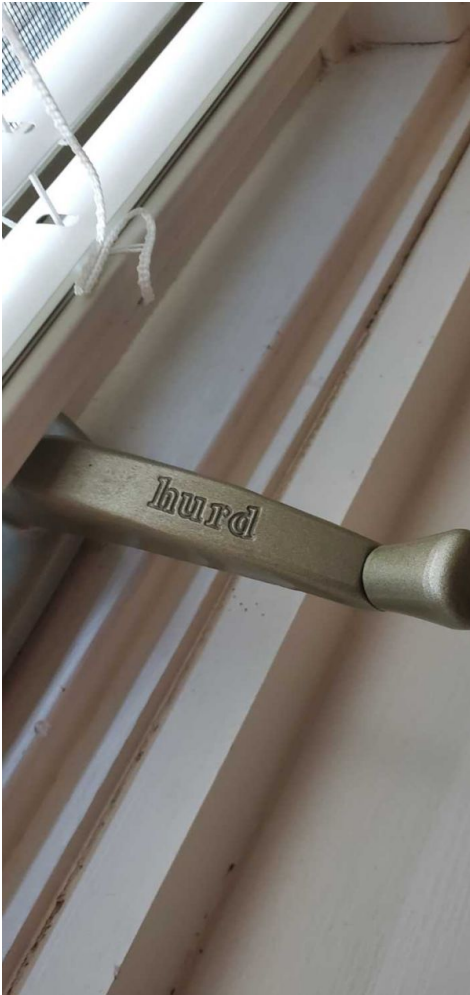
#### **FOGGED / BROKEN SEAL**

I observed a fogged window and broken seal that caused condensation between the window panes.

I recommend further evaluation by a qualified contractor for and repairs or replacement.

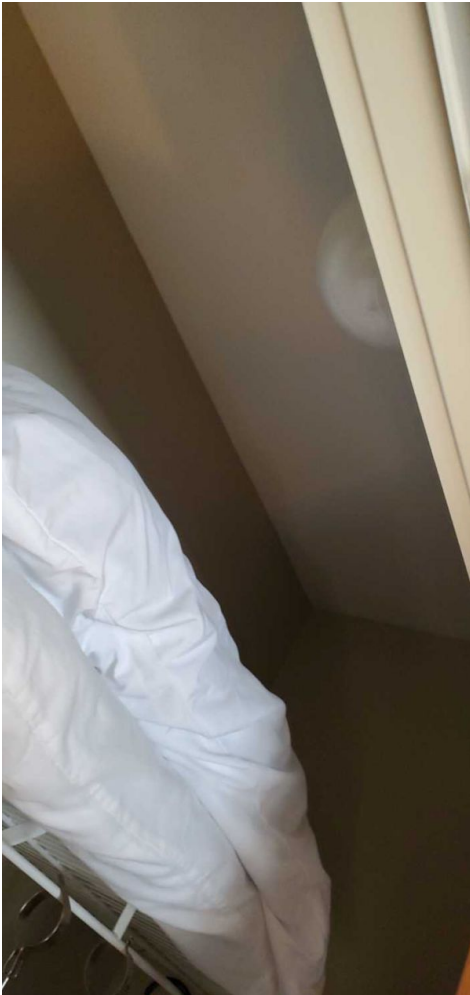
2nd Floor closet

I observed one or more lights that were not turning on. A new light bulb is possibly needed. Further evaluation be a electrician if a new bulb doesn't repair the fixture.

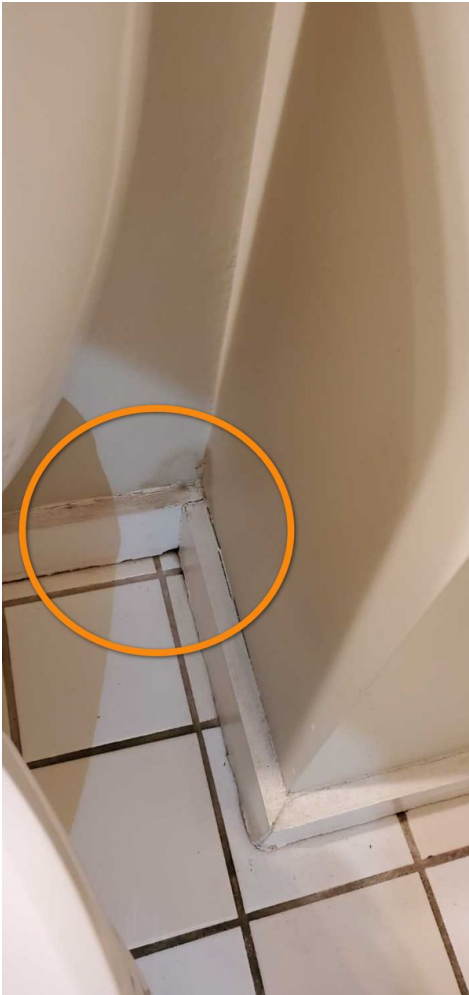
Basement West Bathroom

**MOISTURE DAMAGE/STAINING**

Stains on the walls or ceilings were visible at the time of the inspection and appeared to be the result of moisture intrusion from a unknown source.

Meter showed low moisture content the day of the inspection.

I Recommend further examination by a qualified contractor to provide confirmation if the situation has been corrected.

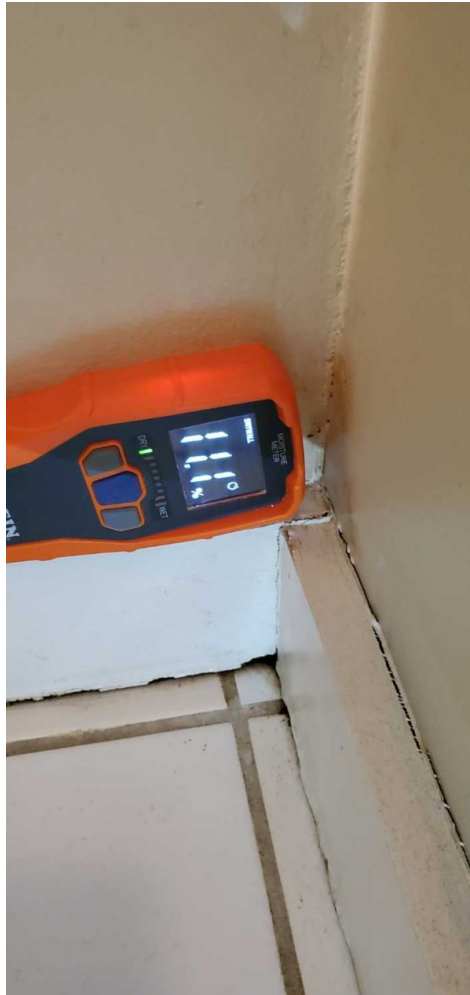
Low moisture

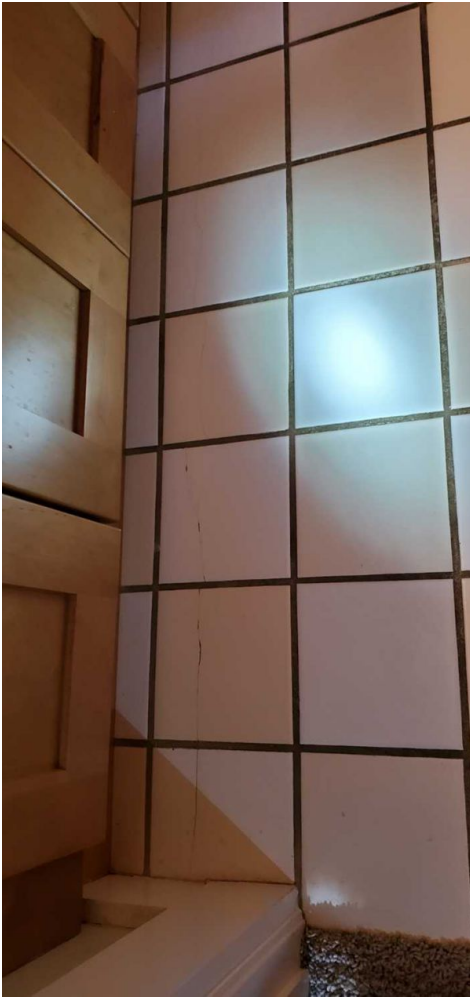
2nd Floor West Bathroom

Broken tiles can be a safety hazard with the sharp edges.

Further evaluation by a qualified contractor

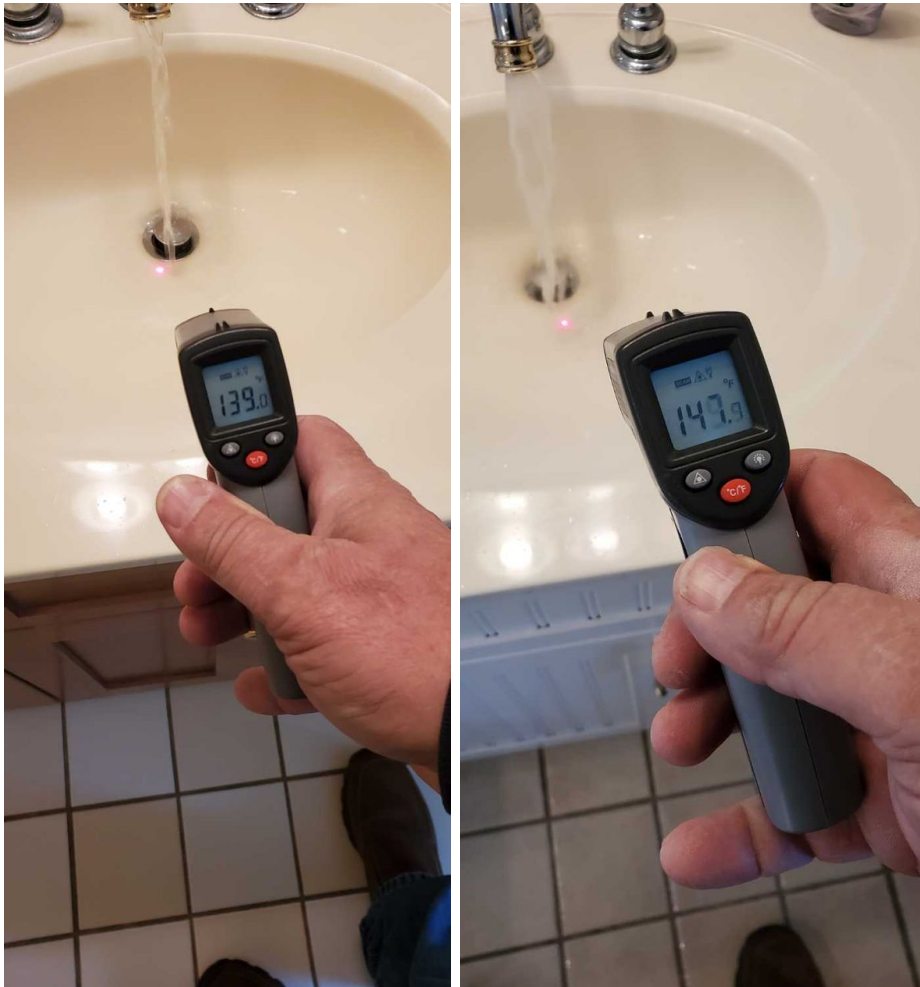
1st Floor Master Bathroom

Did not run the jets due to the signage status. Water and drain system worked as intended

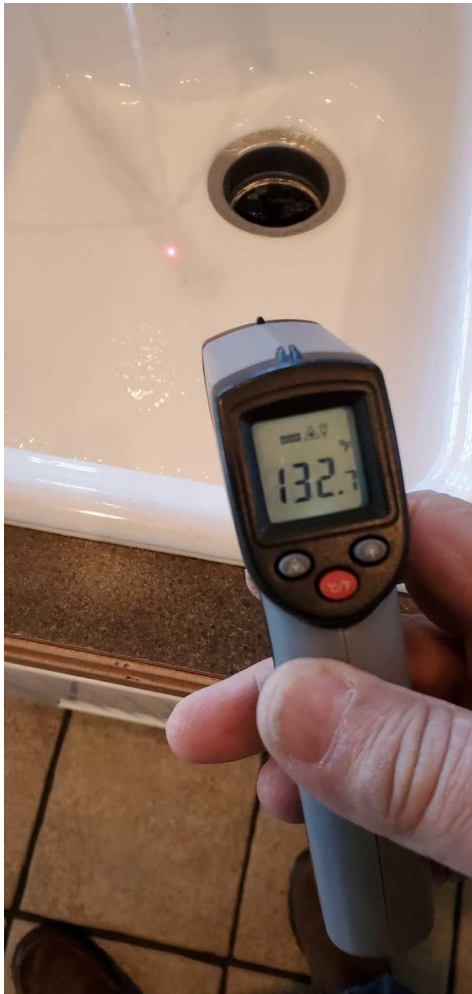
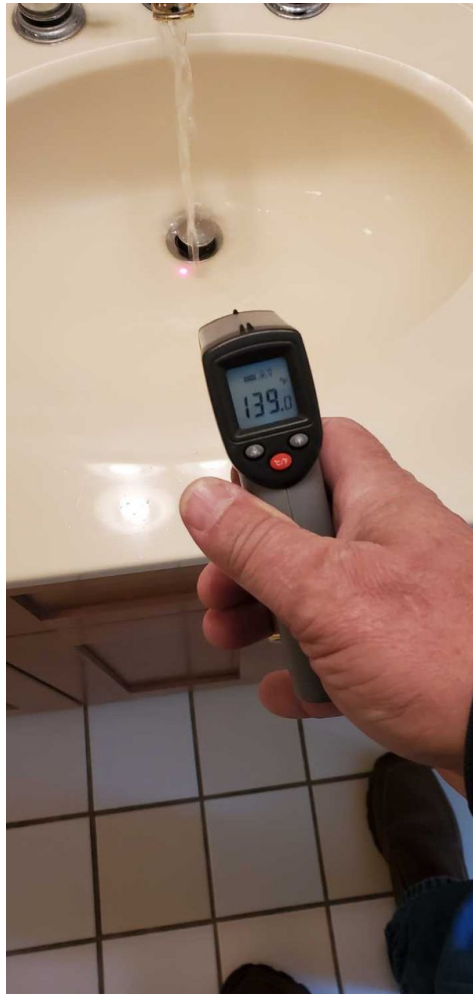
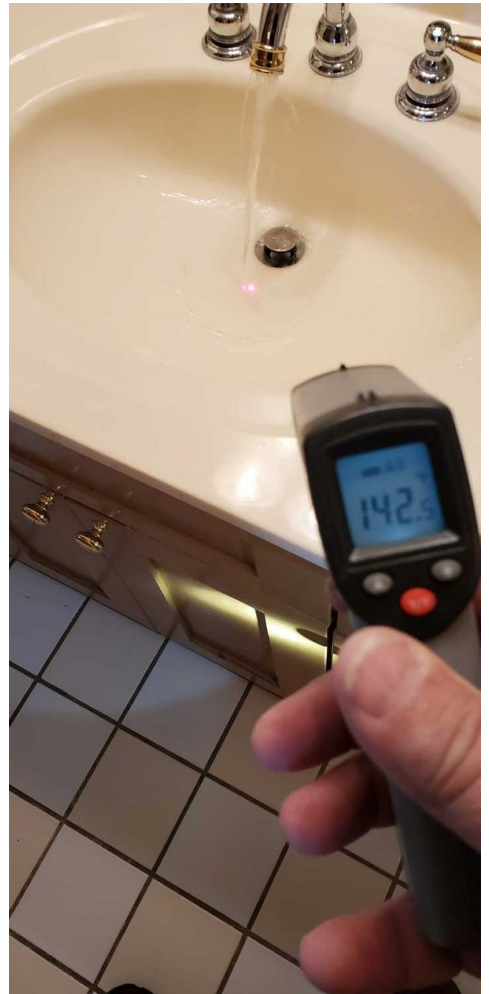
Water pressure is low after running one or more water appliances . I recommend further evaluation by a qualified plumber .

Faucets' appeared to slightly limed up which can create some low pressure

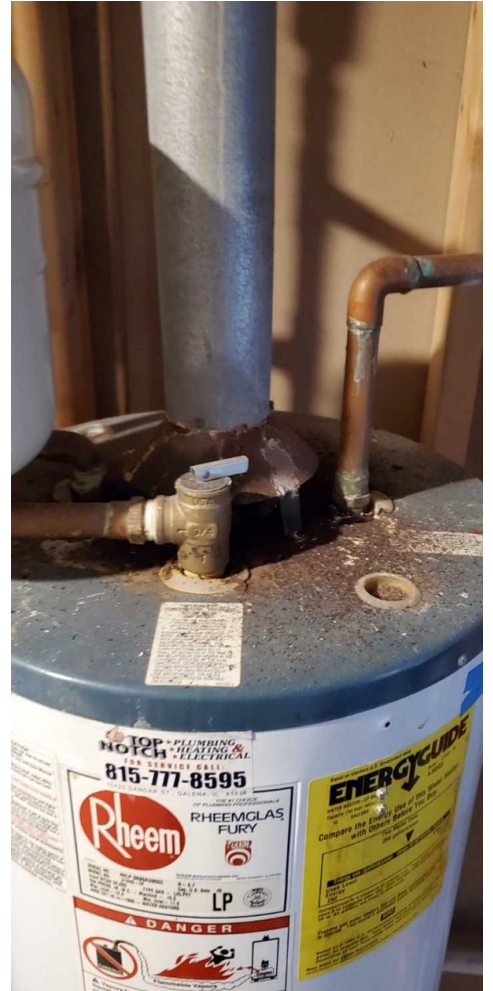
I observed corrosion at the hot water venting source.

For in floor heat

I recommend further evaluation by a qualified plumber/HVAC is recommended .

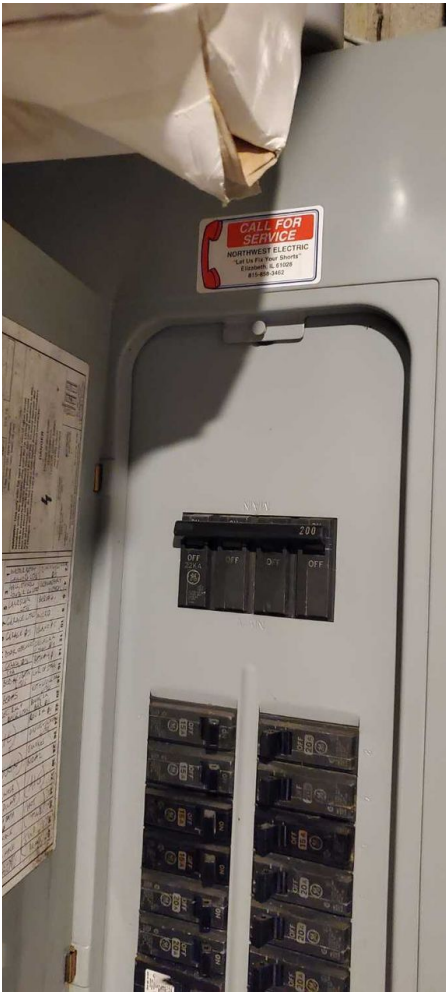
I inspected the electrical main service disconnect.

Limited access due to shelving for removing dead front cover.

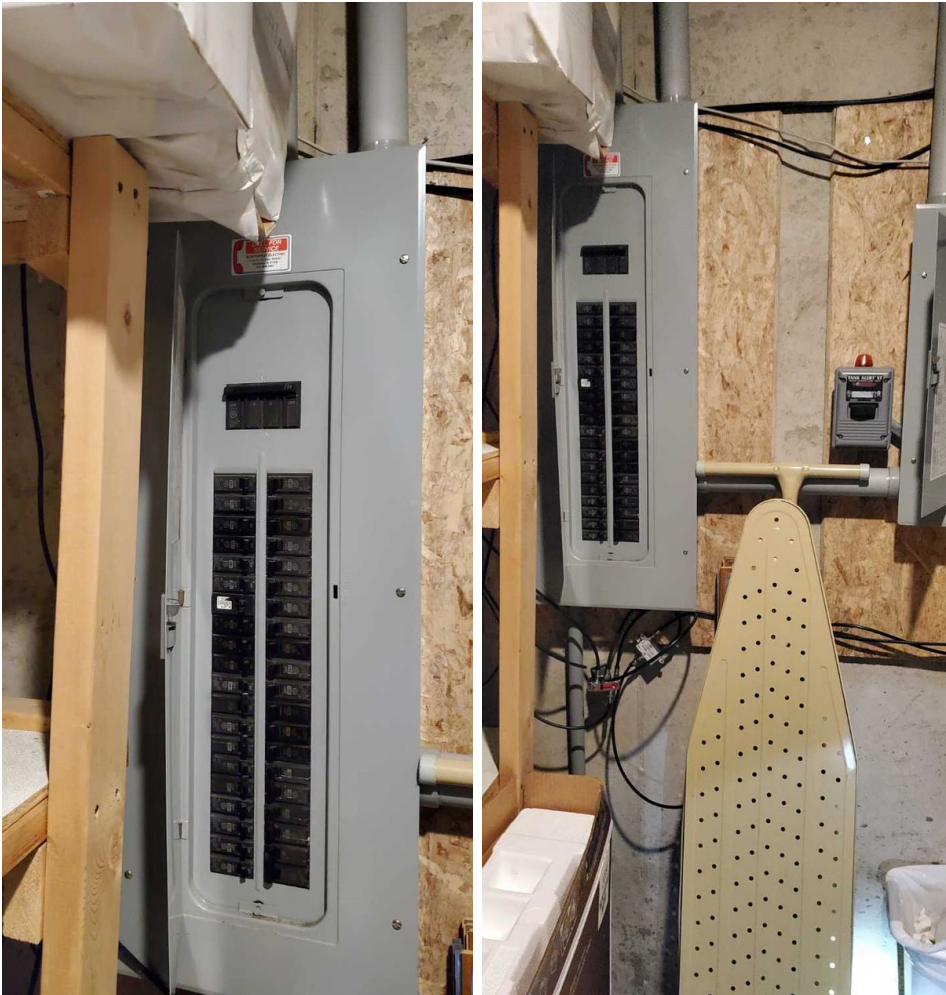
## INADEQUATE WORKSPACE AT PANELBOARD

I observed inadequate workspace at the panelboard.

A clear working space for accessing all of the electrical equipment is needed. A clear space that is 3 feet deep, 30 inches wide, and 6' 6" in height should be provided in front of the equipment.
