CR QUALITY HOME INSPECTIONS

RESIDENTIAL INSPECTION

1234 Main St. Lena Illinois 61048

04/17/2022 9:00AM

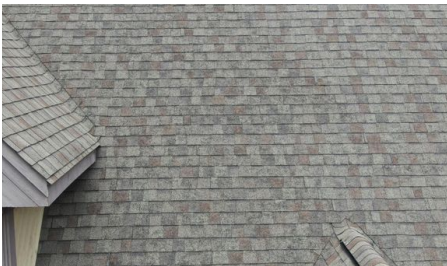
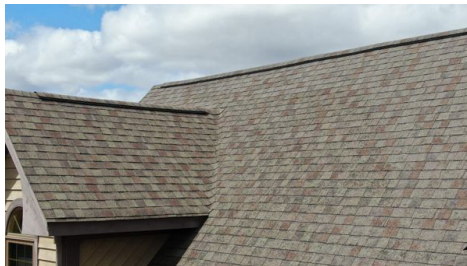
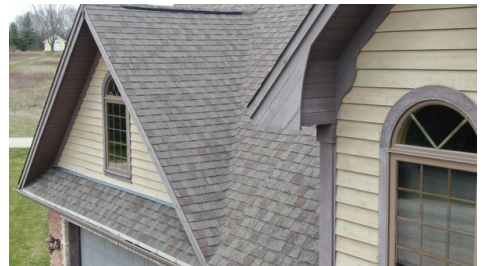
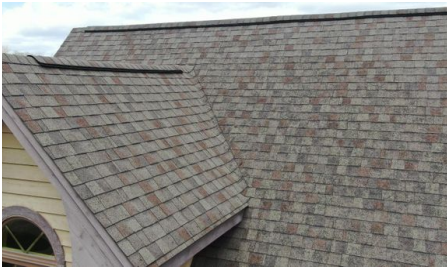
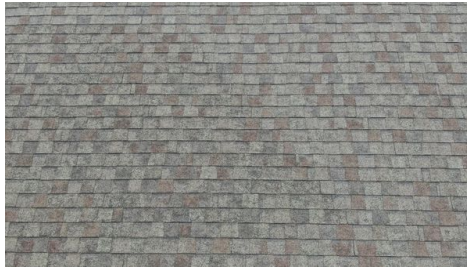
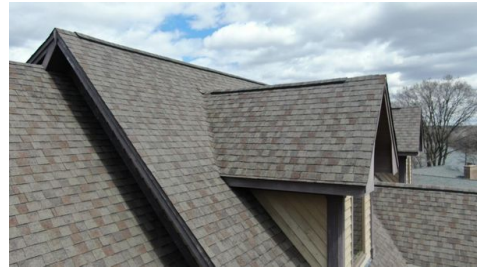
**Roof Covering: Roof Was Inspected****Ground**

We attempted to inspect the roof from various locations and methods, including from the ground and a ladder and drone. Weather permitting and the ground conditions allow.

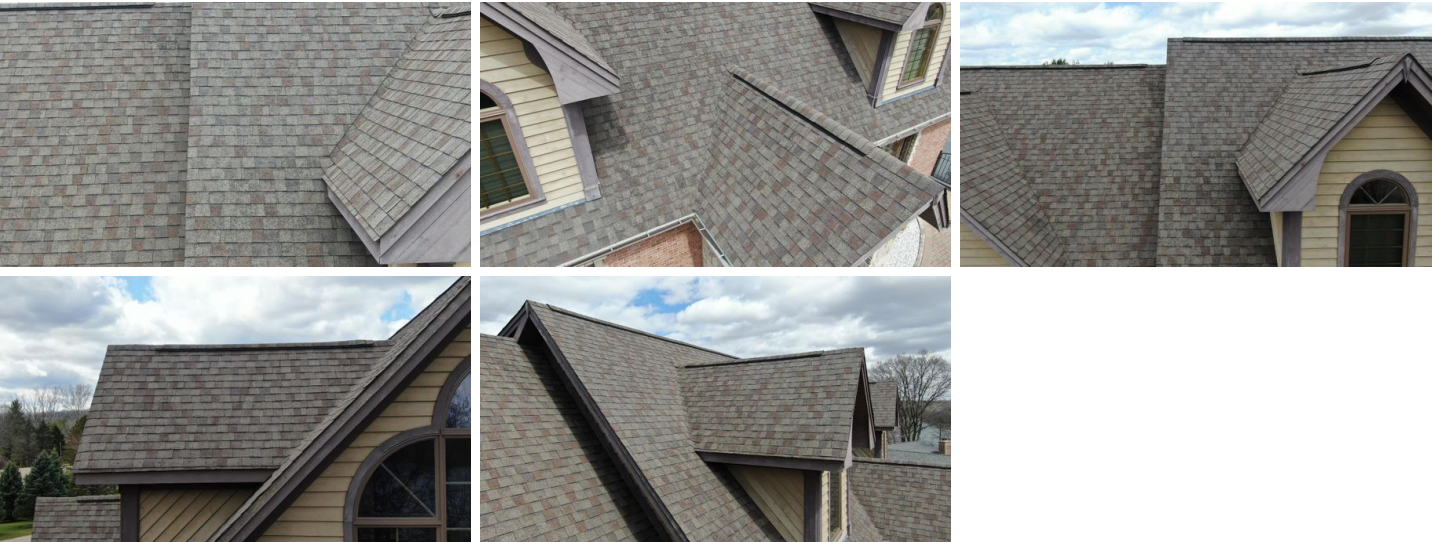
SHINGLES ARE STARTING TO LOOSE THERE GRANULES

Keep all debris cleaned off of the roof and out of the gutters .

The down spouts need to be flowing 4-6 feet away from the dwelling

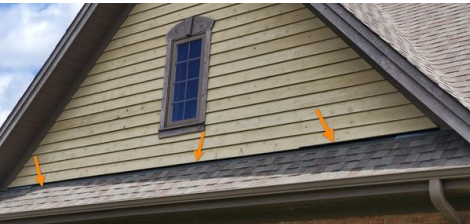
West

MISSING FLASHING

I observed areas where flashing was missing. Not installed or Improper installation of flashing. These areas of missing flashing are prone to water penetration. Flashing is installed to provide protection against roof leaks and to divert water away from certain areas. Correction and further evaluation is recommended.

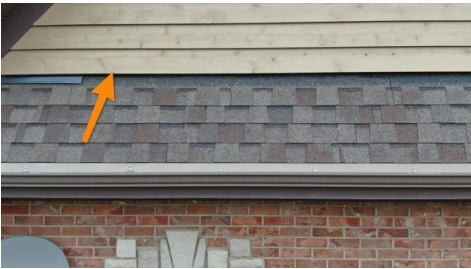
2.3.1 Plumbing Vent Pipes

MONITOR YEARLY FOR SEALANT FAILURE AND ALL GUTTERS, DOWN SPOUTS FOR DEBRIS

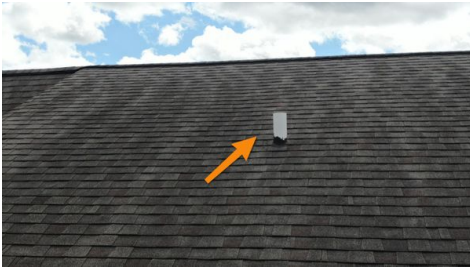
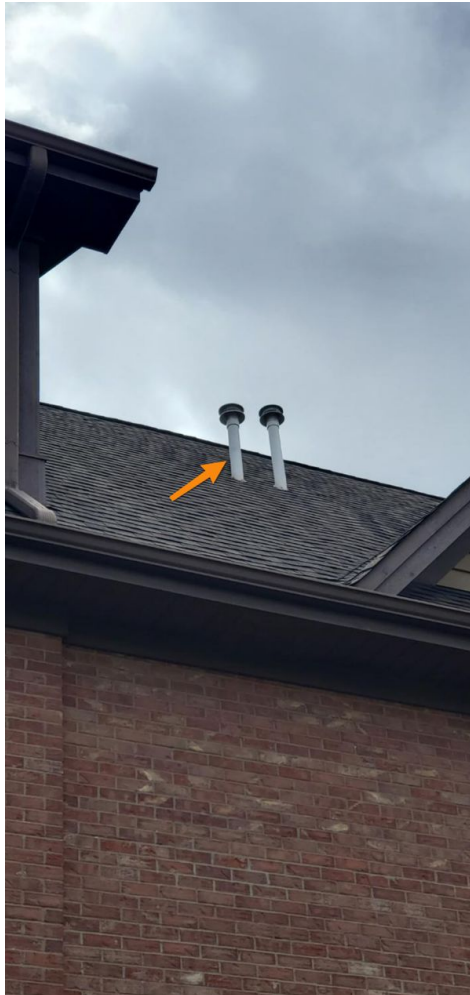
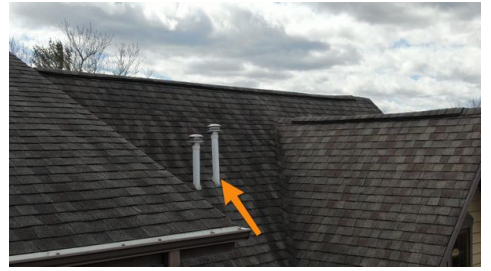
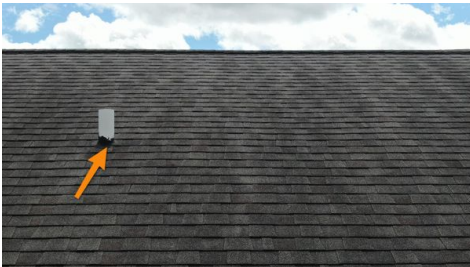
Recommend evaluation by a qualified roofer for proper sealant repair and maintenance yearly.
Have all flashings checked and sealed .
Gutters, downspouts, roofing material cleaned and working properly .
Put the roofing on a maintenance schedule yearly to assure the roof is monitored for further deterioration and damage that may occur due to weather or other circumstances.

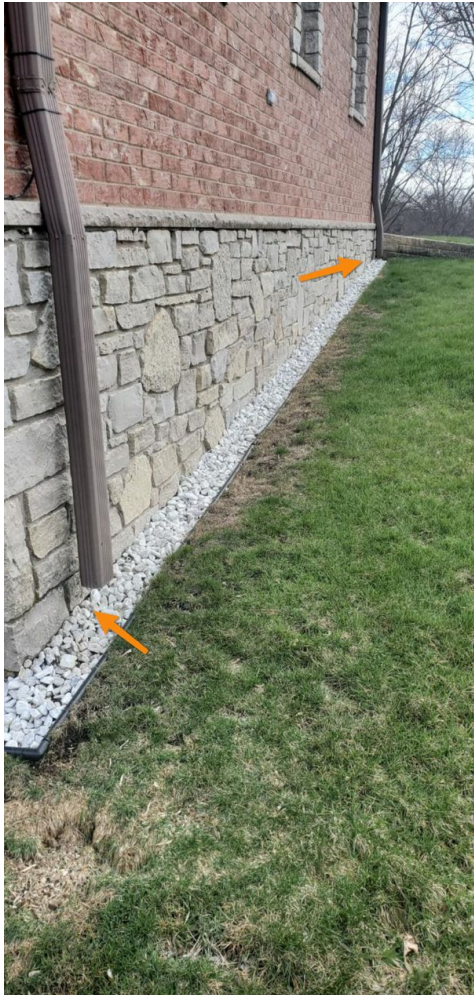
West

DOWNSPOUTS DRAIN NEAR STRUCTURE

One or more downspouts drain too close to the home's foundation. This can result in excessive moisture in the soil at the foundation, which can lead to foundation/structural movement.

I Recommend a qualified contractor adjust downspout extensions to drain at least 6 feet from the foundation.

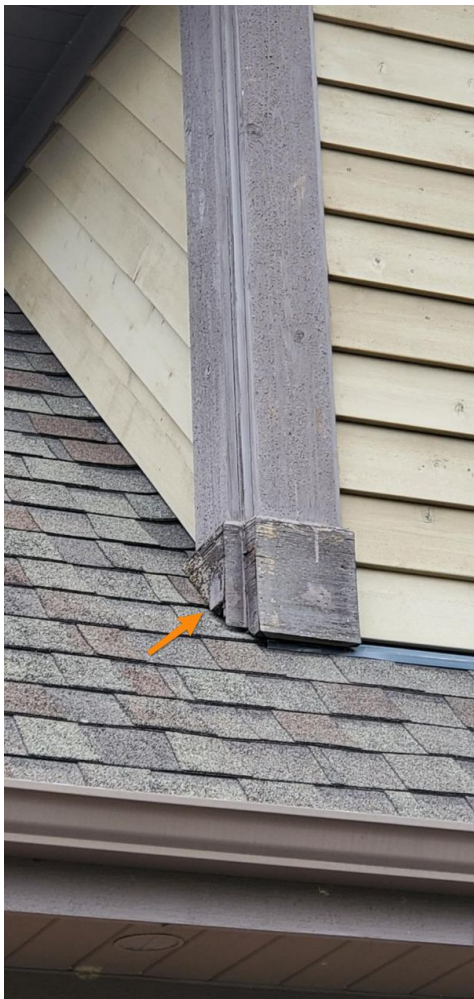
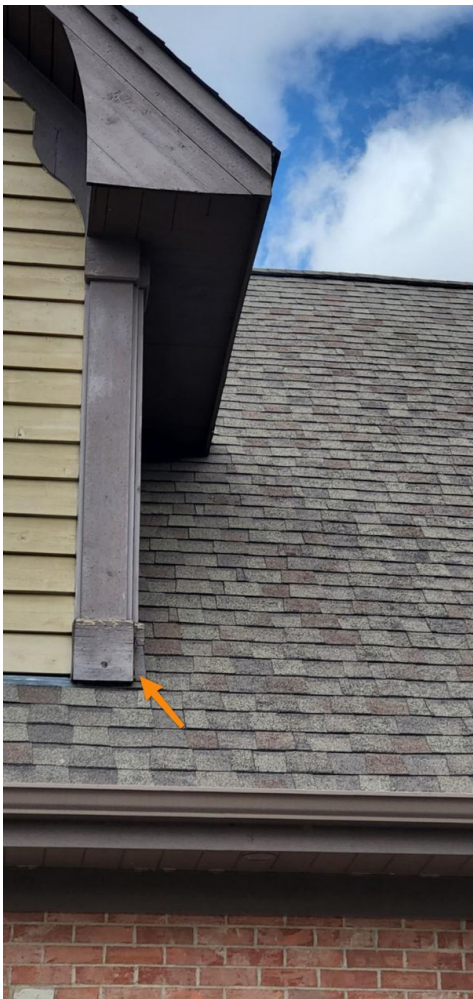
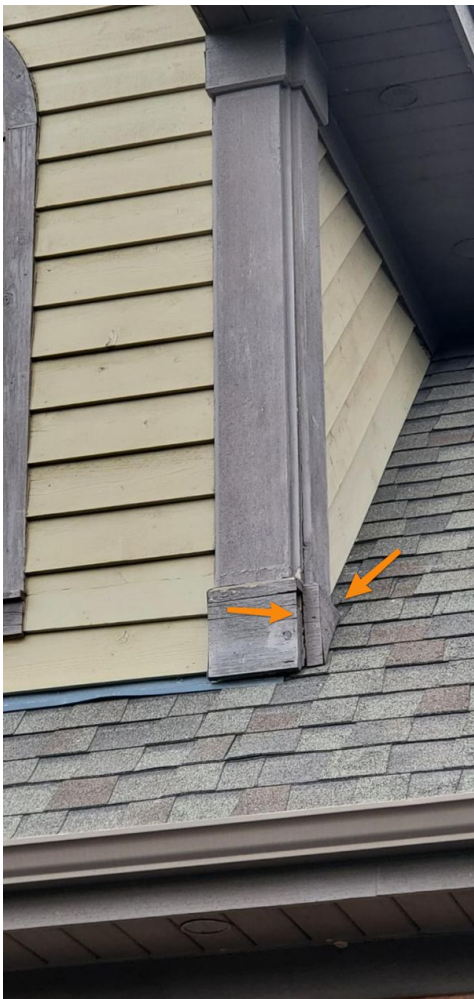
South

I observed indications of a defect at the exterior wall-covering material.
Correction and further evaluation is recommended by a qualified contractor
Holes and cracks should be sealed shut or siding replaced to protect against the element's from getting into the wall cavities.

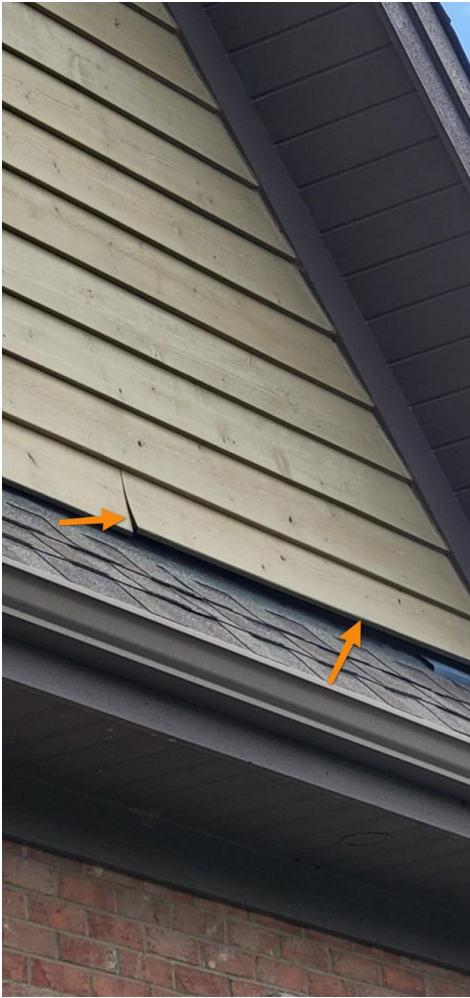
West

LOOSE WALL-COVERING MATERIAL

I observed indications of loose areas of the exterior wall-covering material.
Correction and further evaluation is recommended by a qualified siding contractor
Water could enter behind the siding and enter into the attic or wall space of the home creating a environment for mold, mildew and rotten structural damage.

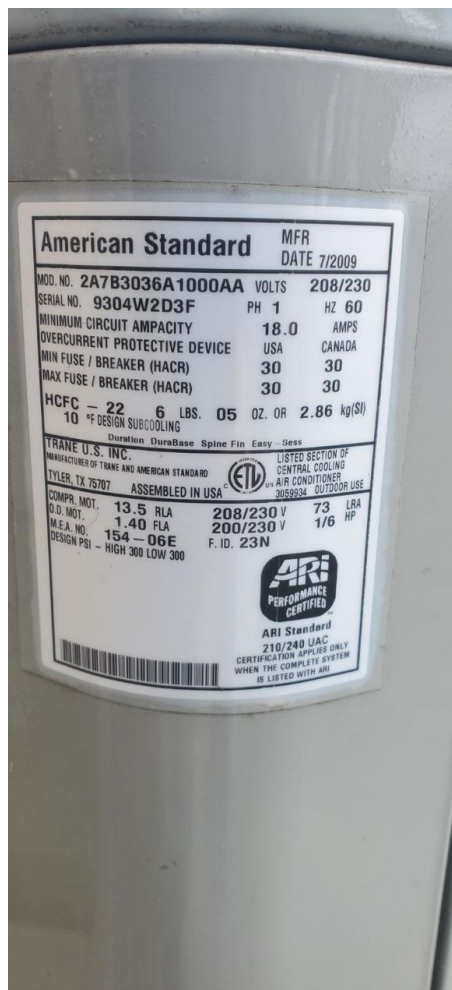
Left unit

Due to the low temperature i was not able to run the air-conditioner

I recommend further evaluation by a qualified HVAC for repairs and maintenance on yearly schedule

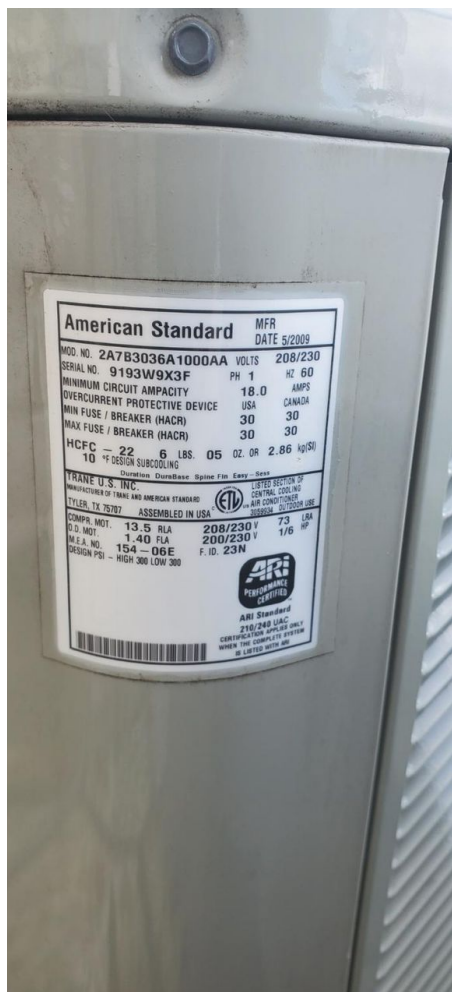
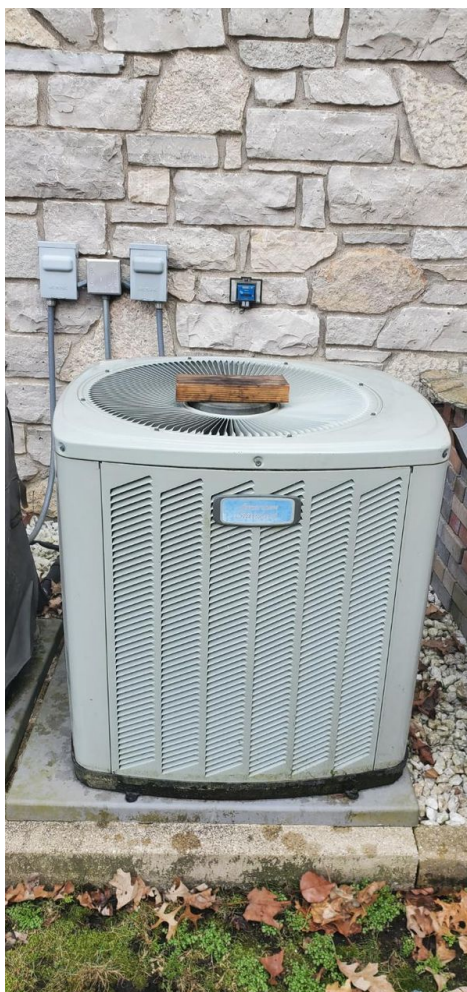
Right unit

Due to the low temperature i was not able to run the air-conditioner

I recommend further evaluation by a qualified HVAC for repairs and maintenance on yearly schedule

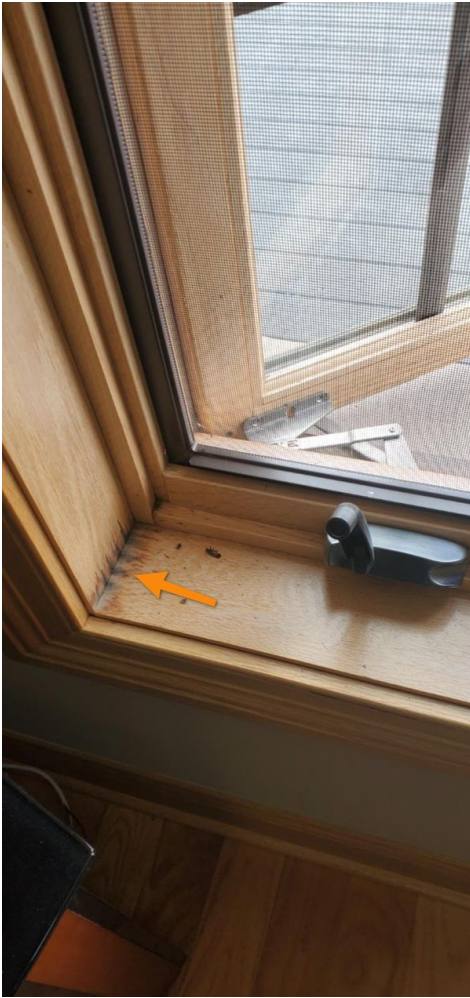
Living Room

The out side has had some repairs done and may be a past problem.

If there is a humidifier present the settings maybe set to high and causing excessive moisture in the home . This excessive moisture can show up in several places such as windows, walls, outlets, skylights, attics

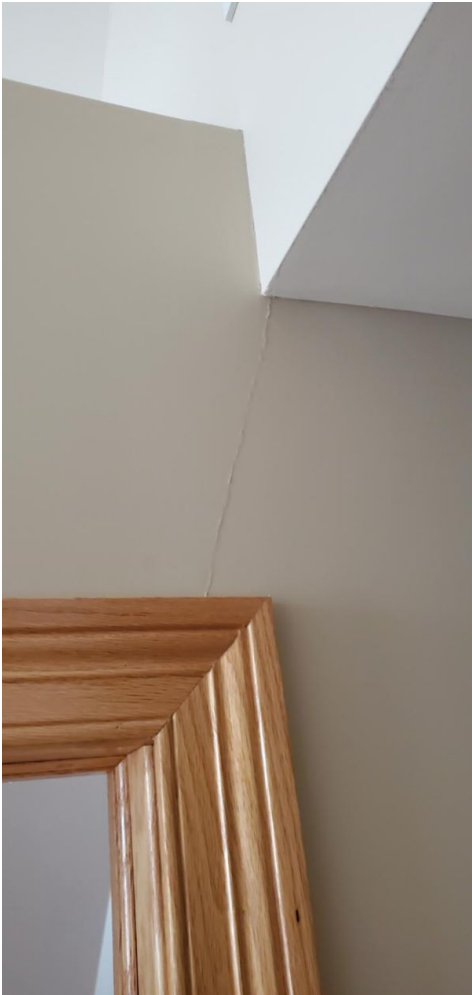
2nd Floor

Minor cracks at the corners of doors and windows in walls. Appeared to be the result of long-term settling. Some settling is not unusual in a home of this age and these cracks are not a structural concern. Further evaluation by a qualified contractor for repairs is recommended before painting

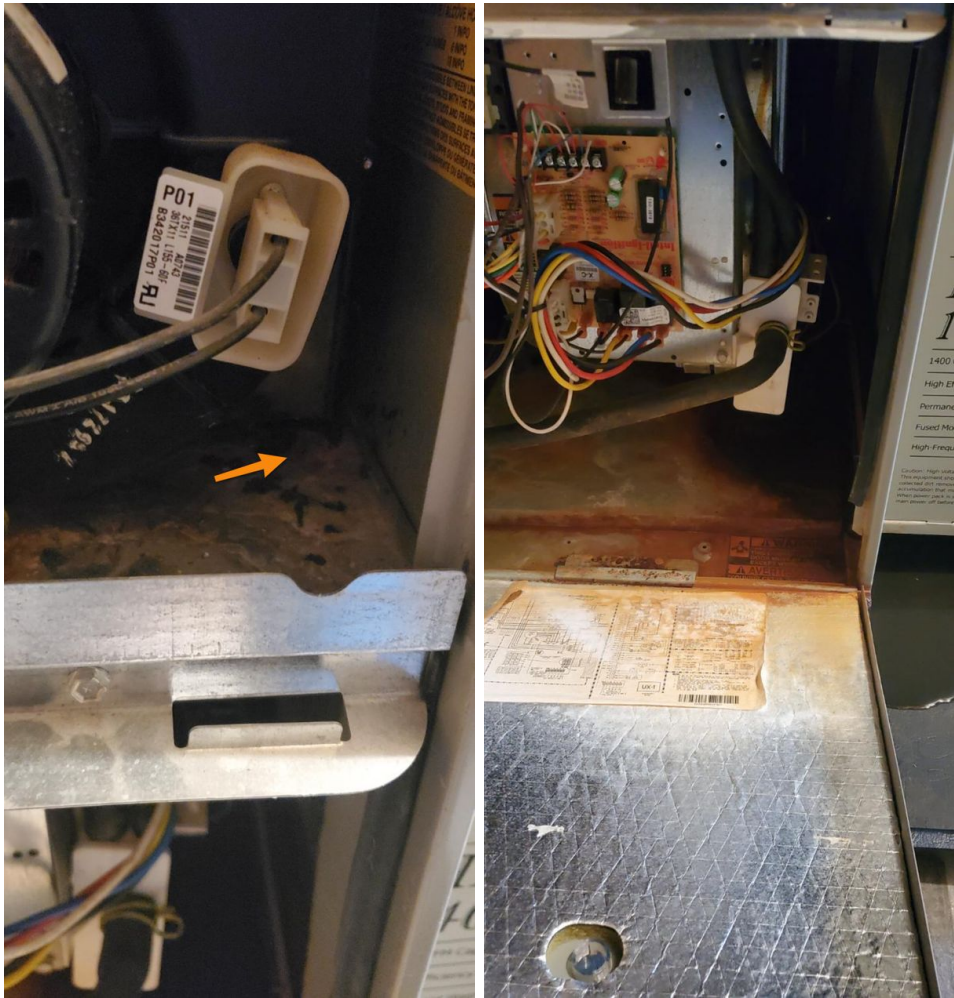
I observed areas of corrosion and rust at the heating system.
Further evaluation is highly recommended by a HVAC.
Older units have a tendency to accumulate rust and corrosion. This could be caused by several factors of which a qualified HVAC can determine and explain.

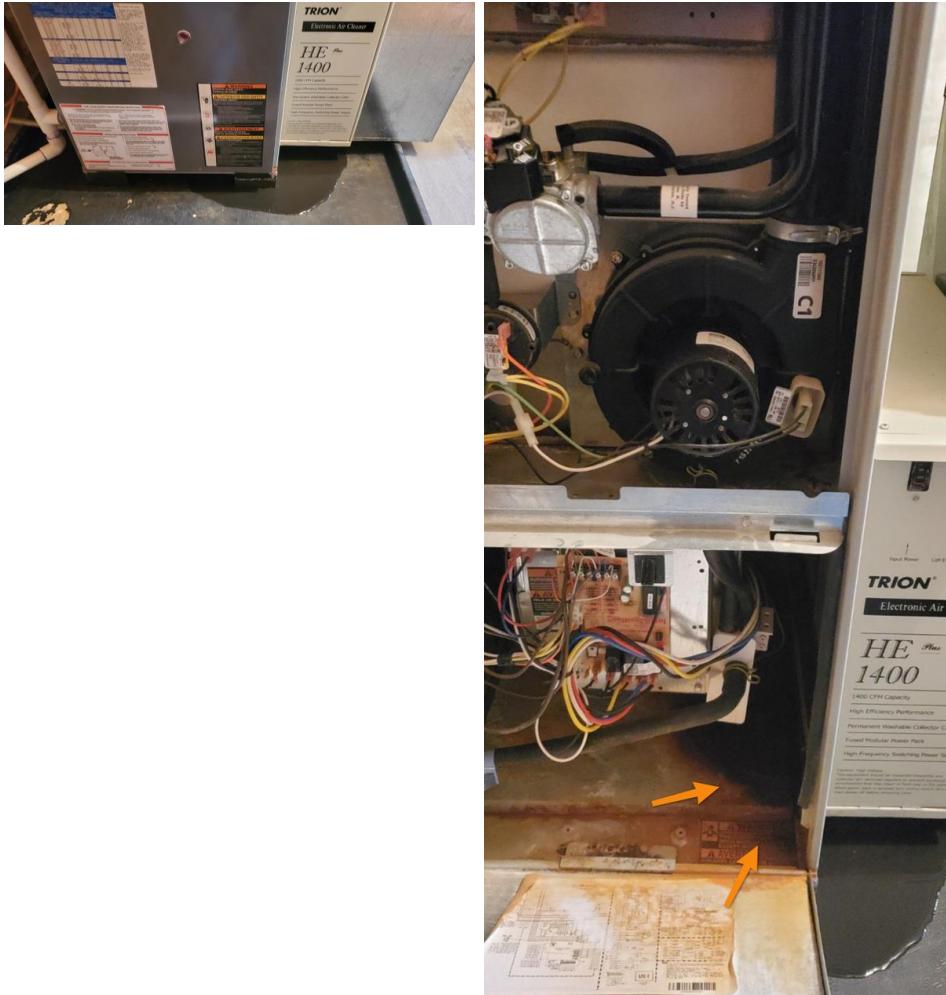
WATER HAS BEEN LEAKING AROUND THE FURNACE .

I recommend having a qualified HVAC service and evaluate.
It could be a plugged condensation drain, a cracked heat exchanger or a malfunctioning humidifier along with other items.

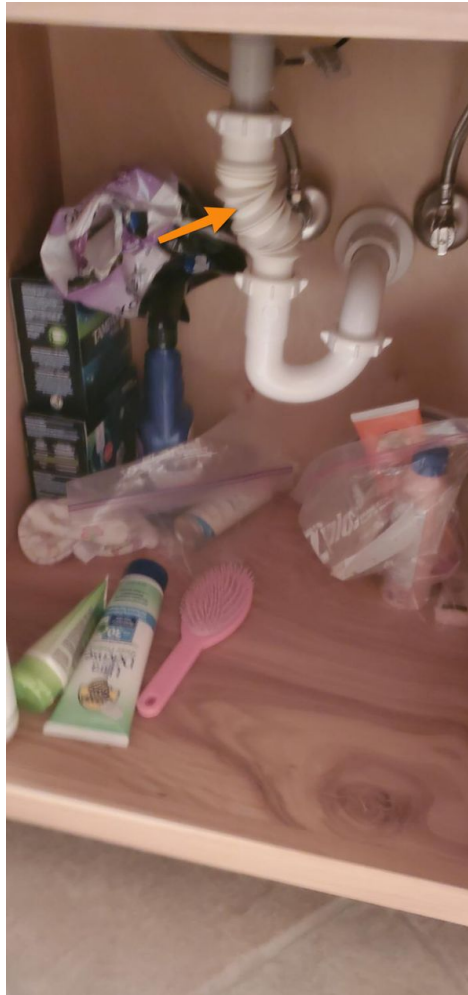
Basement Bathroom

10.2.2 Sinks, Tubs & Showers

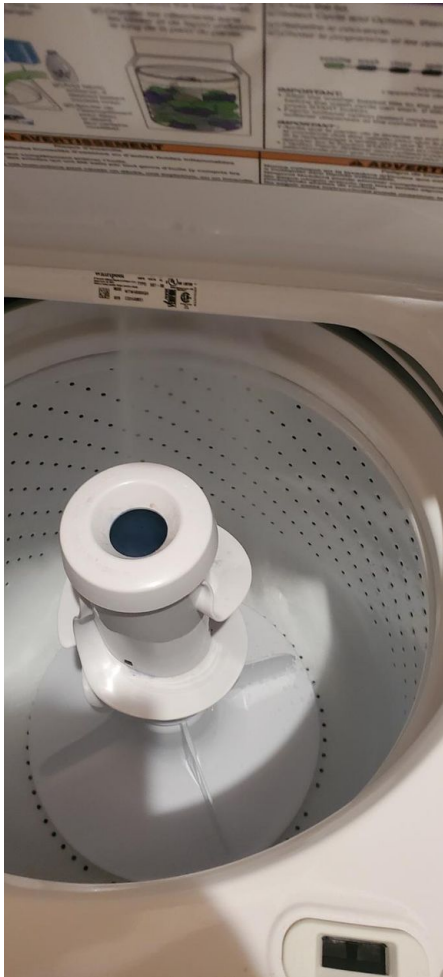
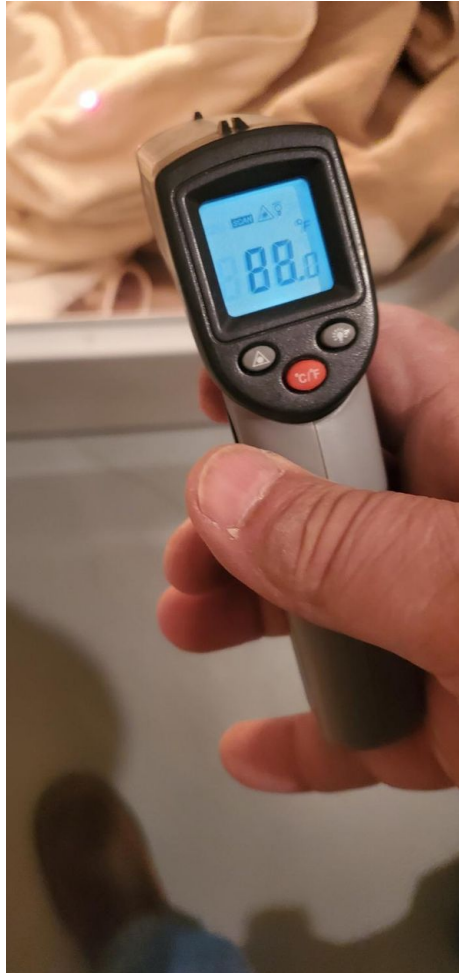
Clothes Washer: Ran one cycle for **Clothes Dryer:** Ran for courtesy courtesy

Laundry Room, Electric, and Tub: Monitor hoses and exhaust system and replace hoses every 5 years

Washer machine Hoses are supposed to be replace every five years to prevent failure and a water problem if they fail. Monitor yearly for corrosion or defects by a qualified plumber is recommended .

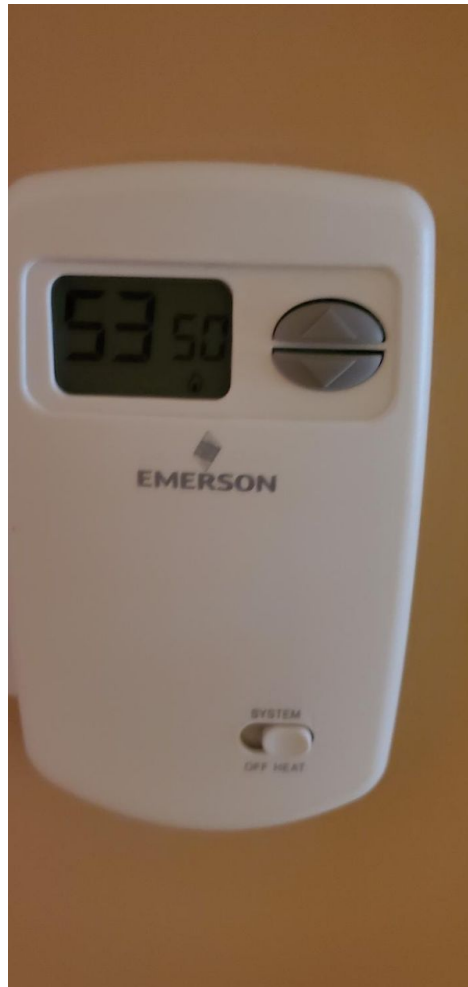
Hot-Water Heating System

I recommend having a scheduled maintenance program yearly with a qualified HVAC

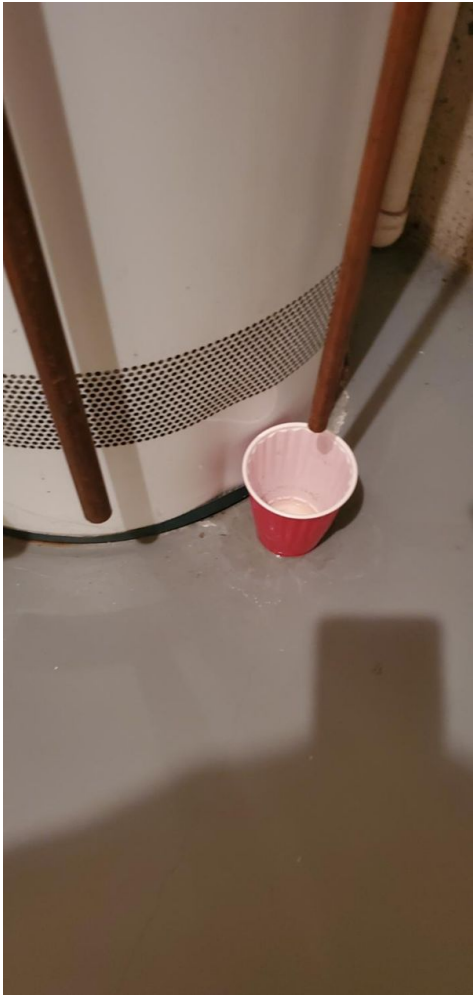
Basement

12.1.1 Heating System Information

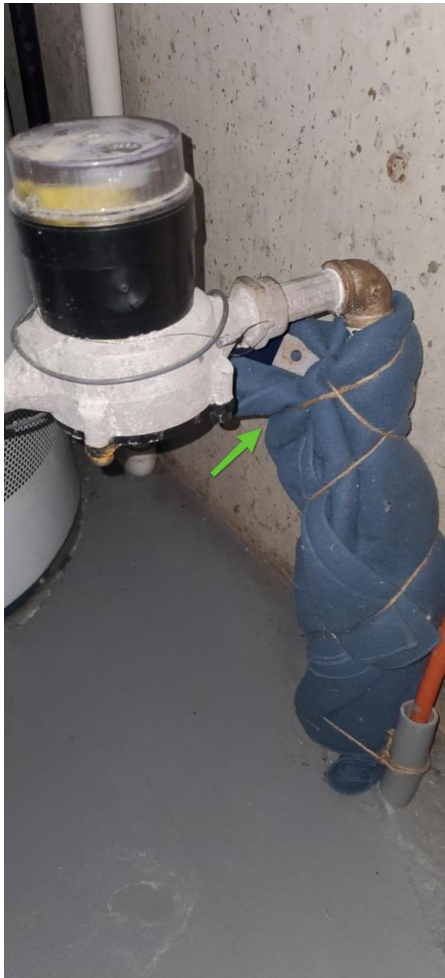
Hot Water Source: Size of Water heater
50

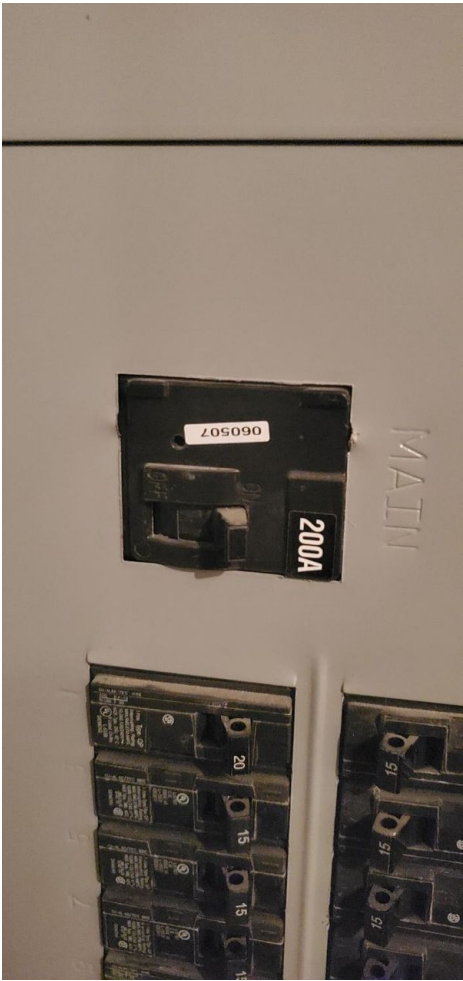
Electric Meter & Base: Type of service Underground	Main Service Disconnect: Inspected Main Service Disconnect I inspected the electrical main service disconnect.	Panelboards & Breakers: Make of Panel Siemens
--	--	---

Electric Meter & Base: Inspected the Electric Meter & Base

I inspected the electrical meter and base.
I recommend a qualified electrician for any electrical issues and repairs if and when any may occur.

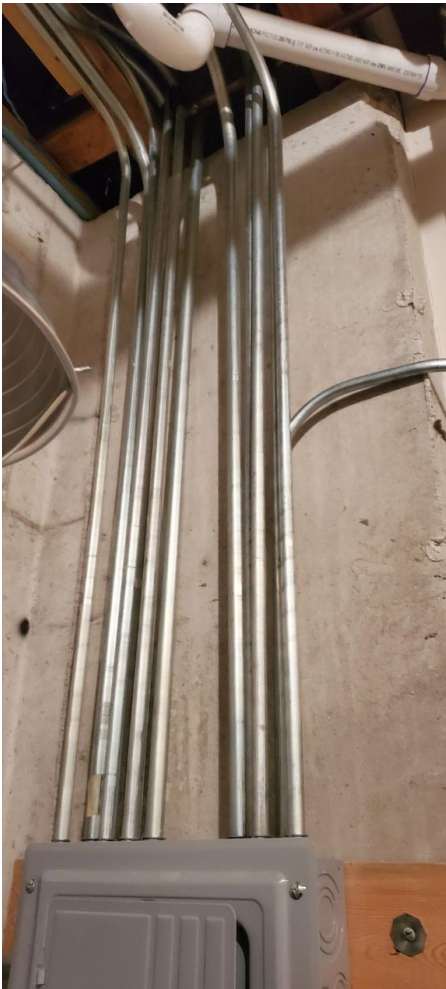
**Panelboards & Breakers: Inspected Main Panelboard & Breakers/fuses**

I inspected the electrical panelboards and over-current protection devices (circuit breakers and fuses).

I recommend Further evaluation by a qualified electrician for any electrical repairs that may occur.

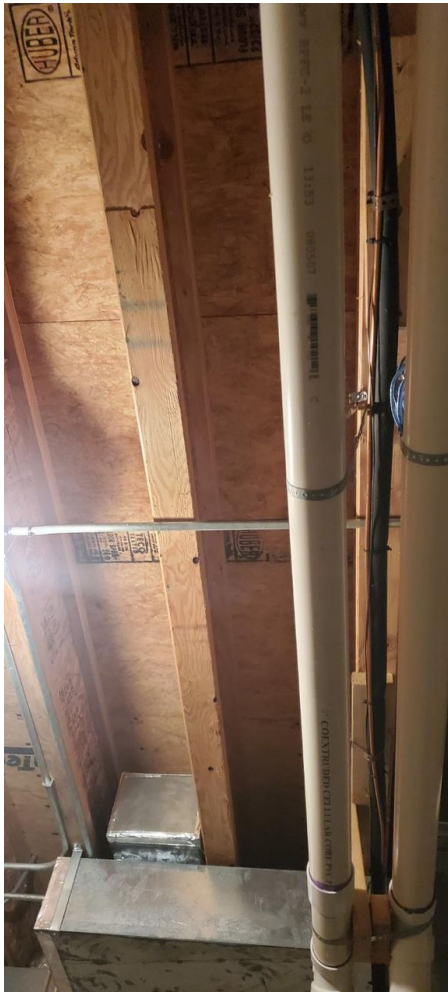
Floor joist

Wood framed , limited visual to inspect due to the design and build of the dwelling and finished surfaces.
