## CR QUALITY HOME INSPECTIONS

### RESIDENTIAL INSPECTION

1234 Main St. Lena Illinois 61048

01/03/2022 9:00AM

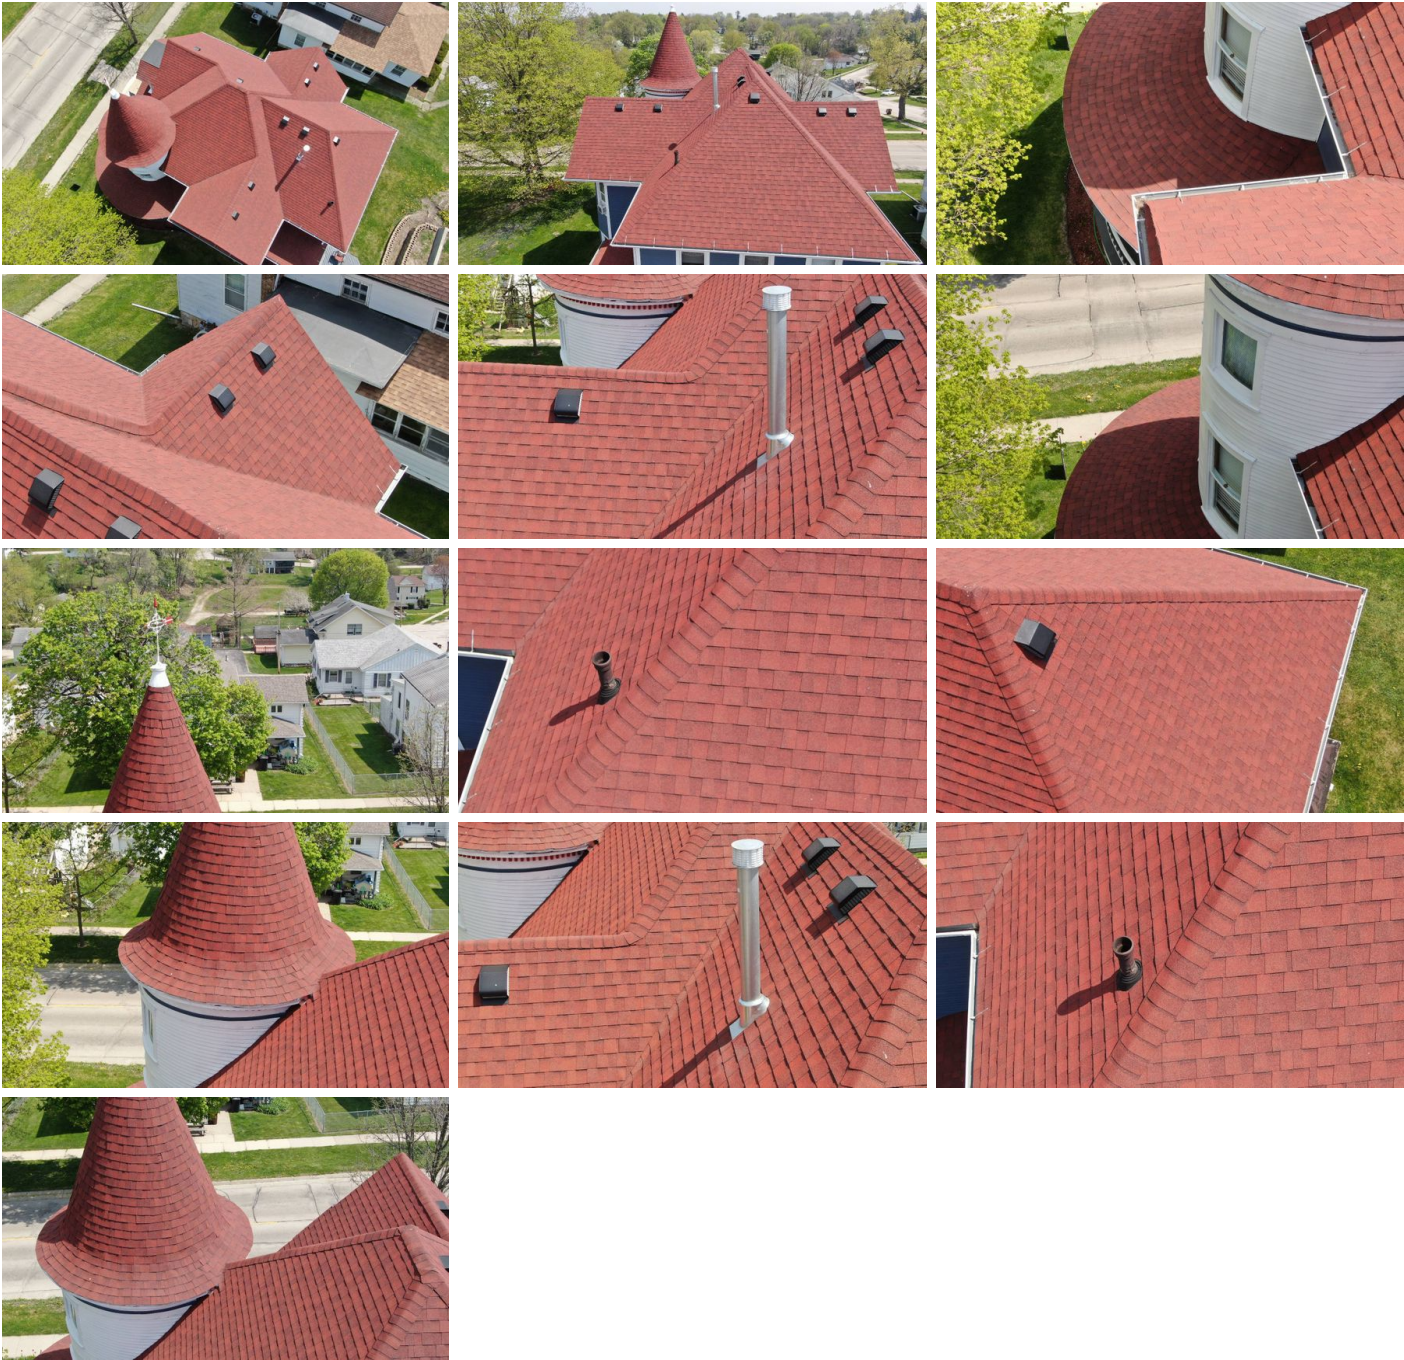
Roof Covering: Roof Was Inspected

Drone, Ground

We attempted to inspect the roof from various locations and methods, including from the ground and a ladder. The inspection was not an exhaustive inspection of every installation detail of the roof system according to the manufacturer's specifications or construction codes. It is virtually impossible to detect a leak except as it is occurring or by specific water tests, which are beyond the scope of our inspection. We recommend that you ask the sellers to disclose information about the roof

Monitor yearly for any deterioration or any damage that may be caused by winds, snow, ice, trees and other elements that could create damage. Keep all debris cleaned off and the gutters functioning as intended.

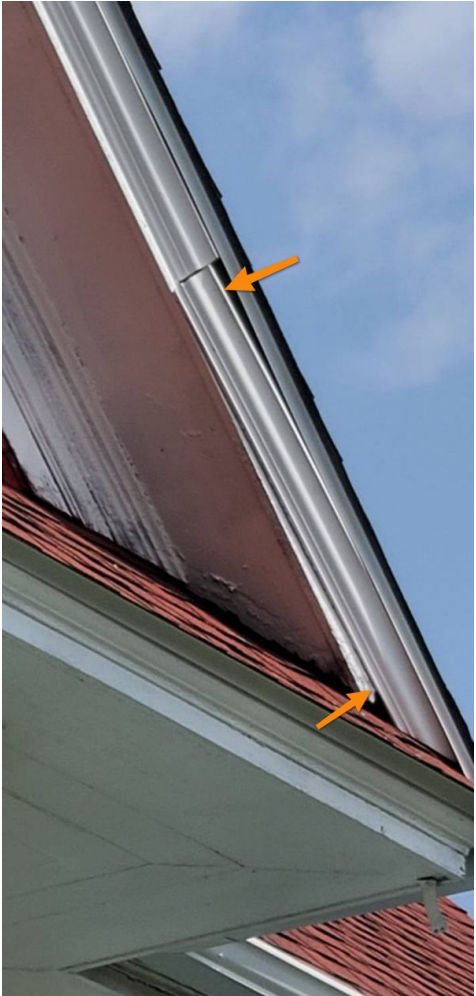
South 3rd Floor

DAMAGE OBSERVED AT EAVES

SOUTH

I observed indications that one or more areas of the eaves were damaged.  
Correction and further evaluation is recommended yearly by a qualified contractor.

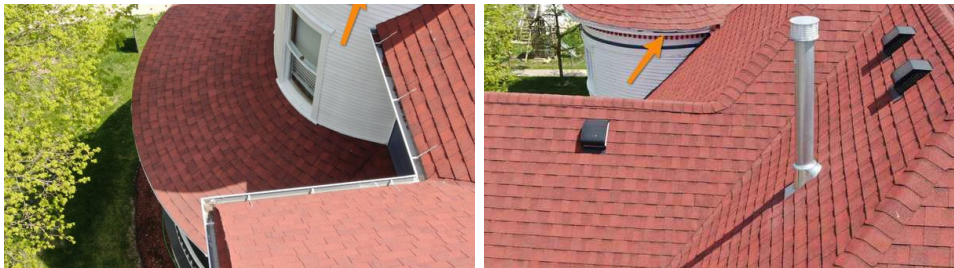
**DAMAGE OBSERVED AT FASCIA**

I observed indications that one or more areas of the fascia were damaged.  
Correction and further evaluation is recommended.

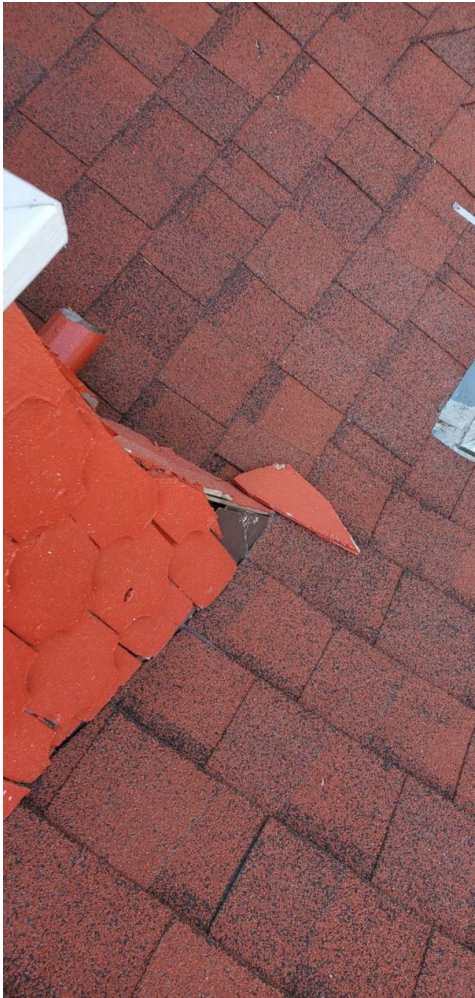
2nd Floor East

**DAMAGED WALL-COVERING MATERIAL**

I observed indications of a defect at the exterior wall-covering material.  
Correction and further evaluation is recommended.

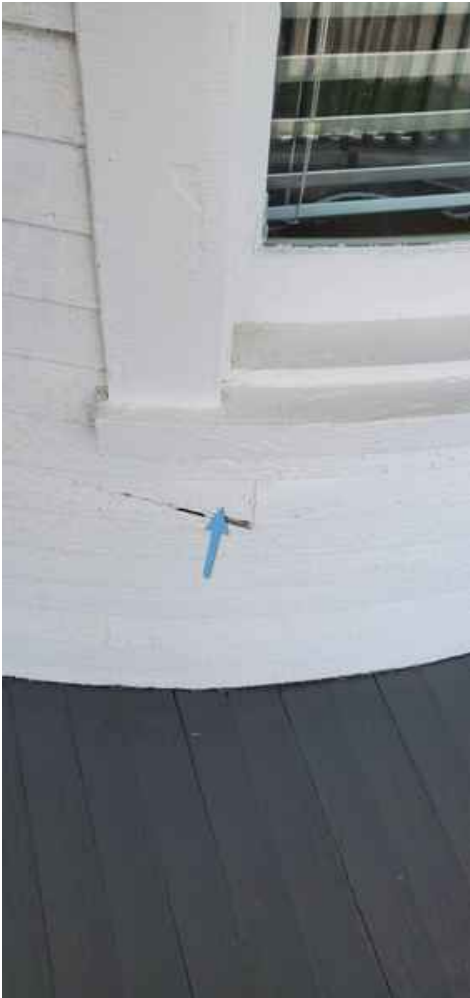
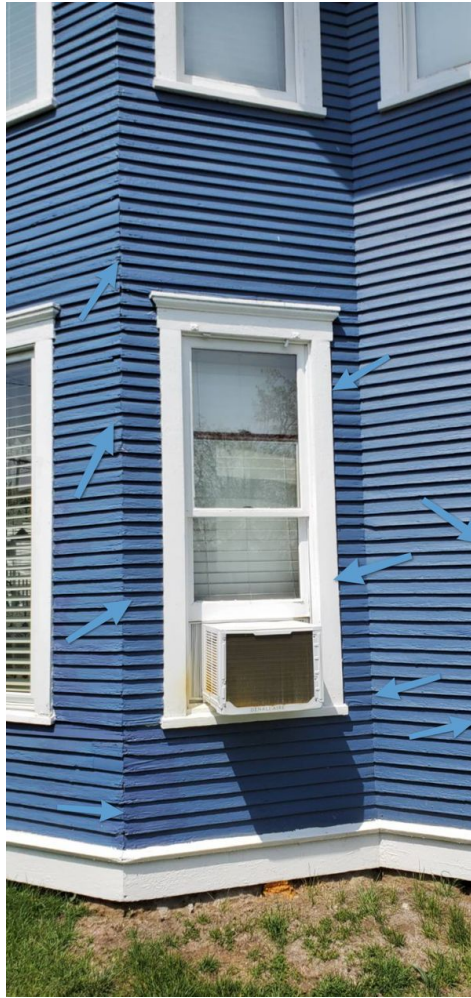
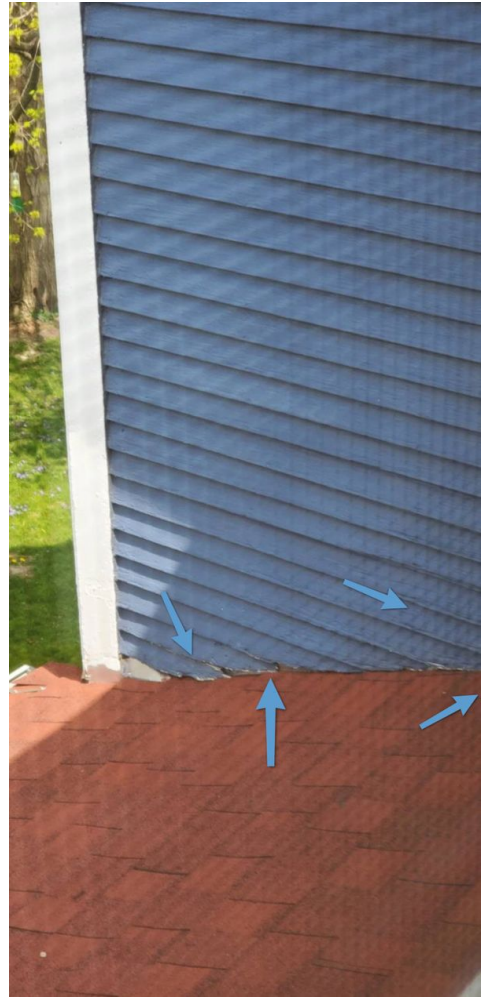
Front porch

**CRACKING - SPLITTING SIDING OR TRIM**

Siding showed cracking in one or more places. Recommend monitoring, repair or replace as needed .  
Consult a qualified contractor .

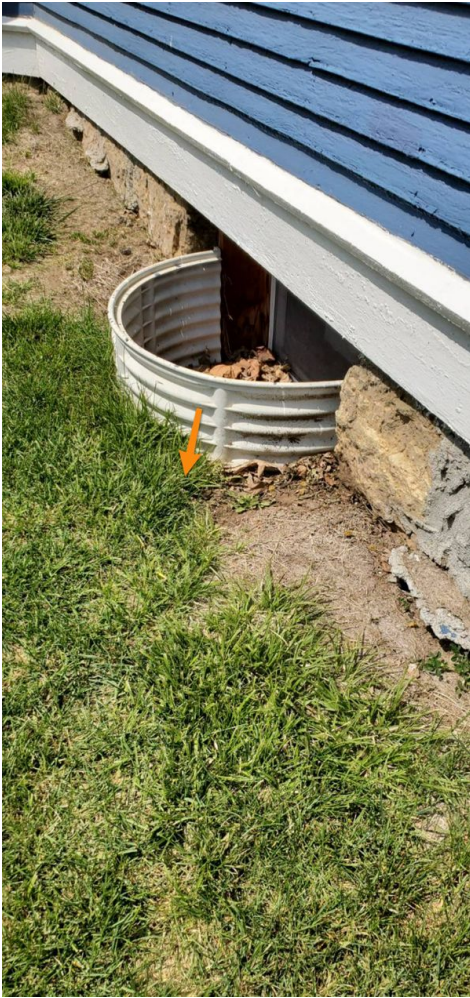
South

Grading is sloping towards the home in some areas. This could lead to water intrusion and foundation issues.

The ground around a house should slope away from all sides, ideally 6 inches for the first 10 feet from the house foundation perimeter. Downspouts, surface gutters and drains should also be directing water away from the foundation.

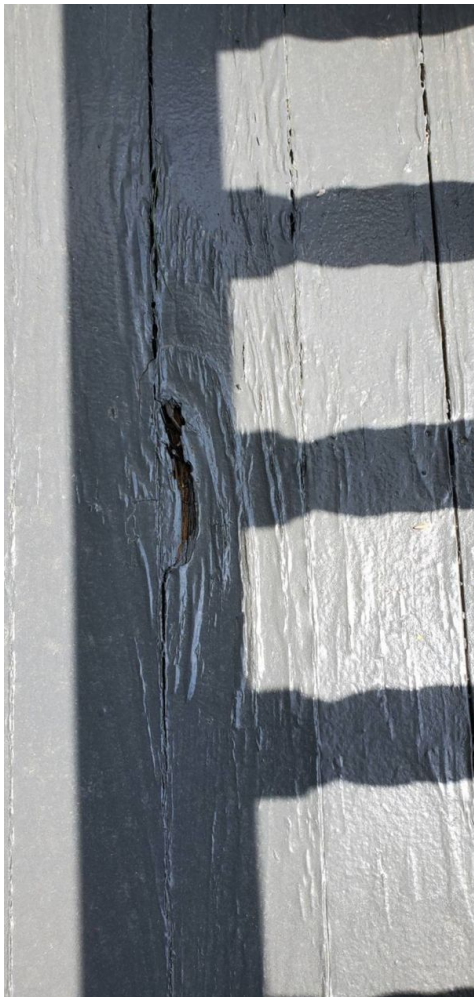
Front porch

### **DECK/PORCH - WOOD ROT**

I observed wood rot at the flooring on the deck/ porch . This condition is a structural defect.

Correction and further evaluation of the deck is recommended.

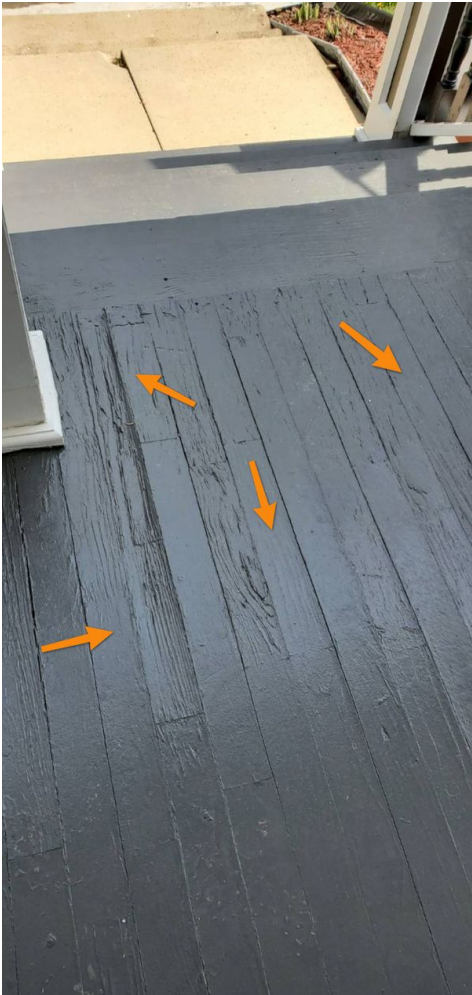
EAST

**SPONGEY PORCH FLOOR ,PREVIOUS REPAIRS**

Further evaluation by a qualified contractor

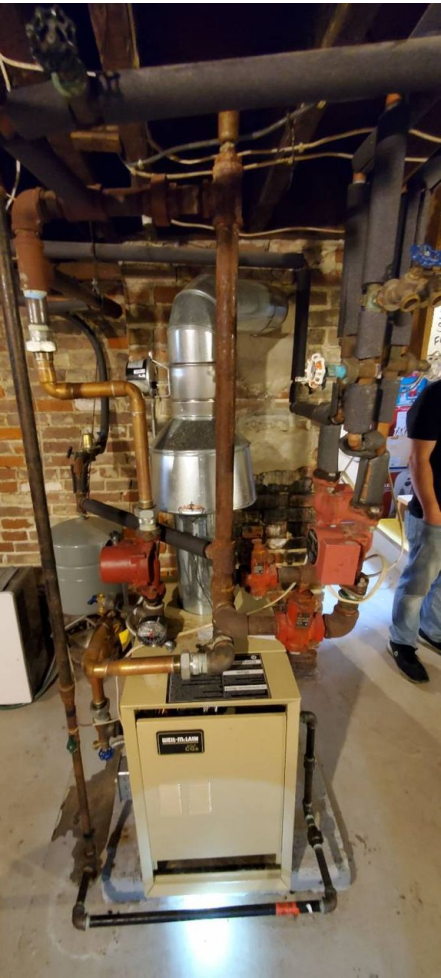
**Heating System Information:**  
**Energy Source**  
Gas, Heat Pump

**Heating Equipment: Energy Source**  
Gas

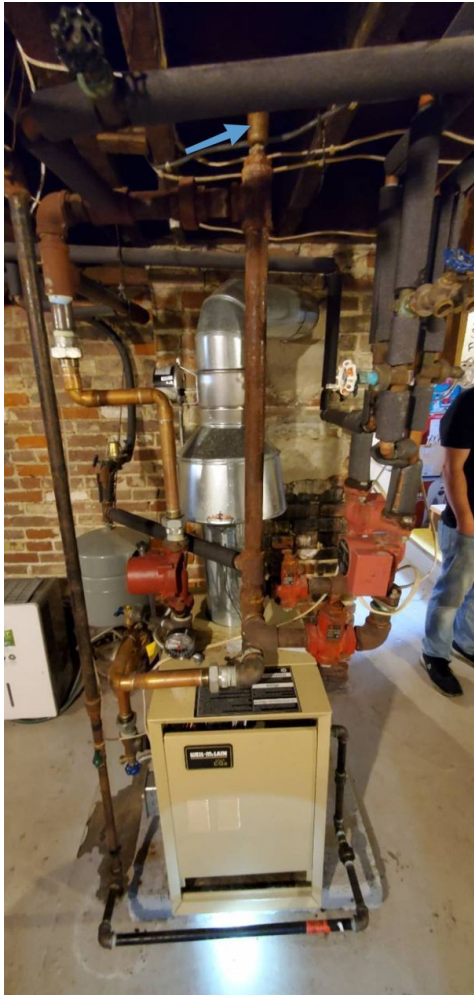
CORROSION STARTING, MONITOR FOR FURTHER DETERIORATION

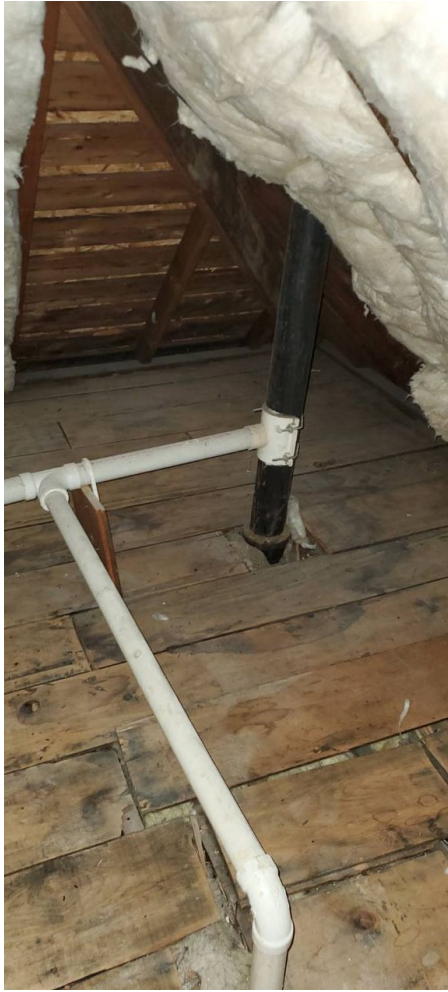
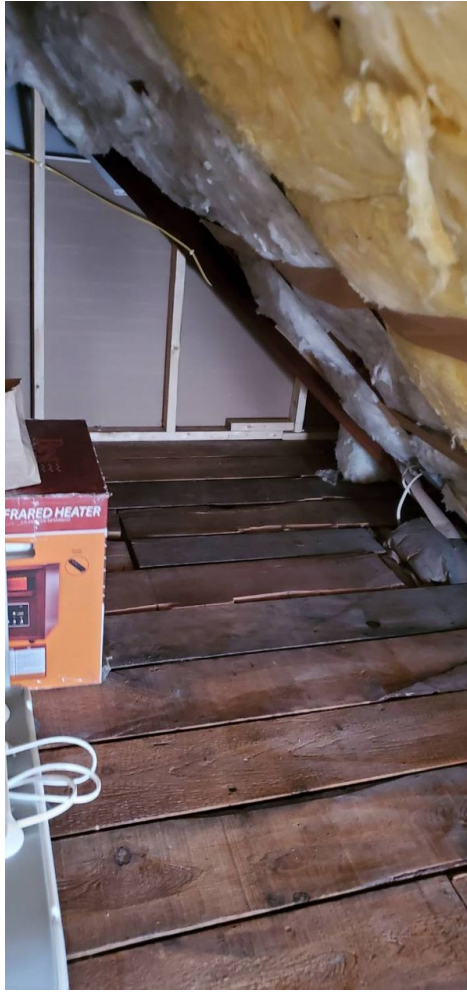
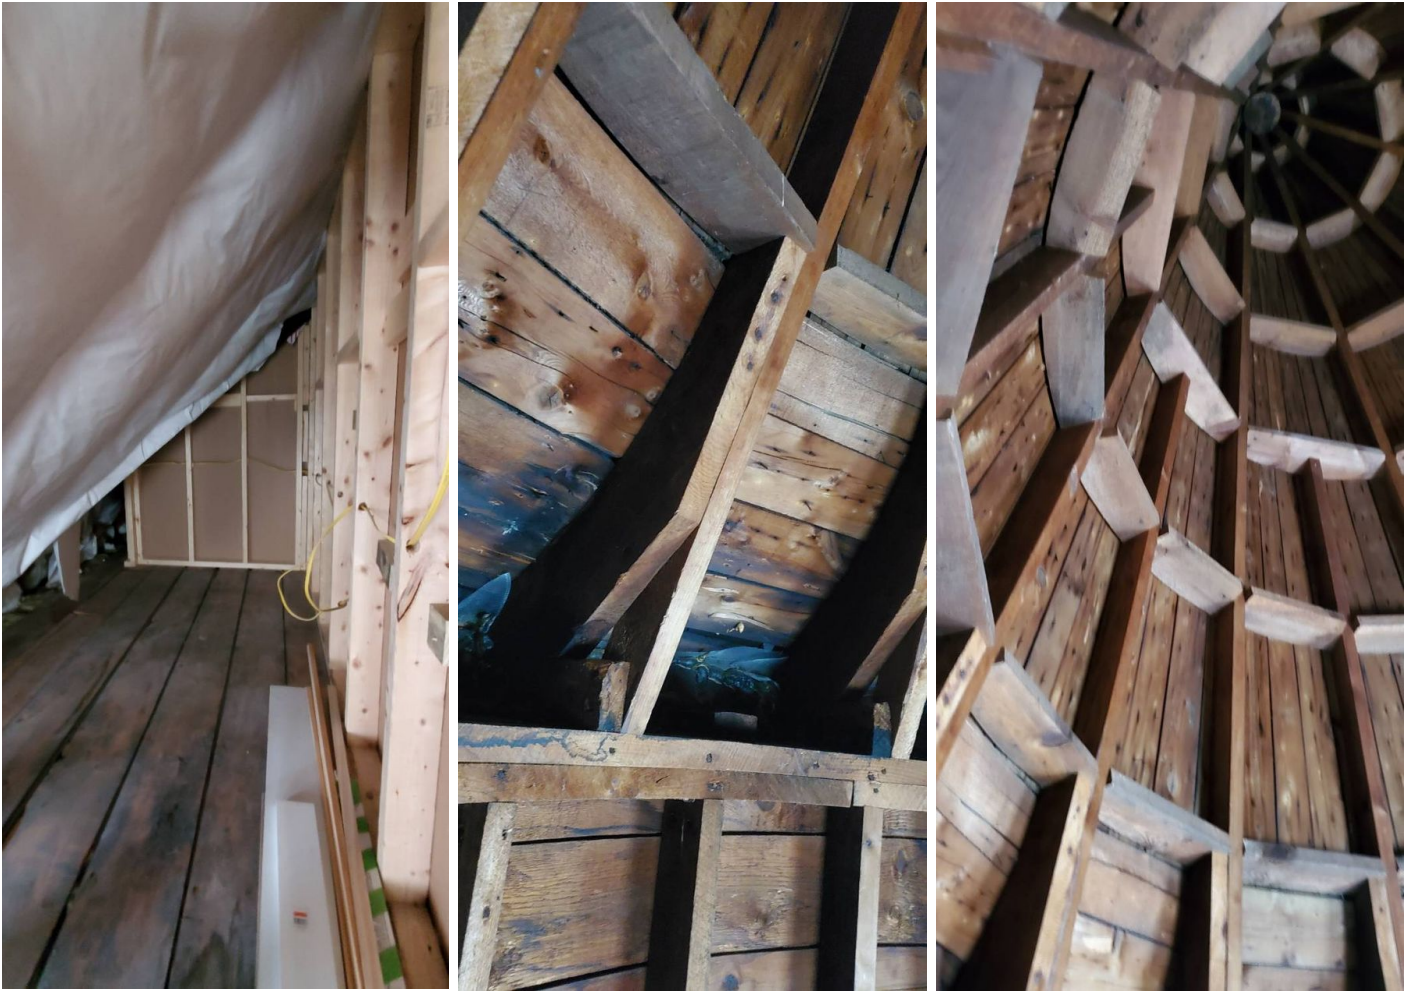
## Structural Components & Observations in Attic: Structural Components Were Inspected

Structural components were inspected from the attic space according to the [Home Inspection Standards of Practice](#). A limited visual and access to all attic areas was encountered due to the structural configuration and build. Even though we strive to fully inspect all areas of the attic they're times that this is not possible .

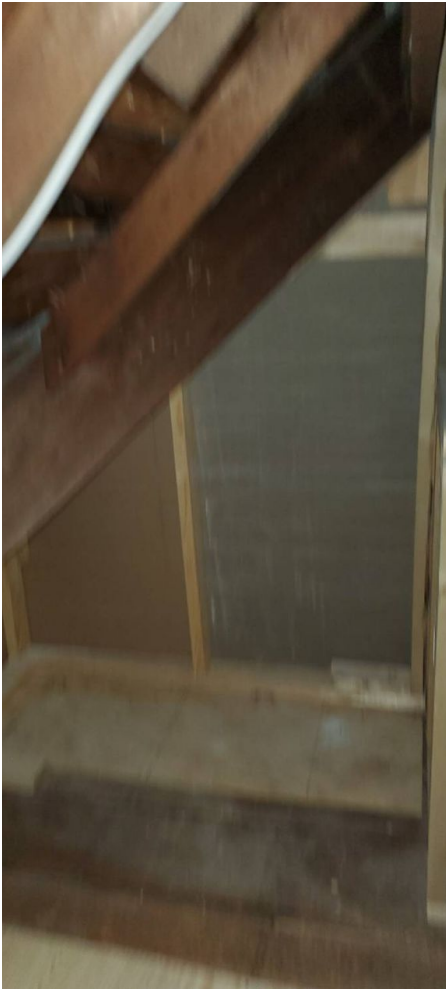
## Structural Components & Observations in Attic: Attic was inspected from

Inside the attic

The attic is open with a good visual of the interior. Inspectors generally don't disturb the insulation and jeopardize the thermo capacity of the insulation. Not all areas are accessible for inspection due to the structural build .

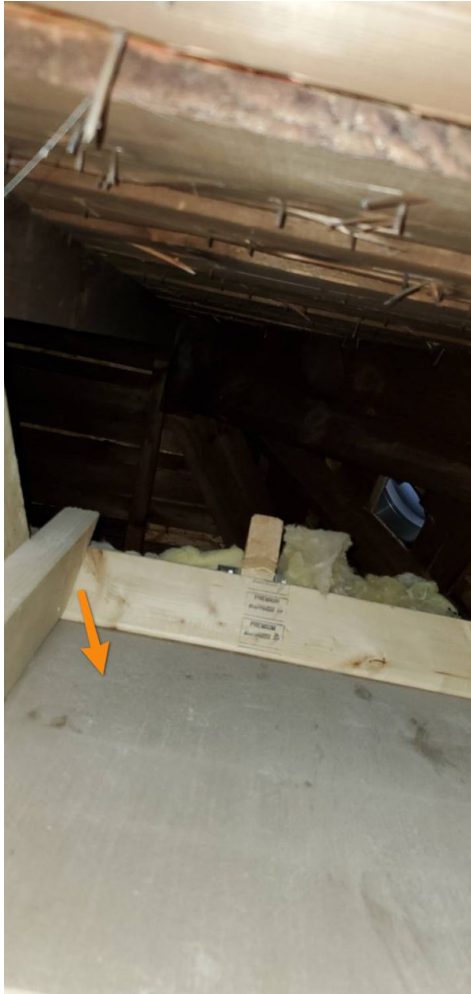
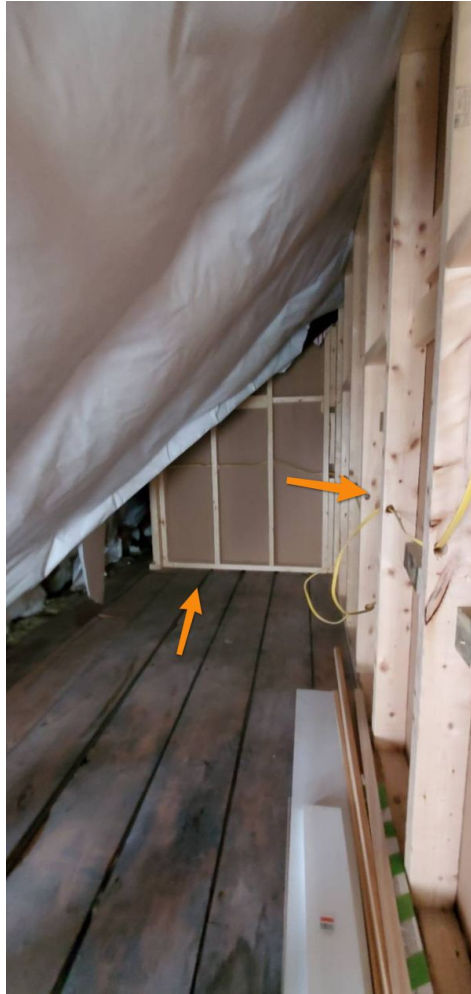
**ADDITIONAL INSULATION RECOMMENDED**

I recommend air sealing and adding insulation to the areas that need more insulation.

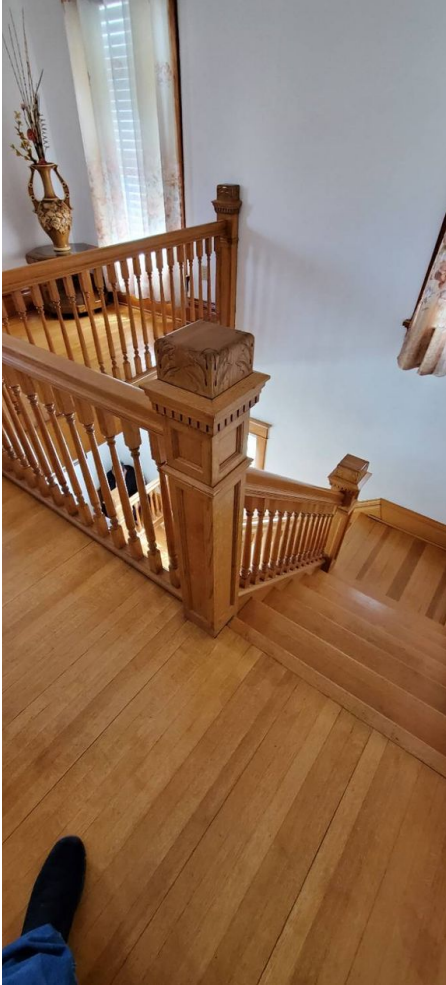
I inspected the stairs, steps, stoops, stairways and ramps that were within the scope of my home inspection.

All treads should be level and secure. Riser heights and tread depths should be as uniform as possible. As a guide, stairs must have a maximum riser of 7-3/4 inches and a minimum tread of 10 inches.

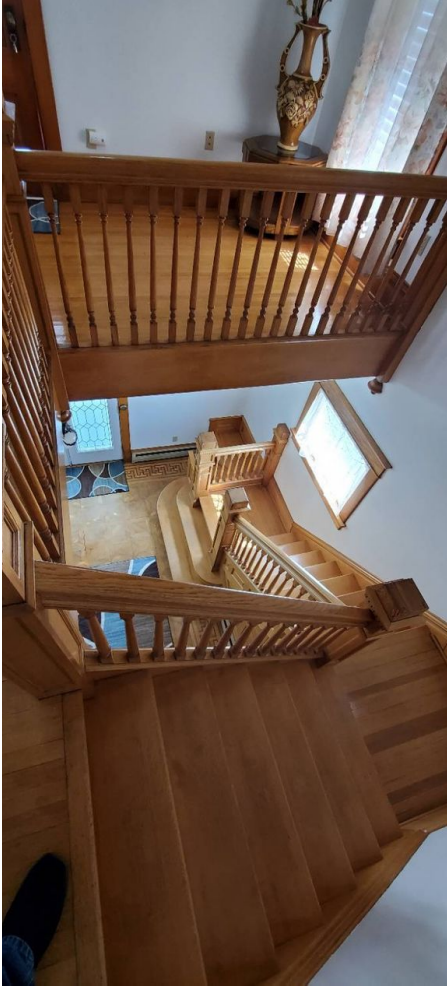
## Railings, Guards & Handrails: Railings, Guards & Handrails Were Inspected

I inspected a representative number railings, guards and handrails that were within the scope of the home inspection.

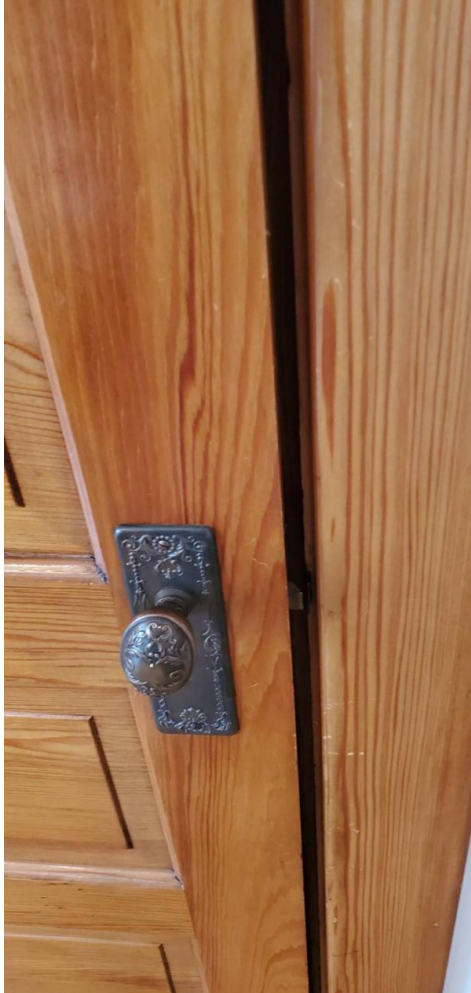
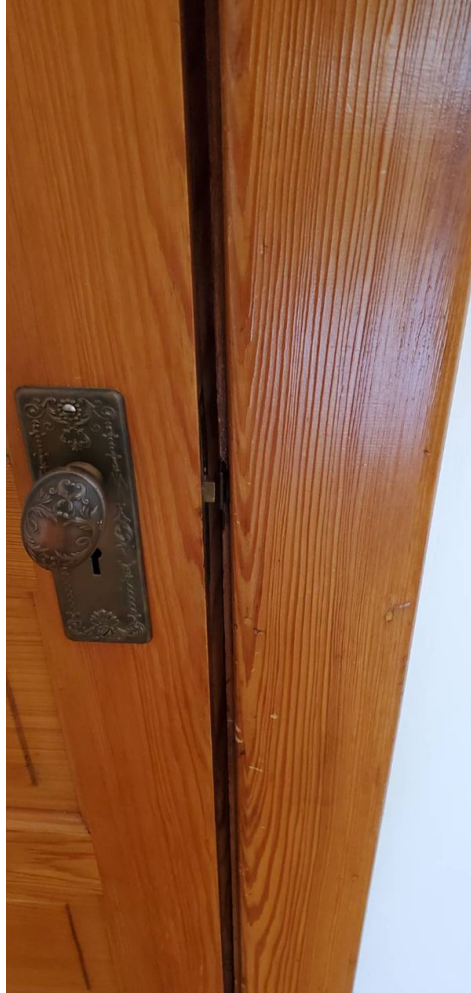
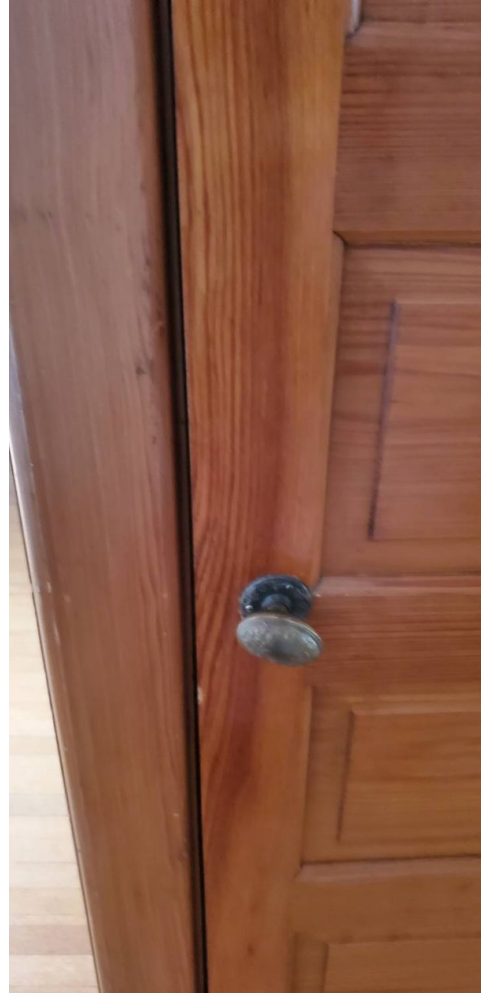
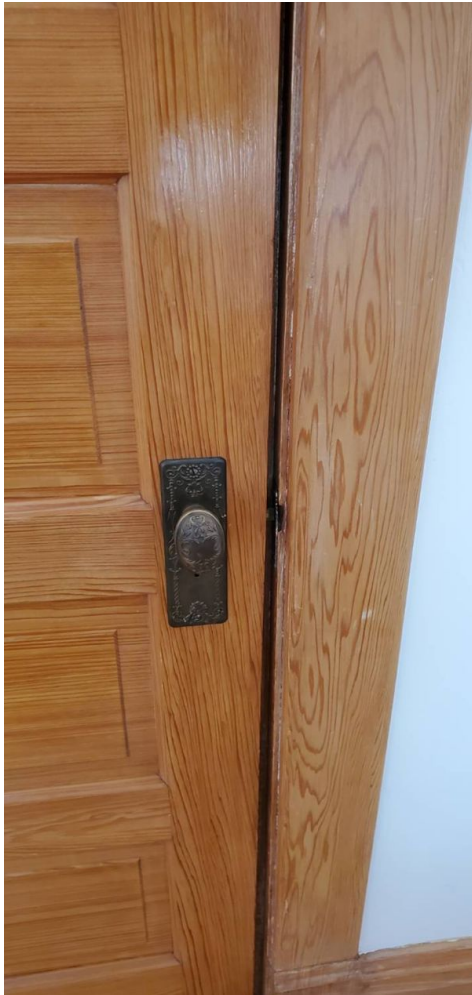
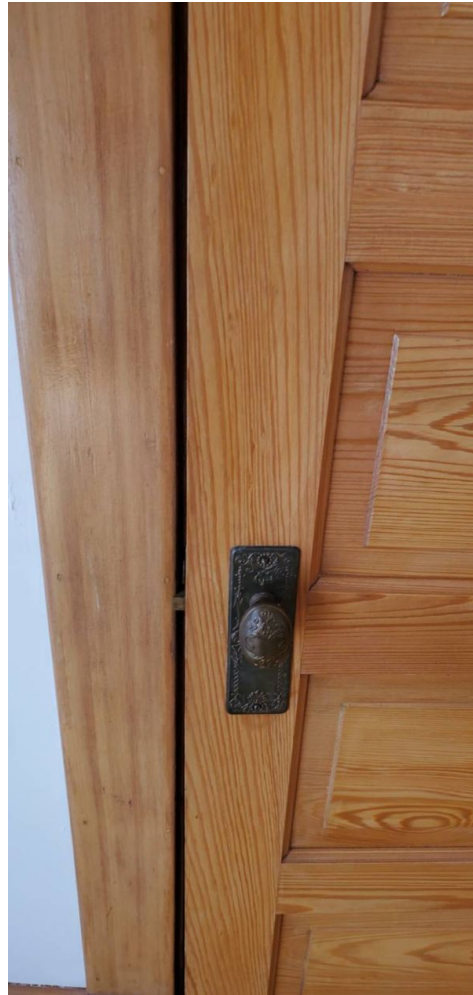
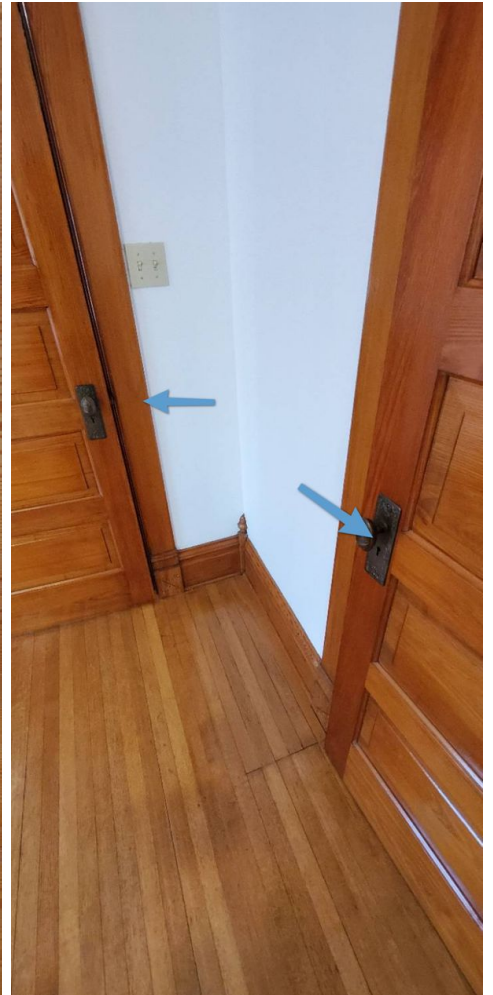
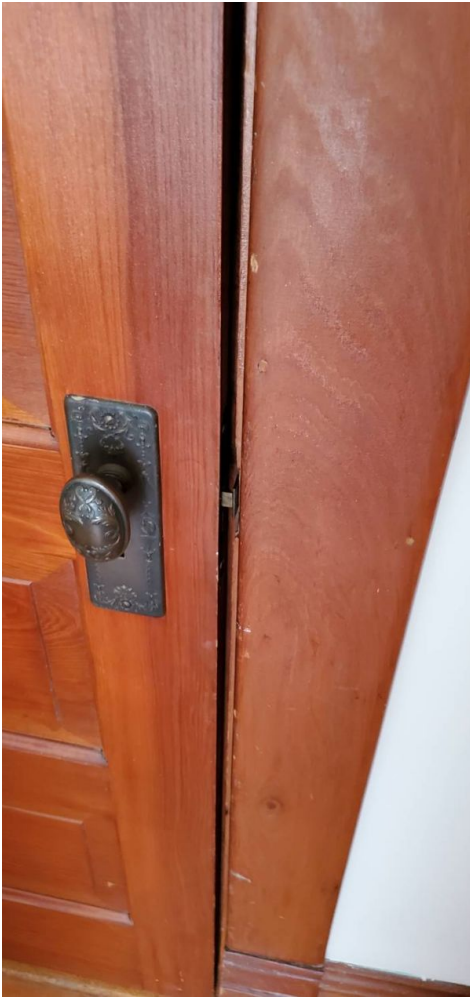
Master Bedroom

I observed that a door does not latch and stay closed properly. Further evaluation by a qualified contractor for adjustments and repairs.

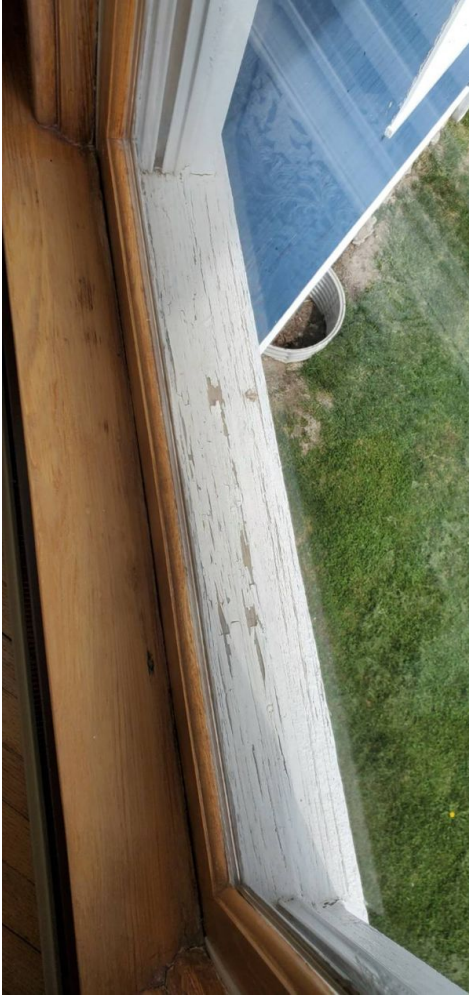
2nd Floor Bedroom

**PAINT,STAIN ,SEALER IS  
DETERIORATED**

Check all windows and doors with wood surfaces. Sand ,prepare, stain or paint to match and reseal all wood to preserve the integrity of the wood .

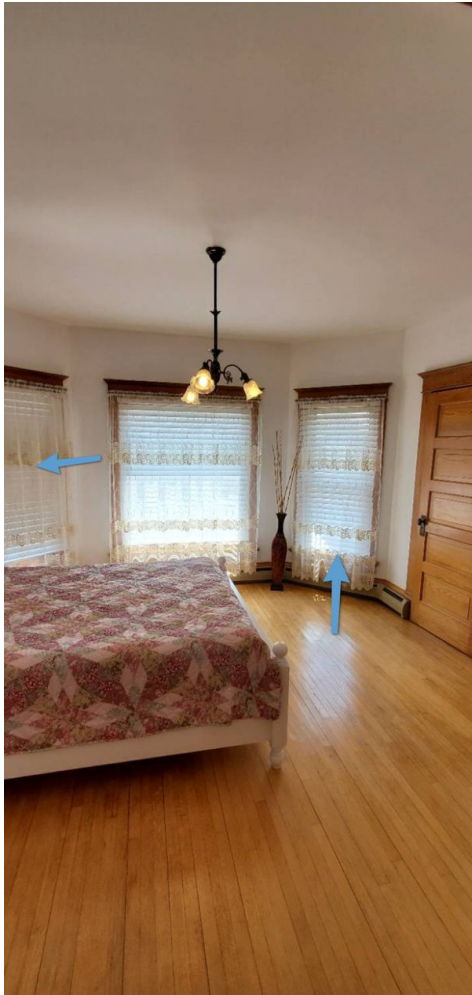
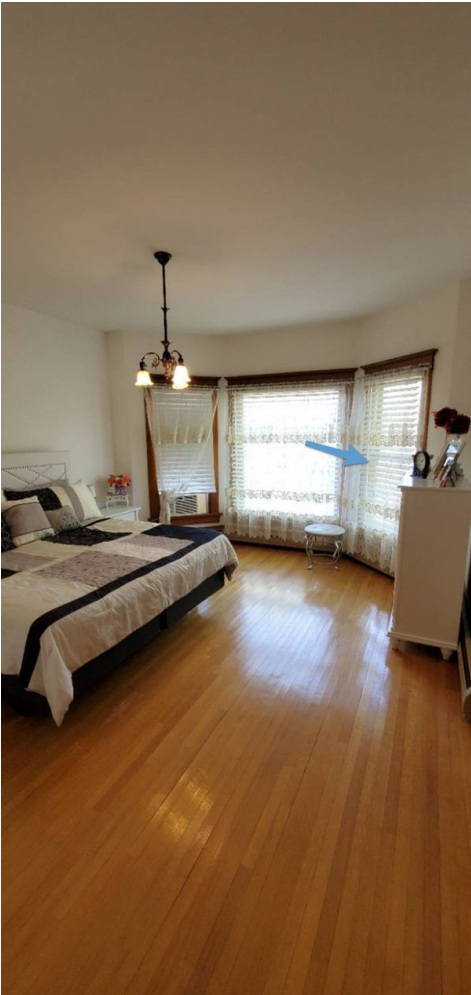
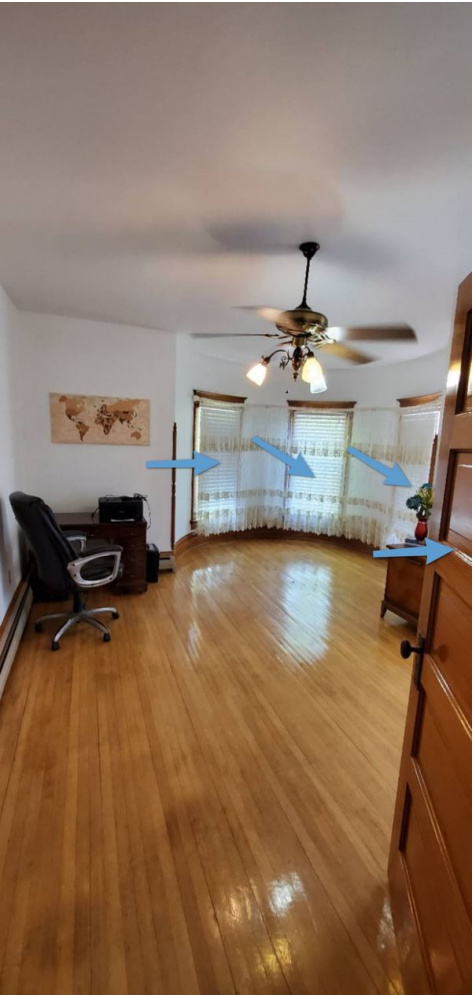
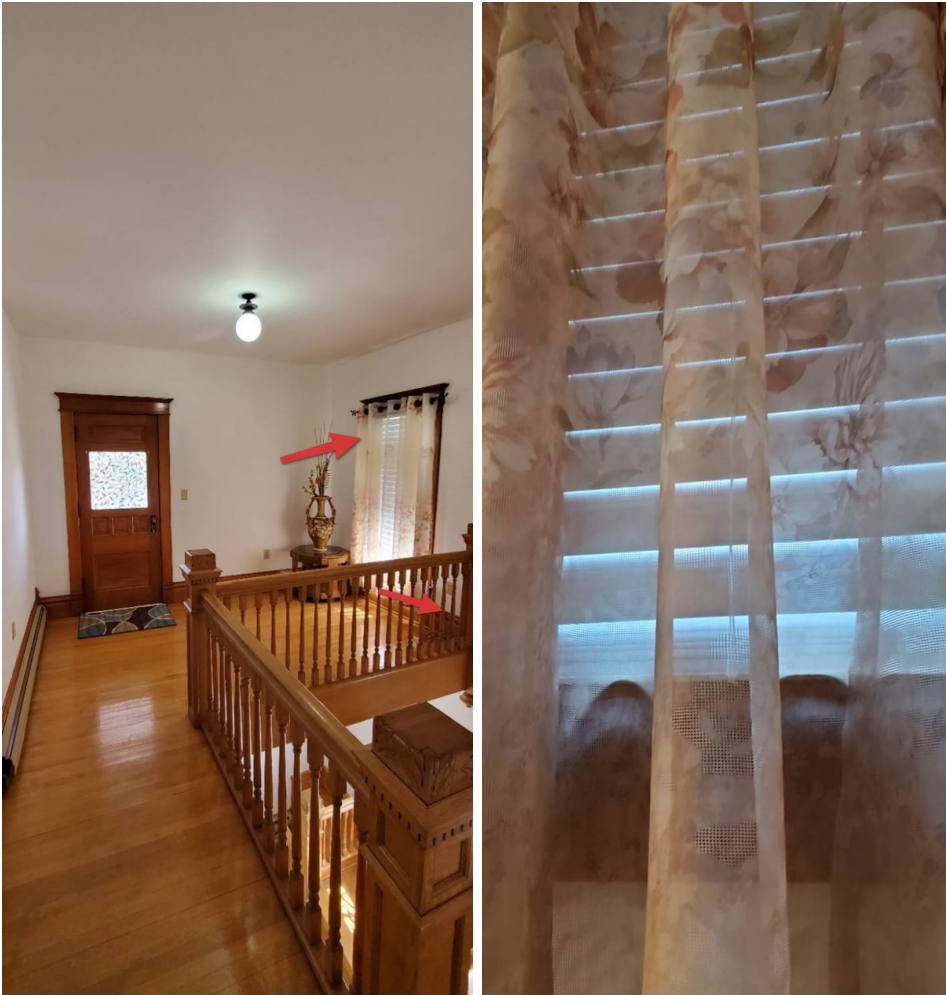
If a emergency would arise escaping from a window would be difficult without breaking the glass which could cause bodily harm as well.

The windows should function without extreme effort.

Check all windows and doors . It may be they were painted shut and need to have the paint cut at the blind stop to loosen the bond and free the sash. Further evaluation by a qualified contractor.

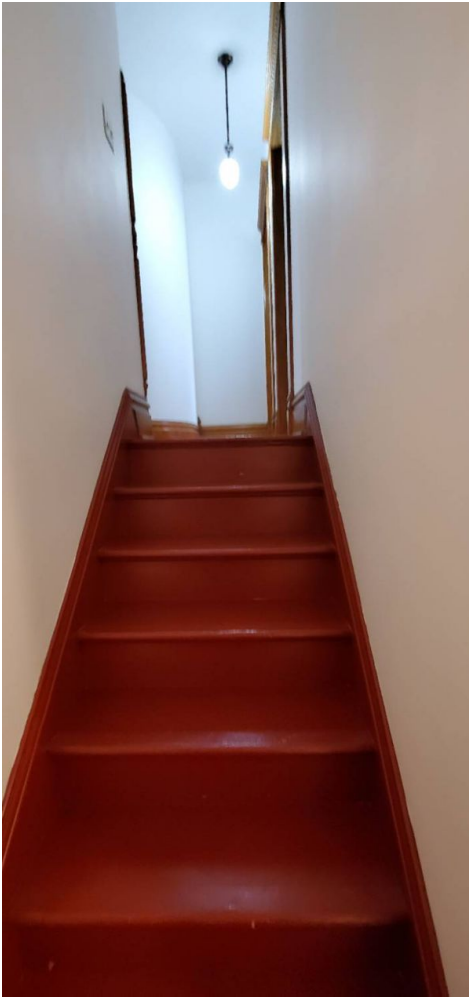
Back stairs

**MISSING HANDRAIL**

I observed a missing handrail.

There is more than one step here, and I recommend installing a handrail for safety.

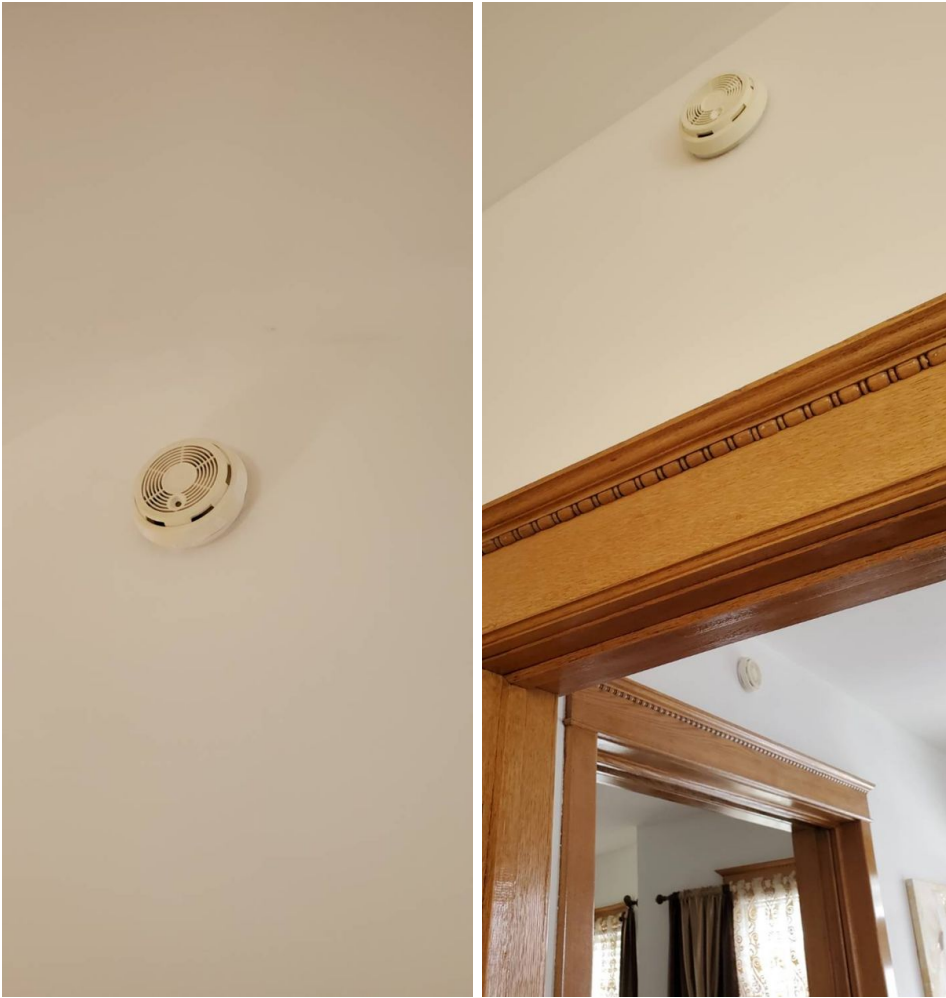
### **OLD DETECTORS, NEW DETECTORS RECOMMENDED**

I observed indications of old smoke and co2 detectors in the house. Detectors should be replaced every 5-10 years. They should be hard-wired with electricity and have a battery backup feature in case the electricity turns off. New smoke detectors are recommended.

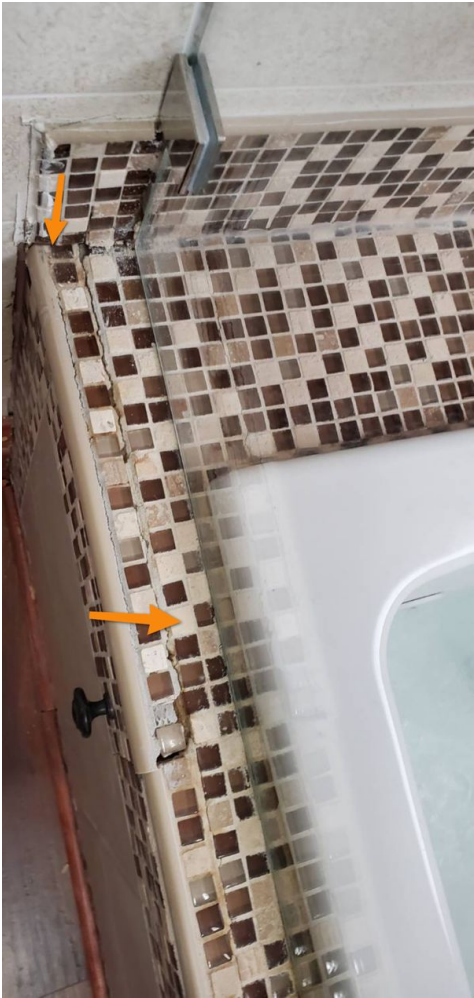
LOOSE TILES IN SHOWER

I observed loose tiles in the bathroom shower which indicates water damage behind the tiles.

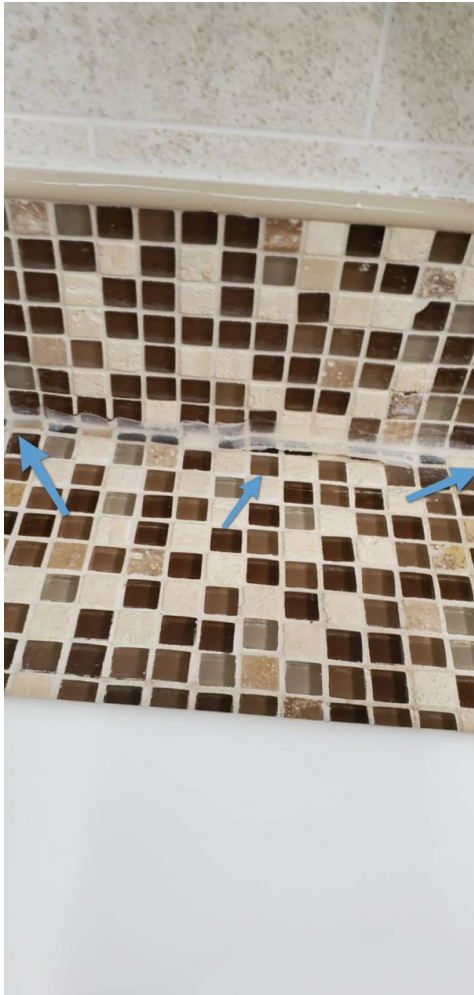
CAULKING OR GROUT IS DETERIORATED

Have a qualified contractor evaluate and repair

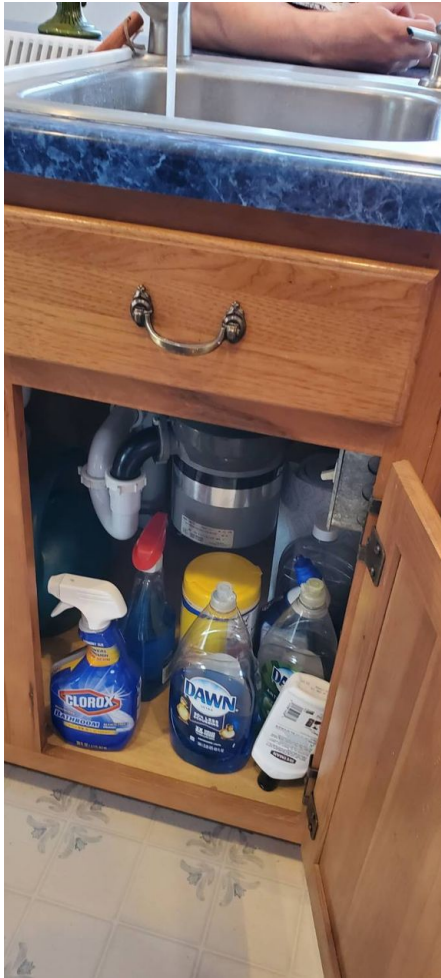
#### Kitchen Sink: Ran Water at Kitchen Sink

I ran water at the kitchen sink.

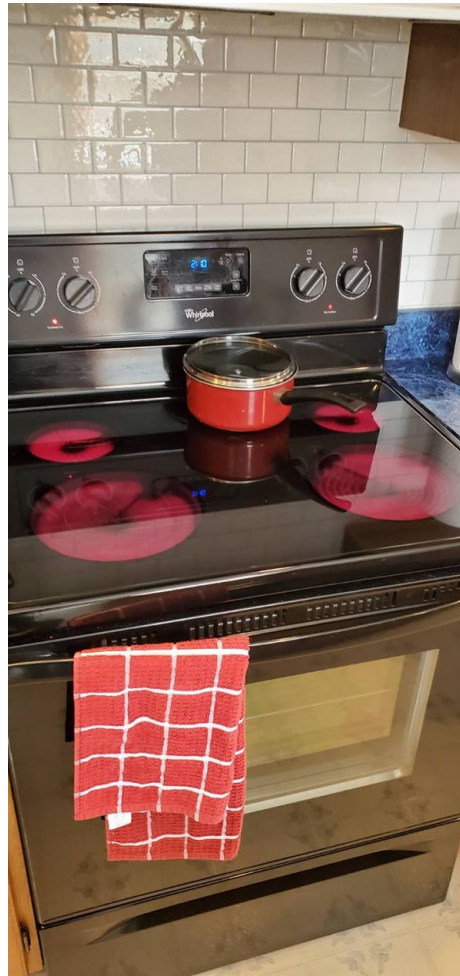
#### Range/Oven/Cooktop: Turned On Stove & Oven

I turned on the kitchen's stove and oven.

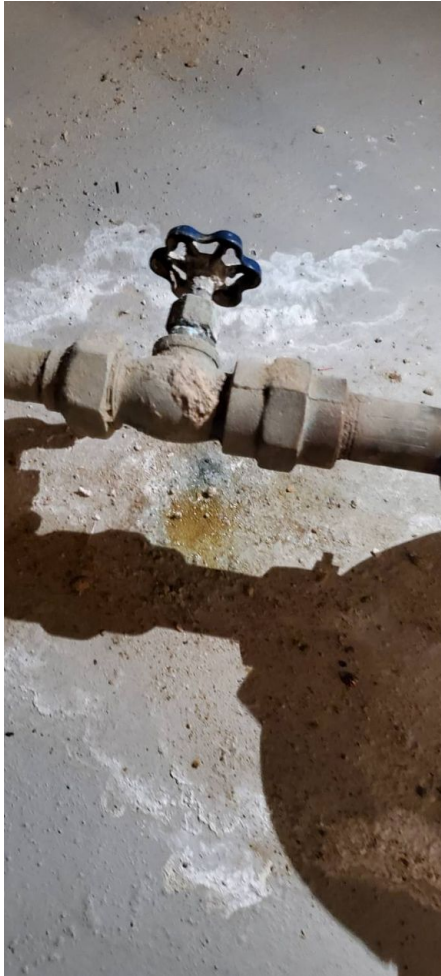
**Main Water Shut-Off Valve:**  
**Location of Main Shut-Off Valve**  
Basement

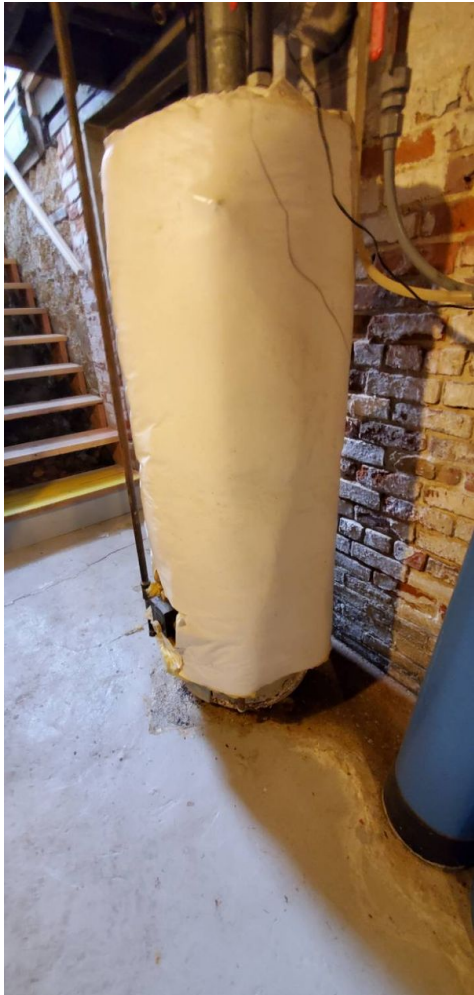
**INSPECTION RESTRICTION**

The inspection of the system was restricted. I was unable to completely inspect the system.
