## CR QUALITY HOME INSPECTIONS

### RESIDENTIAL INSPECTION

1234 Main St. Lena Illinois 61048

01/03/2022 9:00AM

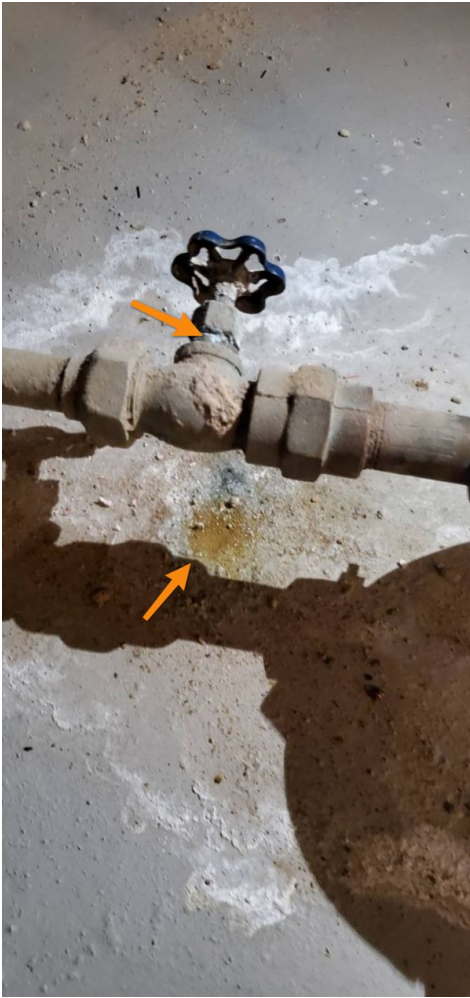
**ACTIVE WATER LEAK AT VALVE**

I observed an active water leak at the main water shut-off valve.

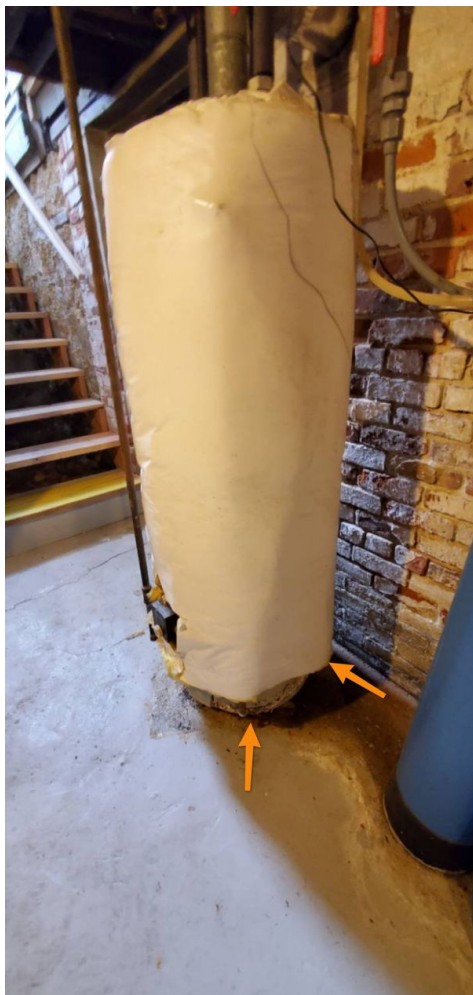
Recommendation /Needs Attention**WATER LEAK**

I observed an active water leak at the hot water source.

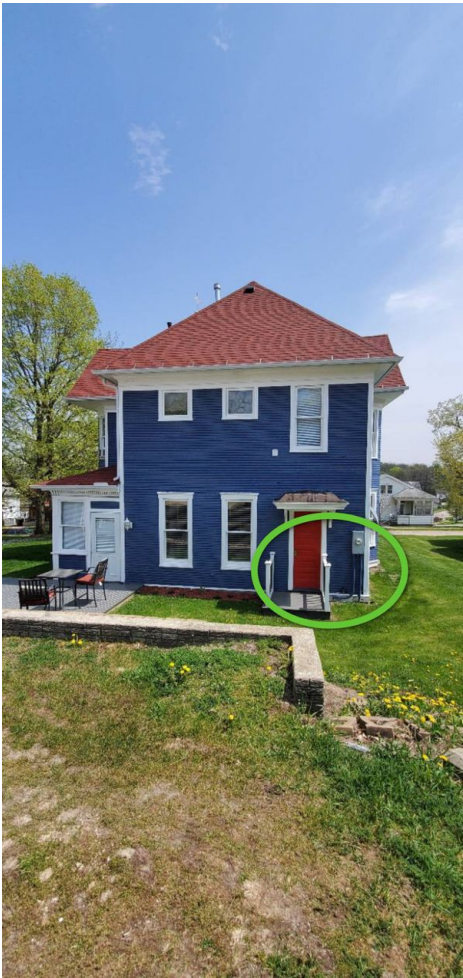
**Service-Entrance Conductors: Inspected Service-Entrance Conductors**

I inspected the electrical service-entrance conductors.

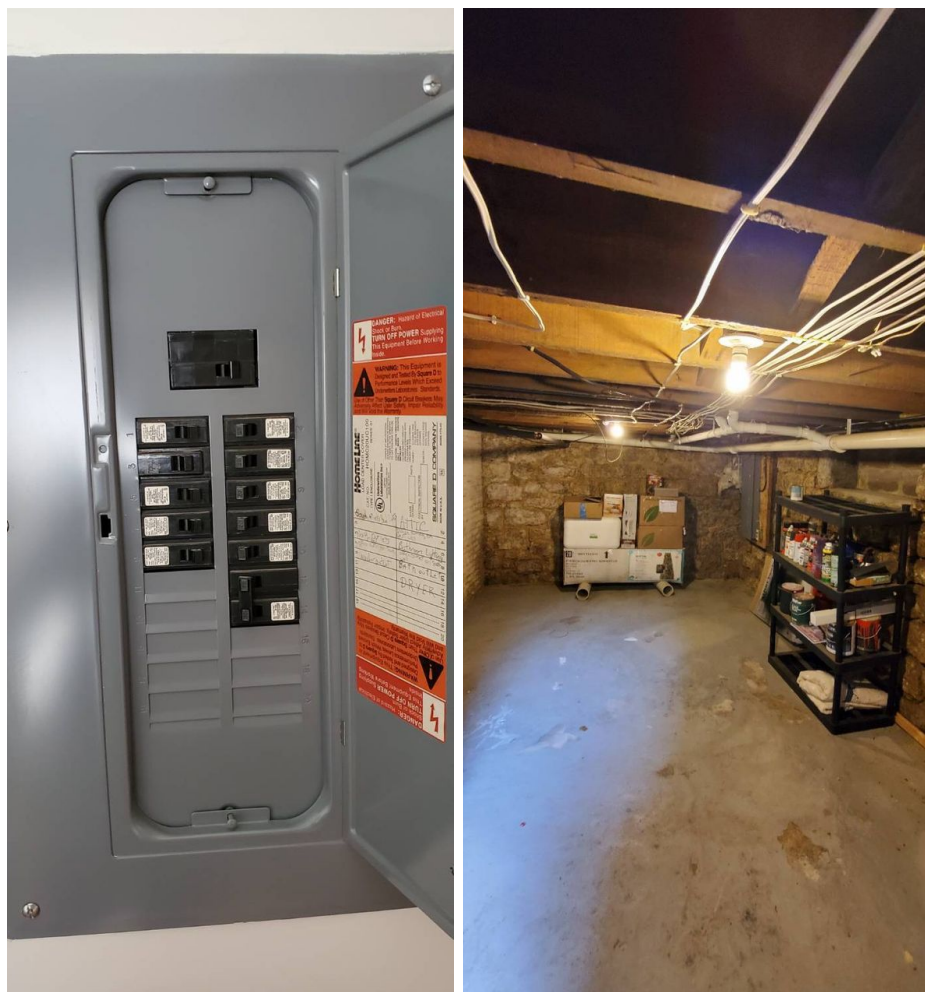
**Main Service Disconnect: Inspected Main Service Disconnect**

I inspected the electrical main service disconnect.

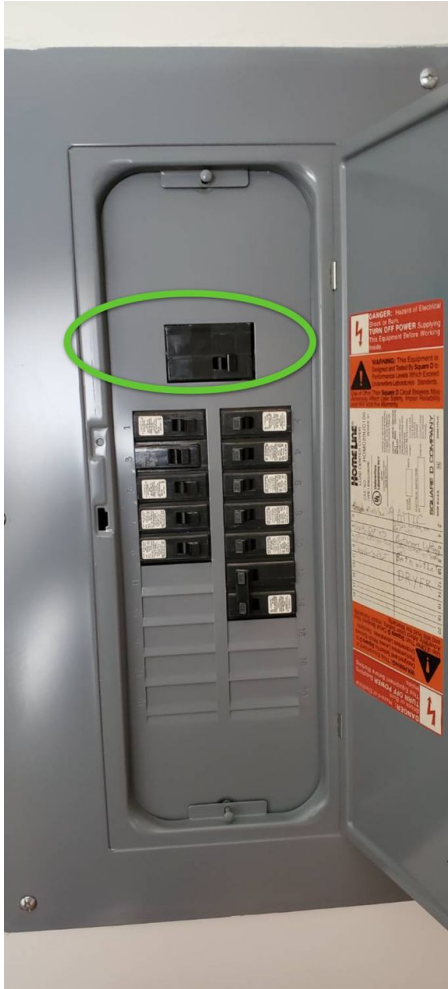
## Panelboards & Breakers: Inspected Subpanel & Breakers

I inspected the electrical subpanel and over-current protection devices (circuit breakers and fuses).

Sub panel laundry room 2nd Floor

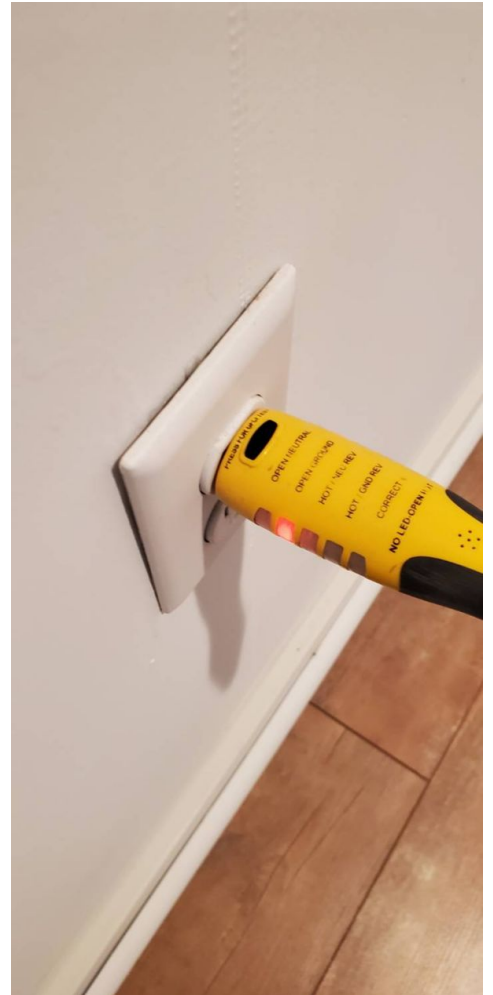
3rd Floor

Have a qualified electrician further evaluate. This is very common for homes that are built pre 1974. Doesn't mean it's unsafe. The wiring used when this home was built was a two wire system compared to today's wiring of three wires. It function's as intended.

When updating the home it is recommend to upgrading the wiring system to the current standards

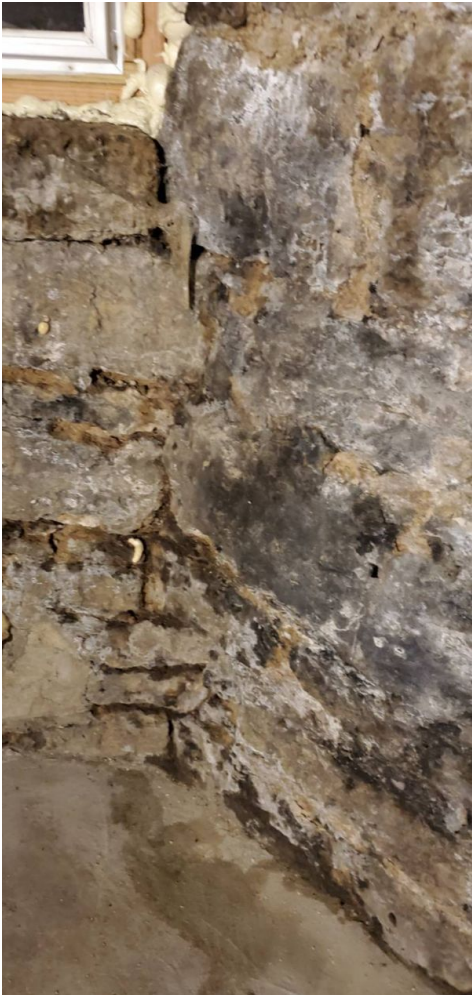
Wall structure showed signs of water intrusion, which could lead to more serious structural damage. Recommend a qualified contractor identify source or moisture and remedy. Be sure all gutters down spouts are clear and run away from the home. All surface grading allows for water run off away from the home

There was no moisture the day of the inspection. This could of been a past problem and has been resolved. I would monitor for further evidence of moisture than consult a qualified contractor for a solution of the problem if it continues.

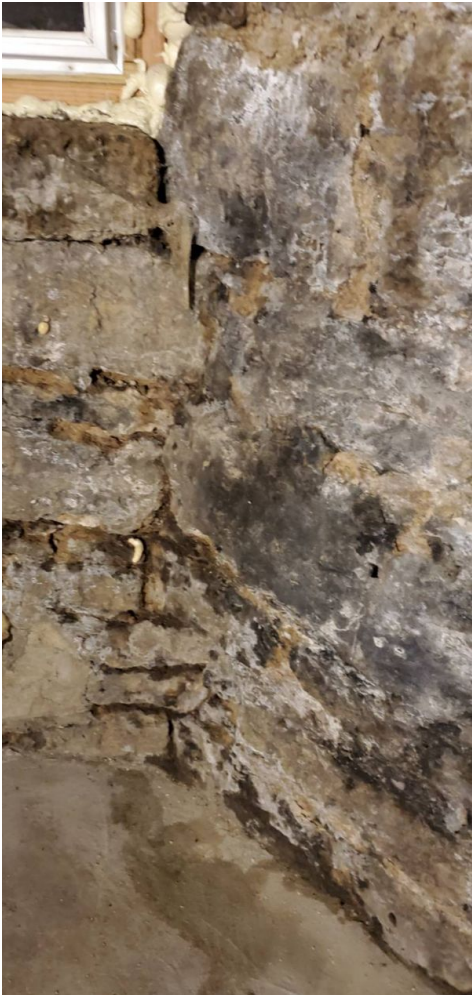
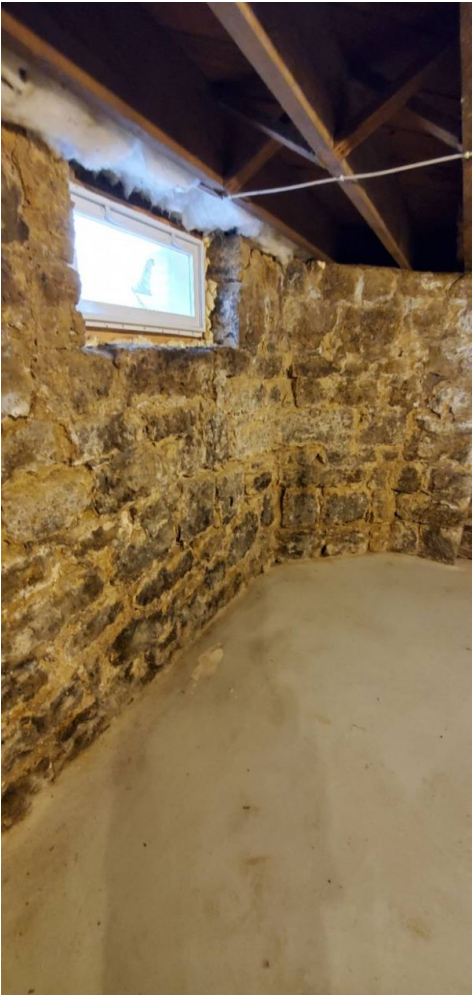
**LIMESTONE FLAKING MORTAR AND FINISH COVER.**
