CR QUALITY HOME INSPECTIONS

RESIDENTIAL INSPECTION

1234 Main Street
Lena , IL 61048

11/10/2022 9:00AM

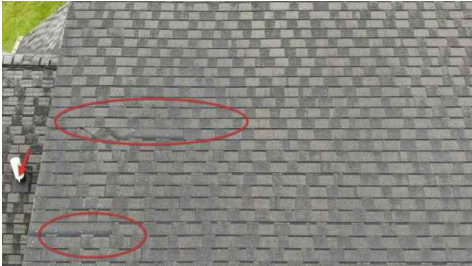
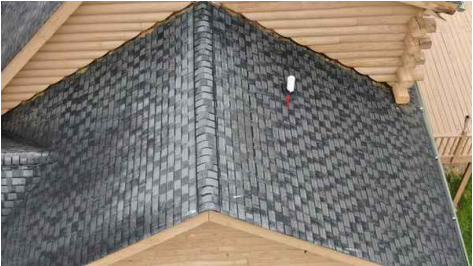
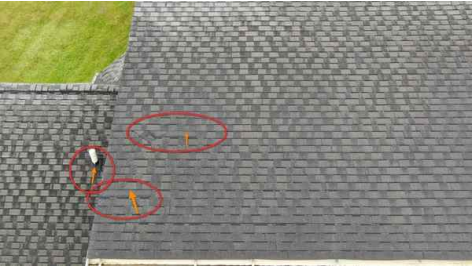
I observed improper fastening at the roof-covering materials. Prone to leaking it the shingles were to blow off. Correction and further evaluation is recommended by a qualified roofer.

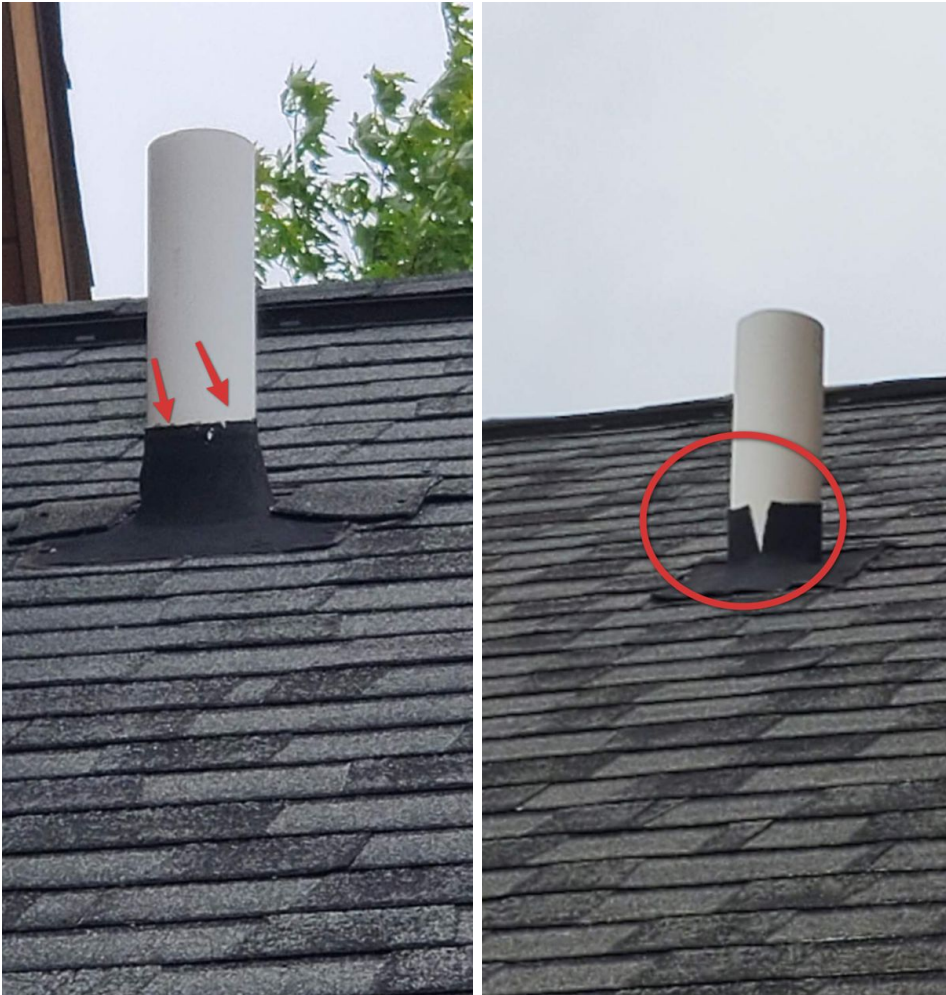
The rubber membrane flashing material around the vent pipe was cracked and damaged. This is prone to water penetration. Correction and further evaluation is recommended by a qualified roofer /contractor.

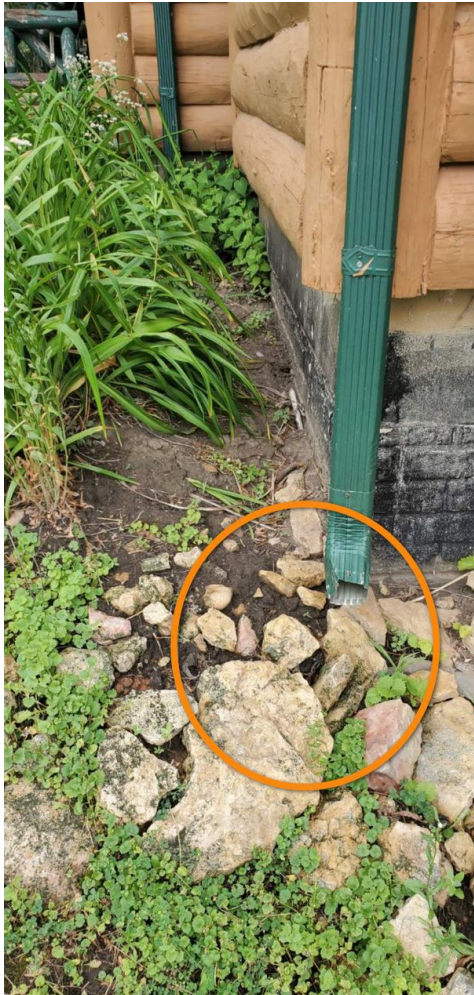
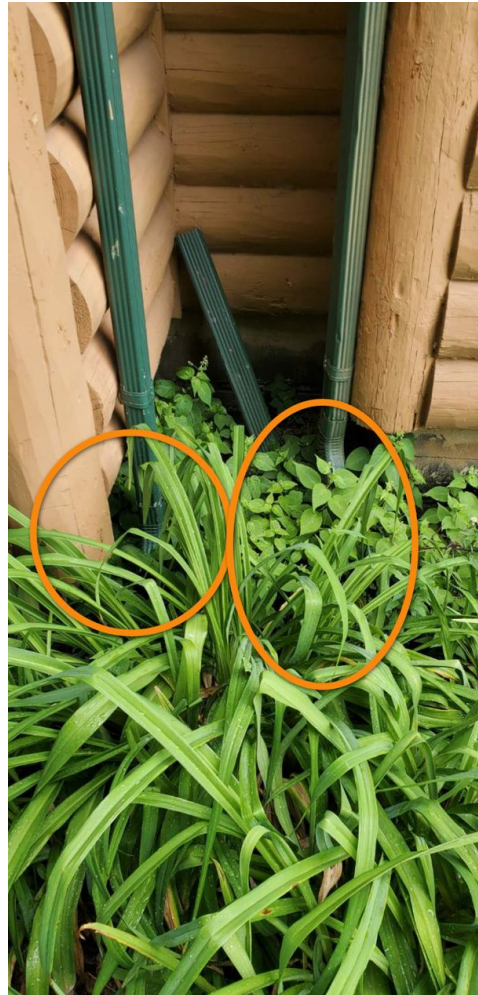
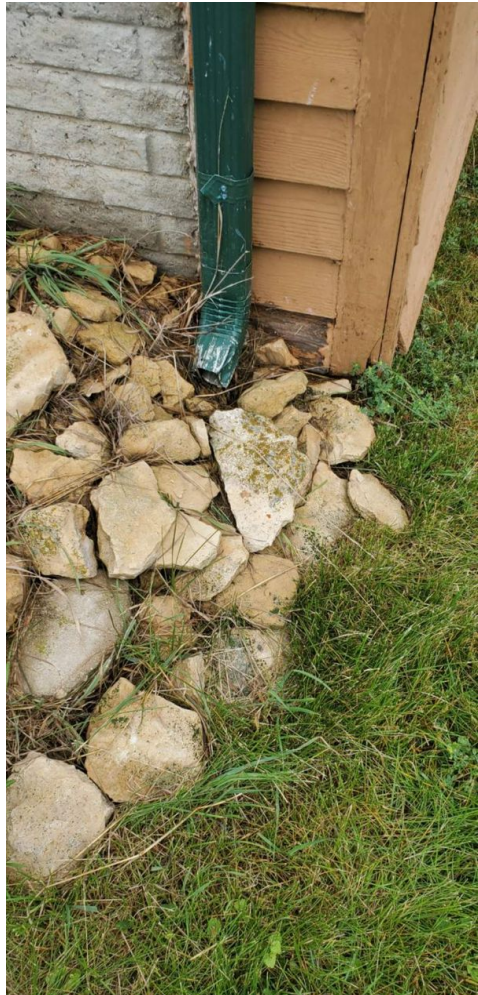
2.4.1 Gutters & Downspouts

DOWNSPOUT DRAIN'S NEAR STRUCTURE

One or more downspouts drain too close to the home's foundation. This can result in excessive moisture in the soil at the foundation, which can lead to foundation/structural movement.

I Recommend a qualified contractor adjust downspout extensions to drain at least 6 feet from the foundation.

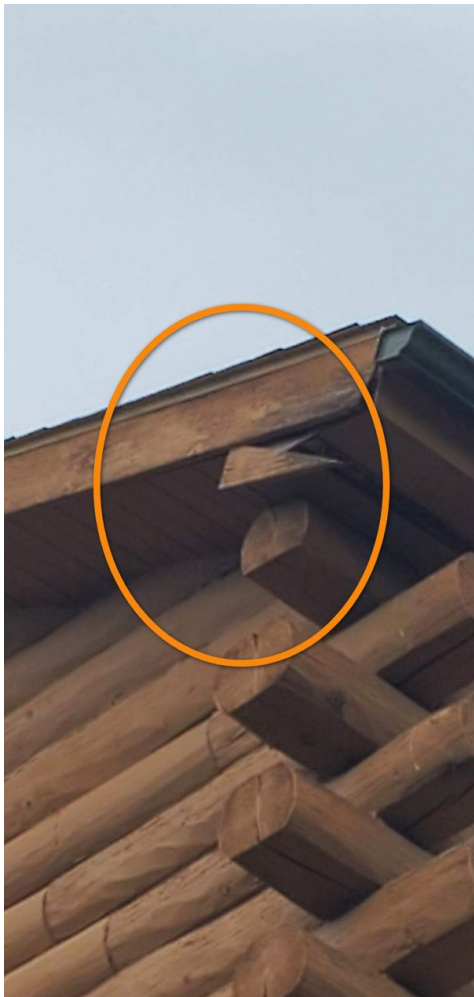
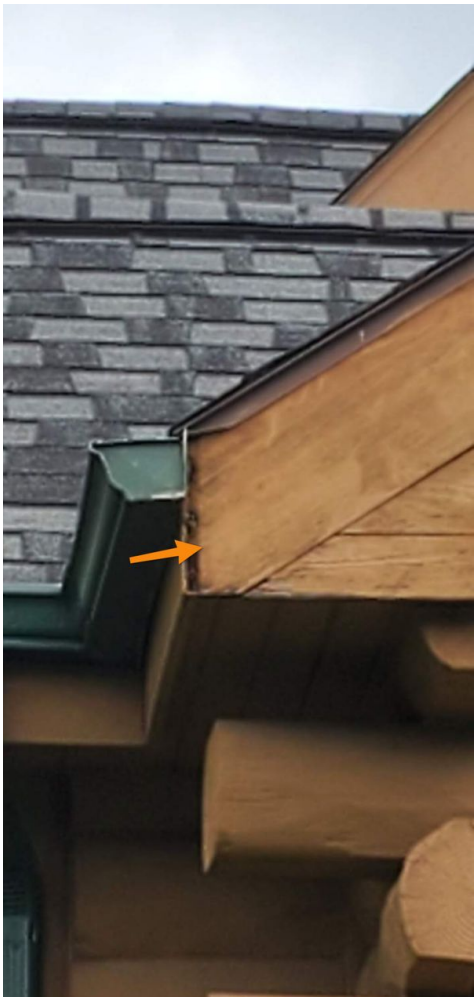
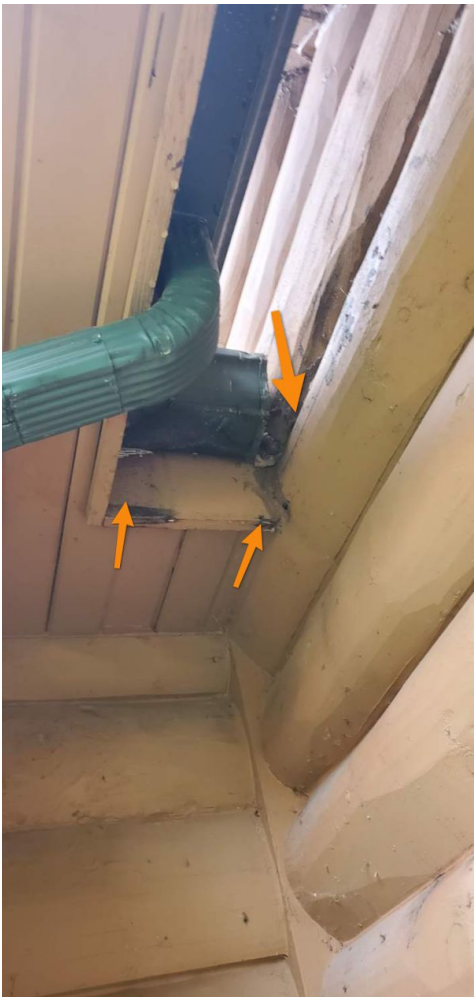
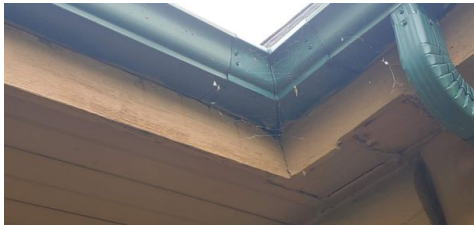
2nd Floor South

I observed indications that one or more areas of the eaves were damaged.

Correction and further evaluation is recommended by a qualified contractor.

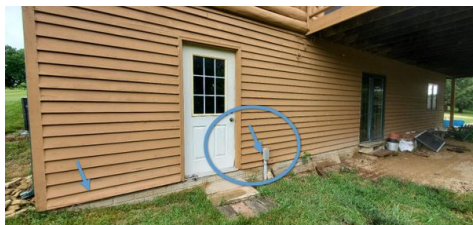
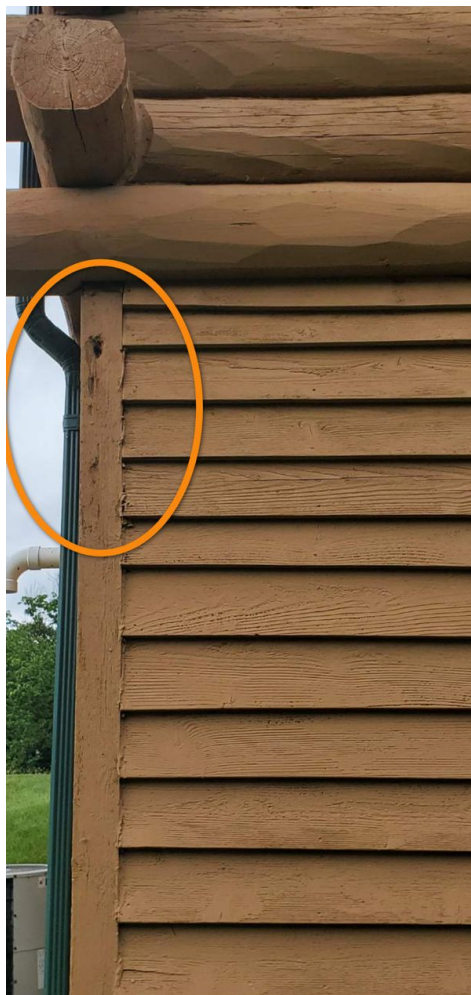
East

3.3.1 Wall-Covering, Flashing & Trim
LOOSE, WARPED, OR BUCKLED OR DAMAGED TRIM
Have a qualified contractor evaluate and repair .

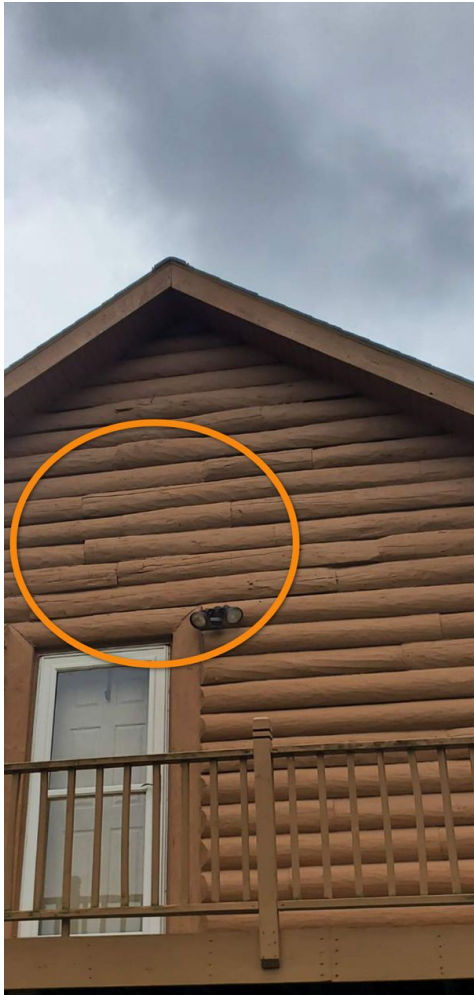
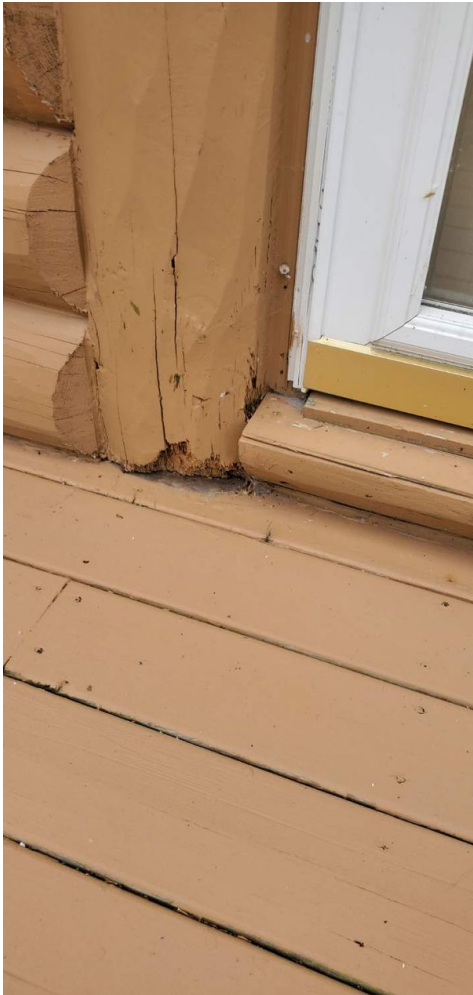
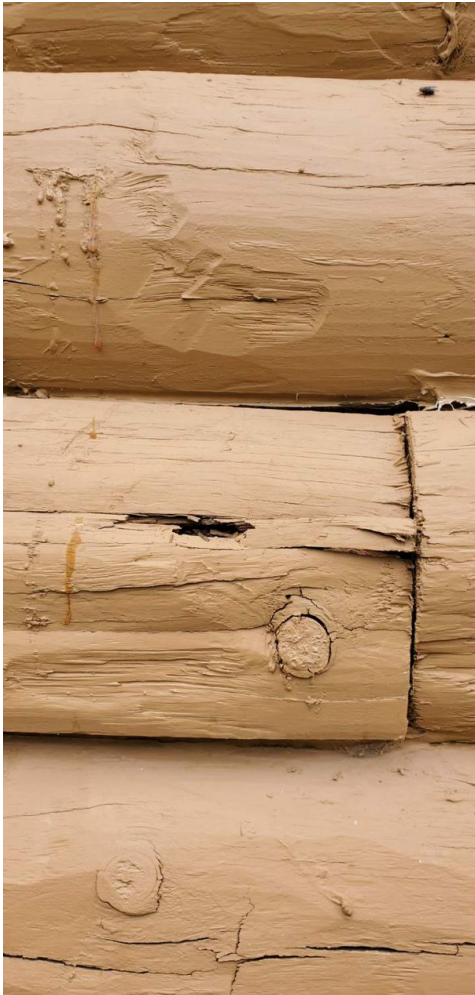
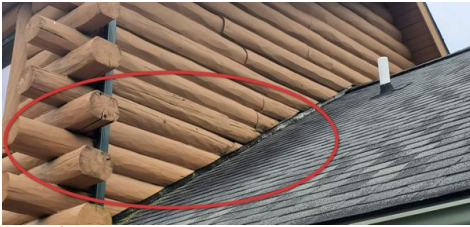
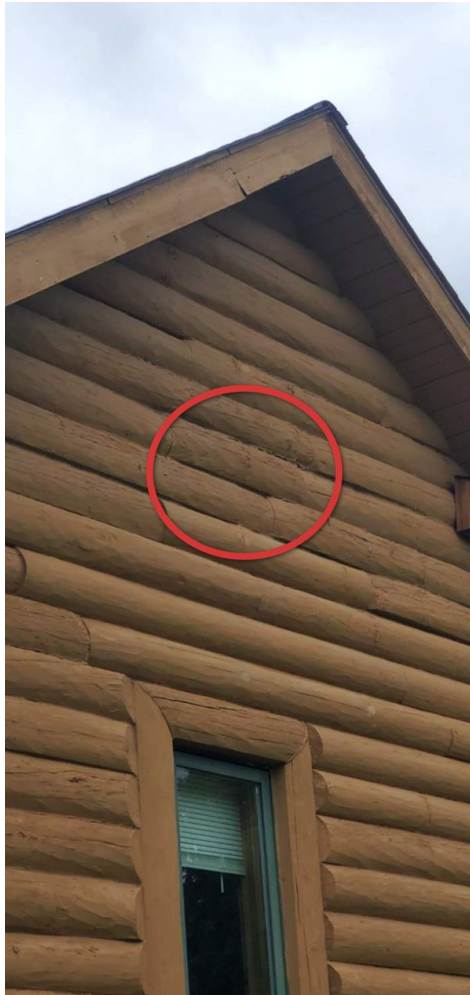
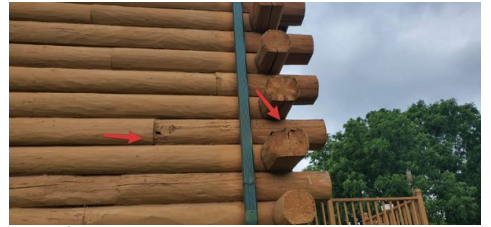
Be sure and check all areas subject to high moisture exposure for decay.

Caulk all joints and repaint , seal to protect against water penetration.

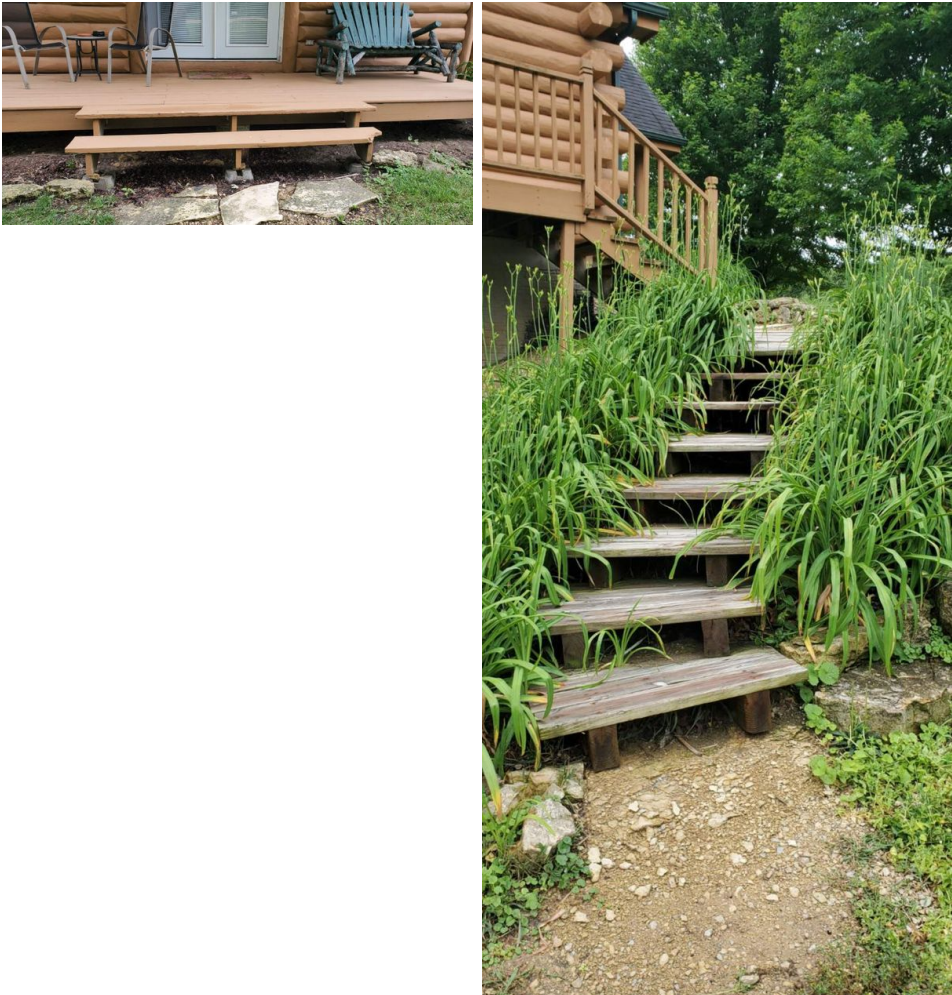
RISER HEIGHT TOO TALL (GREATER THAN 7 3/4")

I observed a defect at the stair riser height.
The riser height maximum is 7 3/4 inches measured vertically
between the stair treads. This poses a trip hazard.
I recommend further evaluation by a qualified contractor

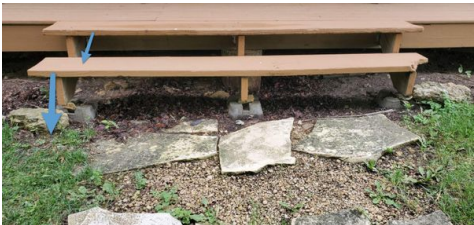
STEPS NOT STRUCTURALLY SUPPORTED PROPERLY

I would recommend having a qualified contractor evaluate and
repair with proper support for the stair stringers.

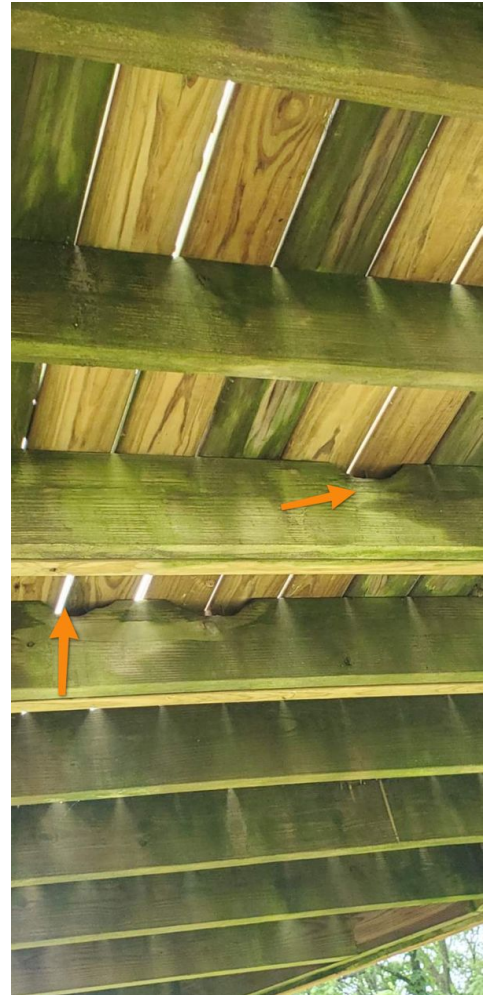
I observed wood rot at the flooring /and or framing of the deck/
porch .

Correction and further evaluation of the deck is recommended by a
qualified contractor

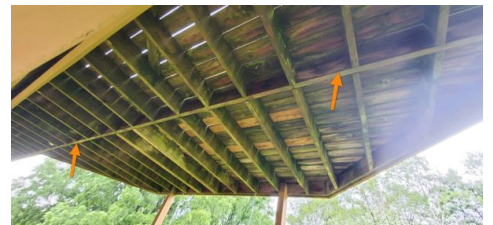
I observed a structural defect at the deck. The deck's structural
condition is inadequate.

Correction and further evaluation of the deck is recommended by a
qualified contractor.

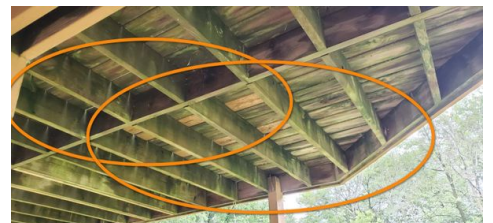
The joist and rim joist are starting to separate and can possibly fail.

Decks have one of the most failure ratings in the housing industry
due to sub standard framing practices.

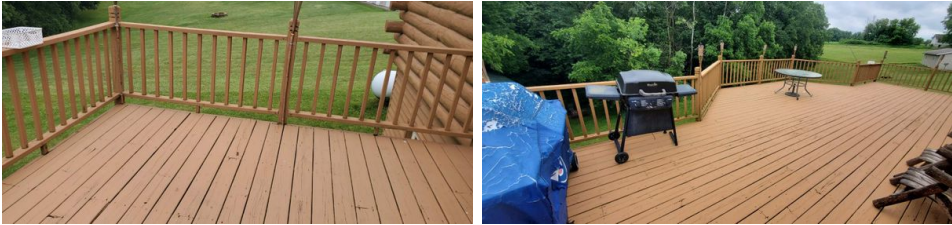
LOOSE RAILING COMPONENT

I observed a loose railing component. This condition is a safety hazard.
Correction and further evaluation is recommended by a qualified contractor
Support post is loose and needs to be anchored solid to prevent movement .

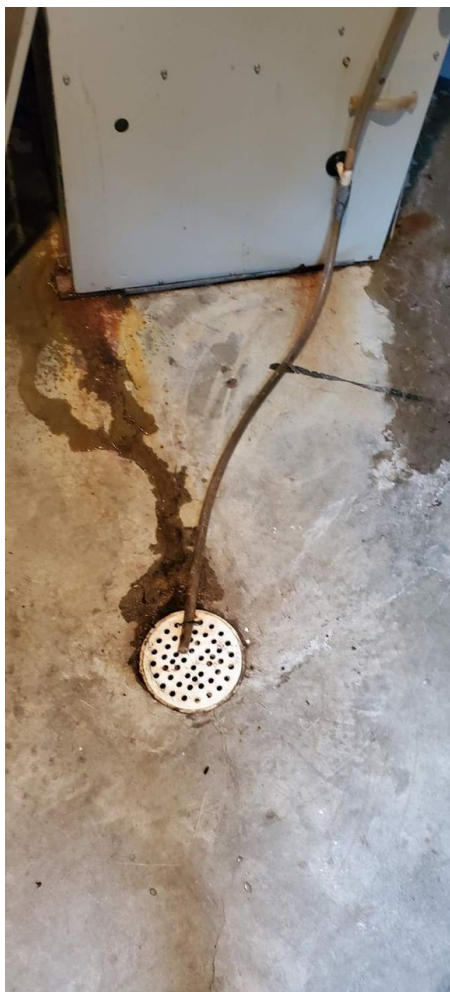
I observed a discharge pipe apparently connected to the condensate pump or drain installed at the cooling system. Water was not running out of the intended drain, rather it was running out of the furnace

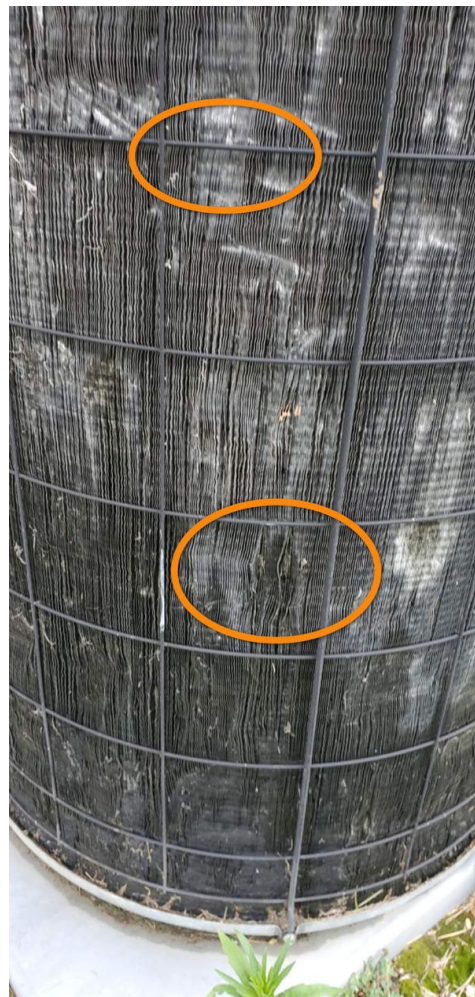
I observed indications of damaged fins on the exterior compressor unit of the cooling system. When the fins are flattened the air doesn't circulate as well through them. Straighten the fins with a butter knife.

Further evaluation by a qualified HVAC

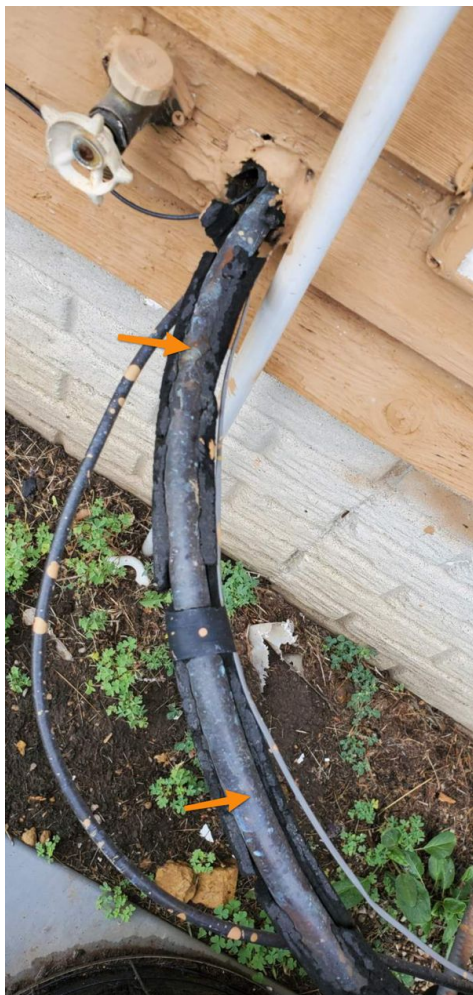
Missing or damaged insulation on refrigerant line can cause energy loss and condensation.

I recommend further evaluation by a qualified HVAC for repairs

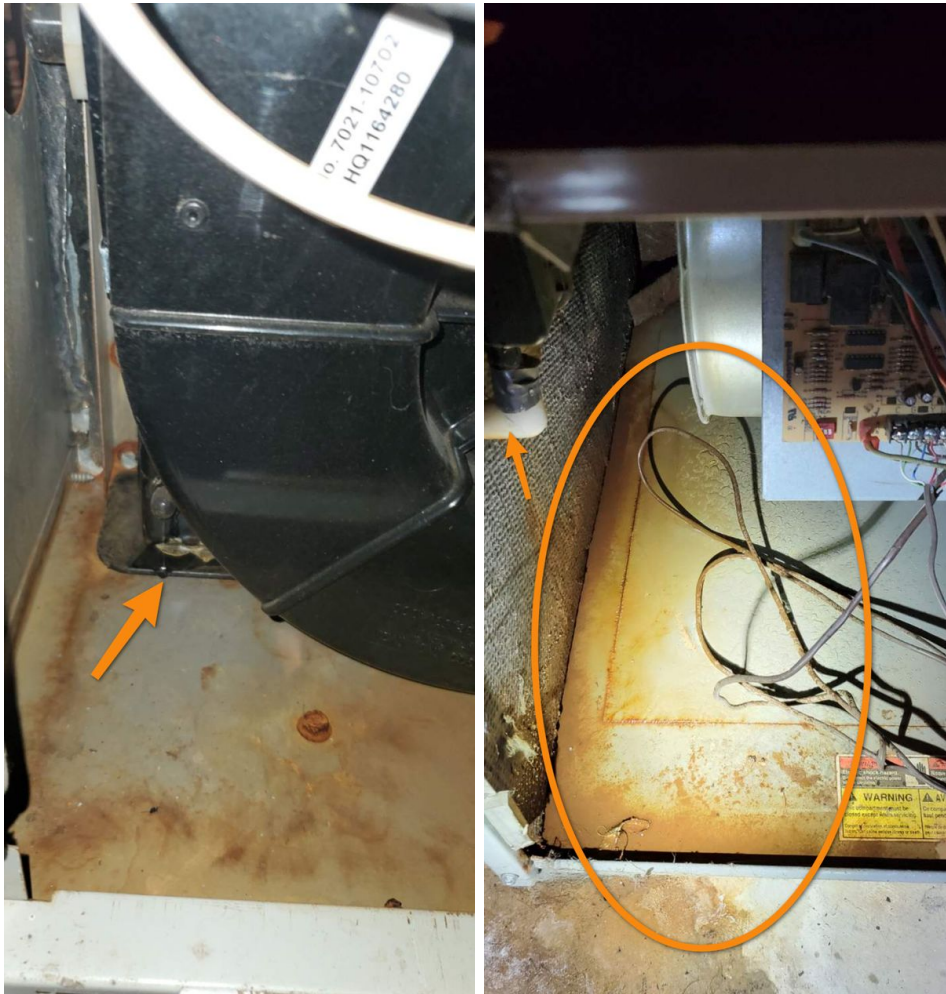
Water is running in the furnace the day of the inspection

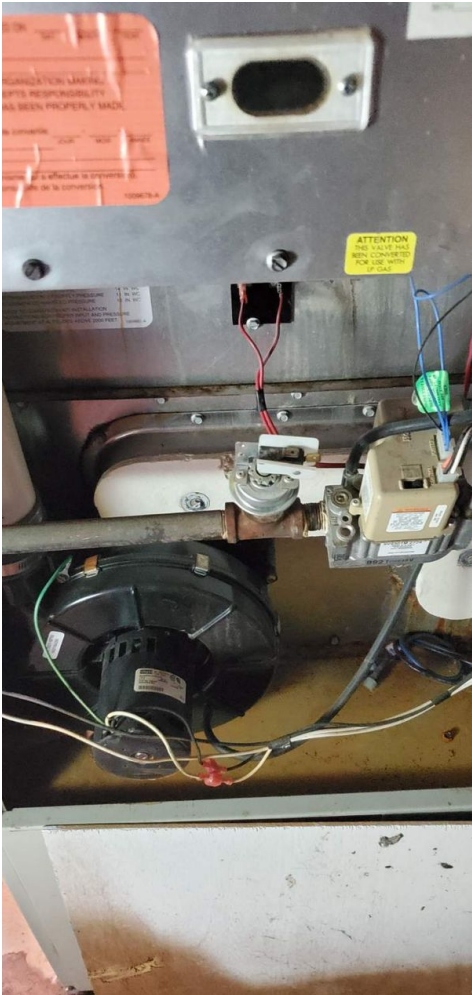
5.2.1 Heating Equipment

CORROSION

Furnace was corroded in one or more areas. This could be the result of improper venting, , drain line plugged or broken along with a many other mechanical items, which the source would need to be identified. I highly Recommend a HVAC contractor to evaluate and repair . It may of been from a past leak and has been repaired.

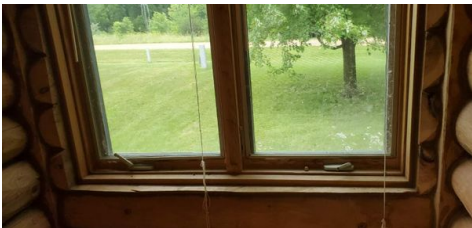
1st Floor South

DAMAGED/ MISSING HARDWARE AT THE WINDOW

I observed damage / missing hardware at a window and its operation. Window hardware would not open or function as intended. Some windows would open but many would not. Further evaluation by a qualified contractor is recommended for repairs and replacement. This could become serious if a emergency was to happen and the windows need to be opened.

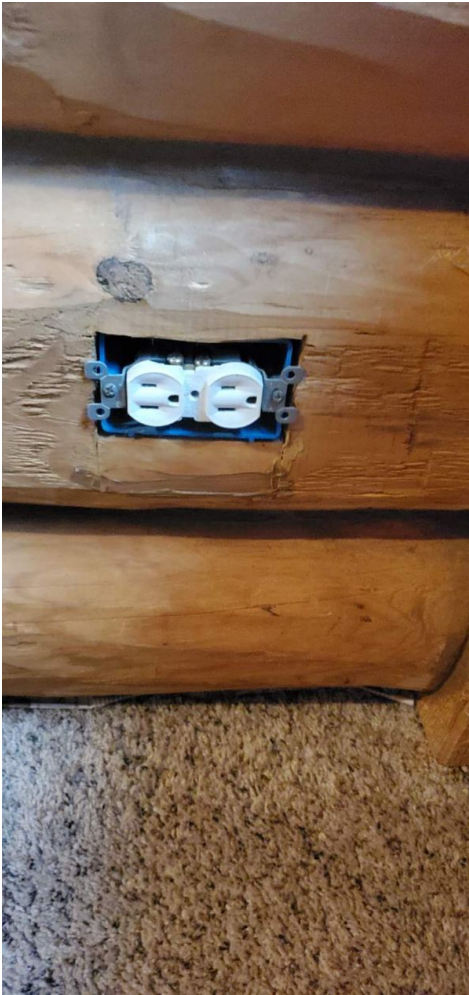
1st Floor Northeast Bedroom

I observed a receptacle/light with a cover (plate) that was not in place.

Consult a qualified electrician is recommended for any electrical repairs and needs .

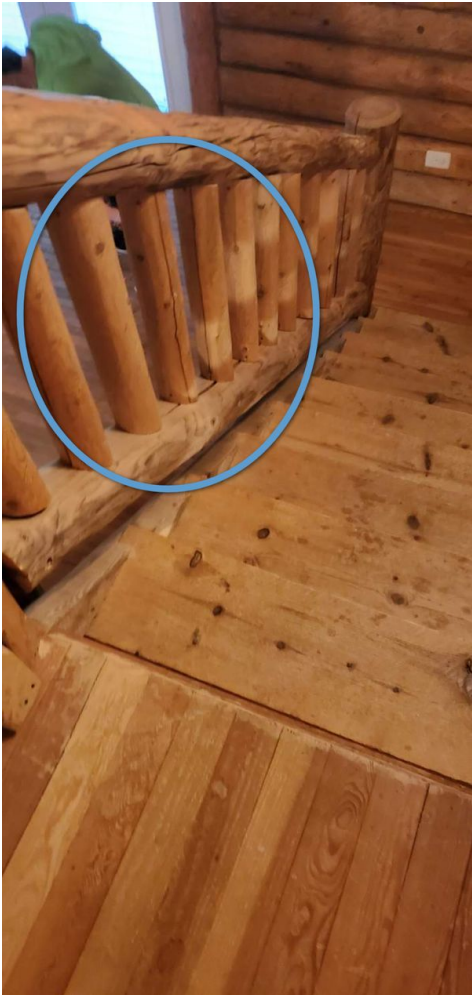
I observed a loose railing component. This condition is a safety hazard.

Correction and further evaluation is recommended.

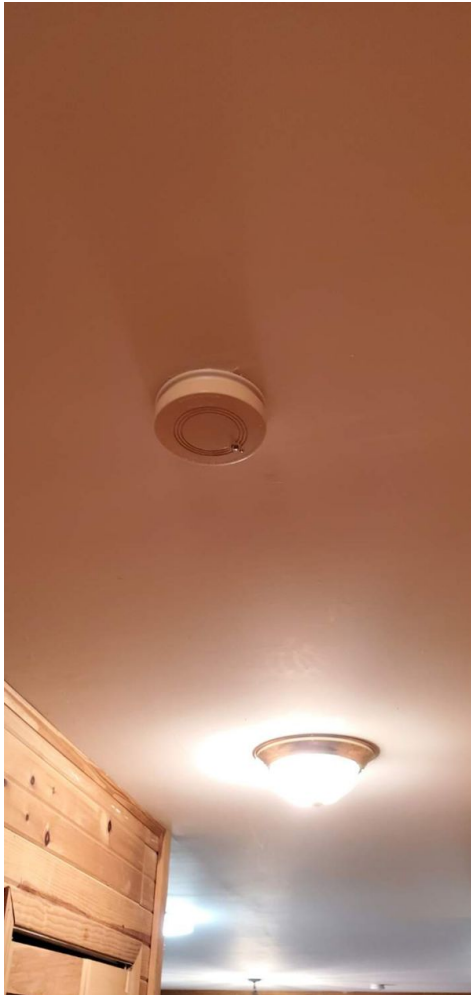
North hallway

7.7.1 Presence of Smoke and CO Detectors
OLD DETECTORS, NEW DETECTORS RECOMMENDED

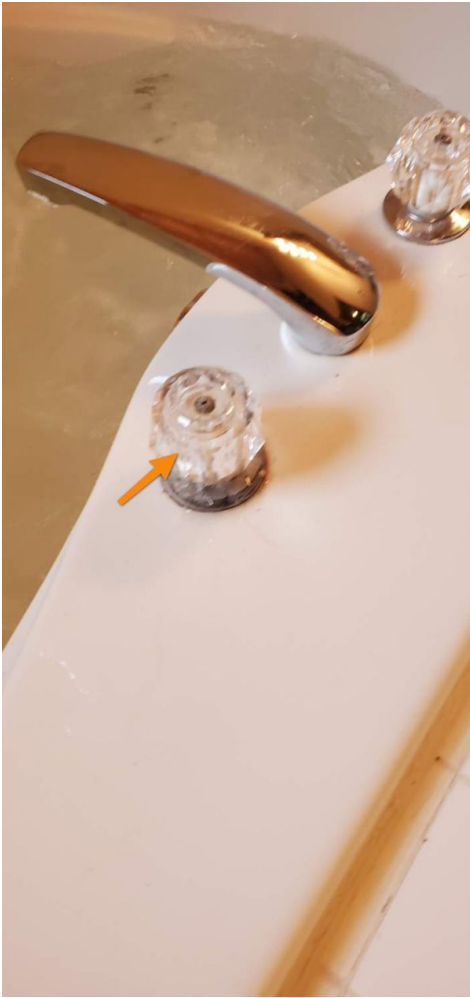
I observed indications of an active water leak at the tub. Recommend having serviced by a plumber

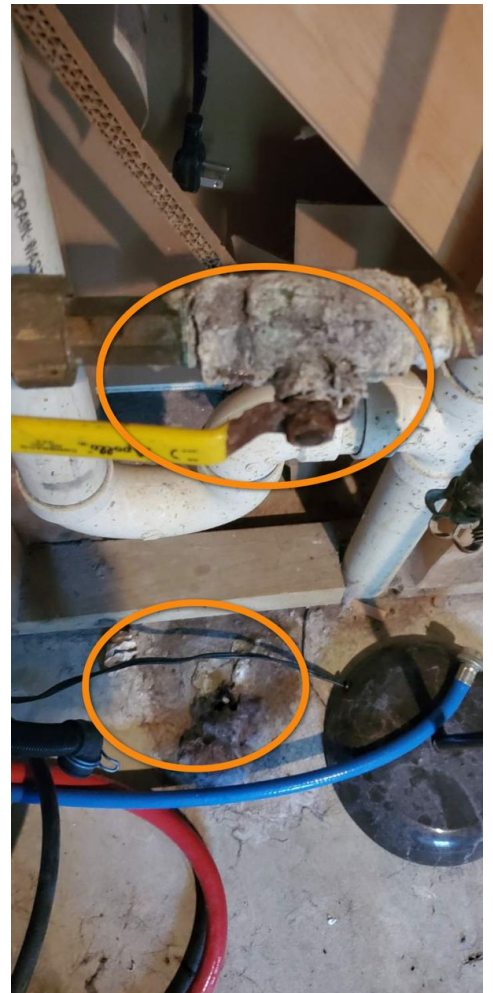
11.3.1 Hot Water Source

WATER LEAKING

I observed an active water leak at the hot water source.
I recommend further evaluation by a qualified plumber

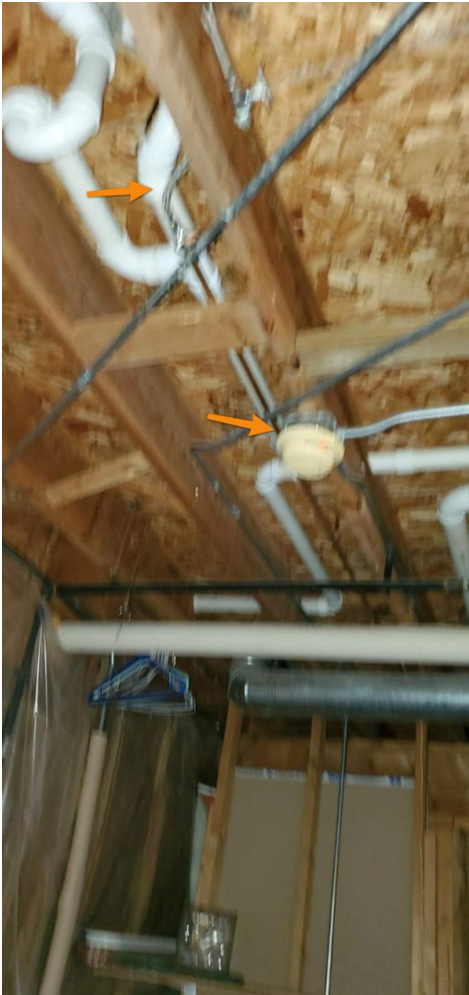
11.4.2 Drain, Waste, & Vent Systems

I observed indications of an improper slope of a drain pipe. Drain pipes must be sloped properly "downhill" in order to drain.

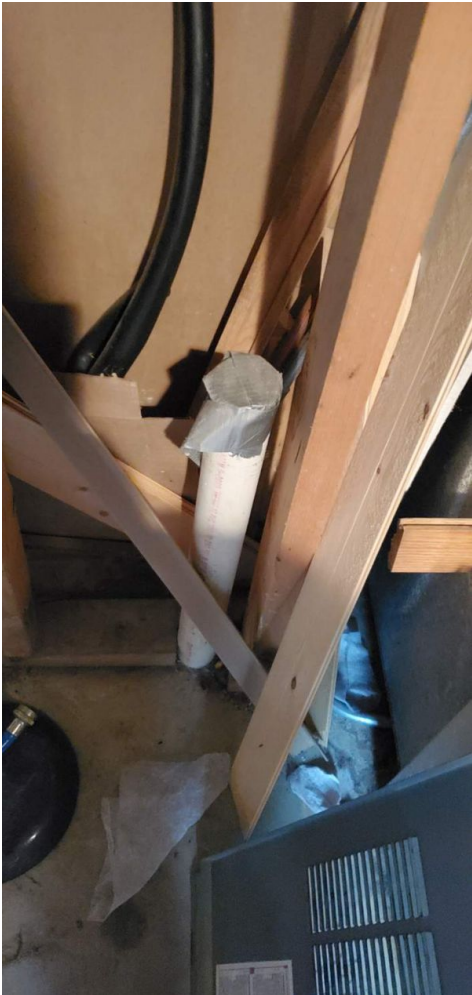
Basement

BASEMENT UTILITY ROOM

Sewer gas could be released in the home . Have a proper cap installed to prevent sewer gas from entering the home .

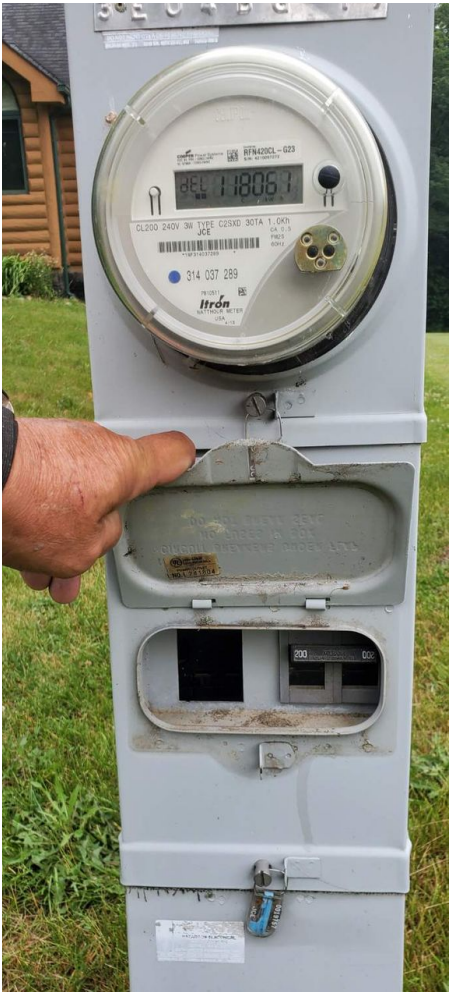
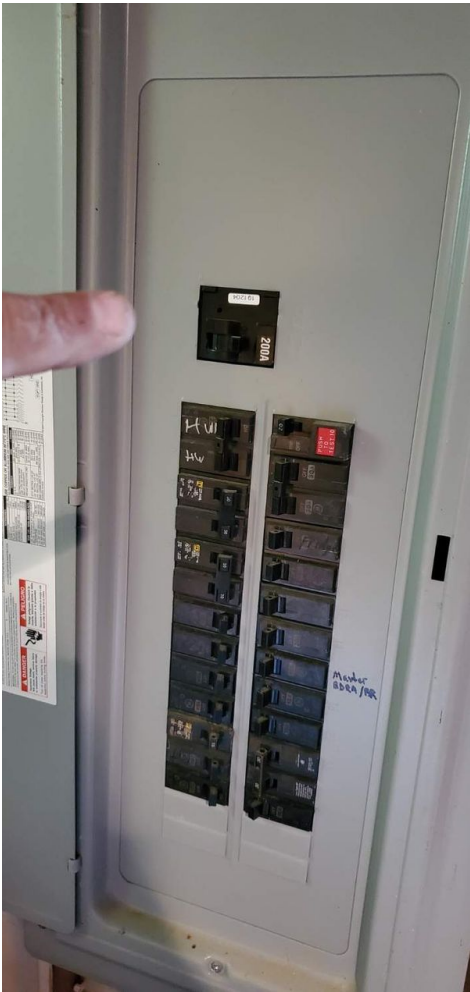
Main Service Disconnect: Inspected Main Service Disconnect

I inspected the electrical main service disconnect.

Main Service Disconnect: Main Disconnect Rating, If Labeled
200

I observed indications of the main service disconnects amperage rating if It was labeled.
Always consult a licensed electrician before adding more circuits.

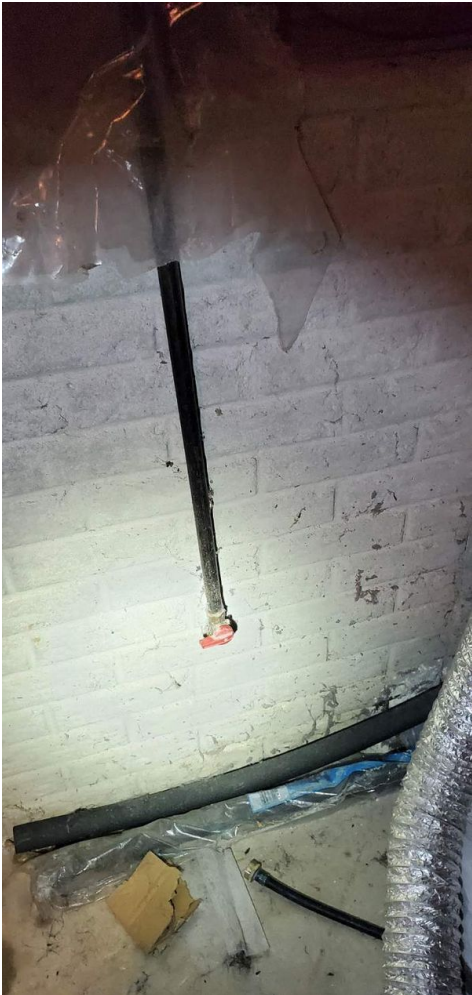
Utility room Basement

Major Material Defect/ Safety Issue

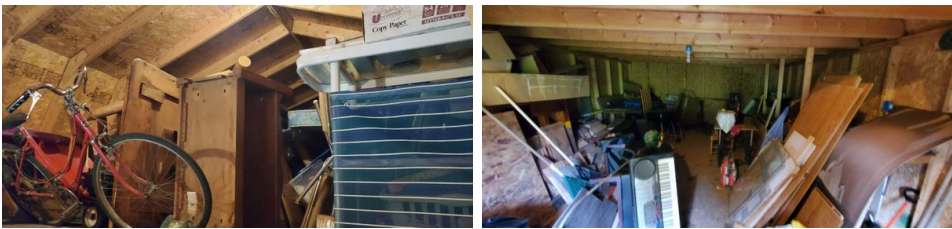
PERSONAL ITEMS STORED UNABLE TO INSPECT ALL AREAS.

Once stored items are removed further evaluation would be recommended

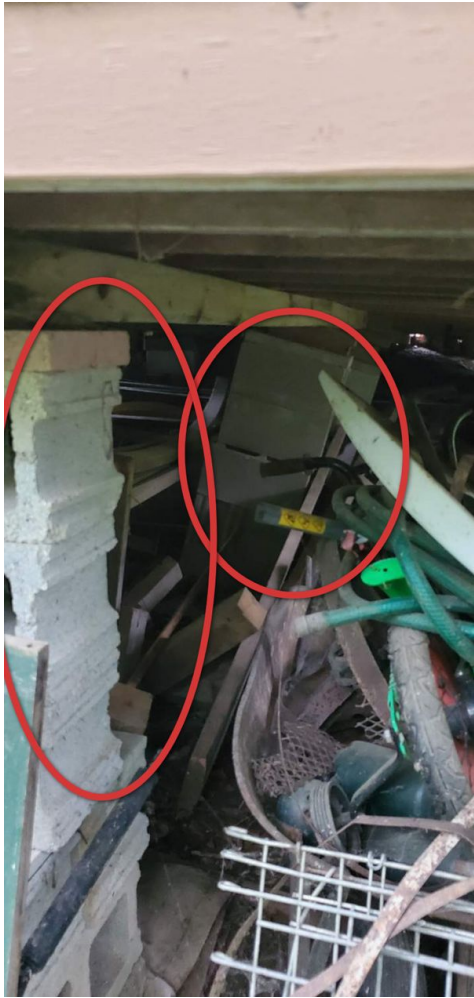
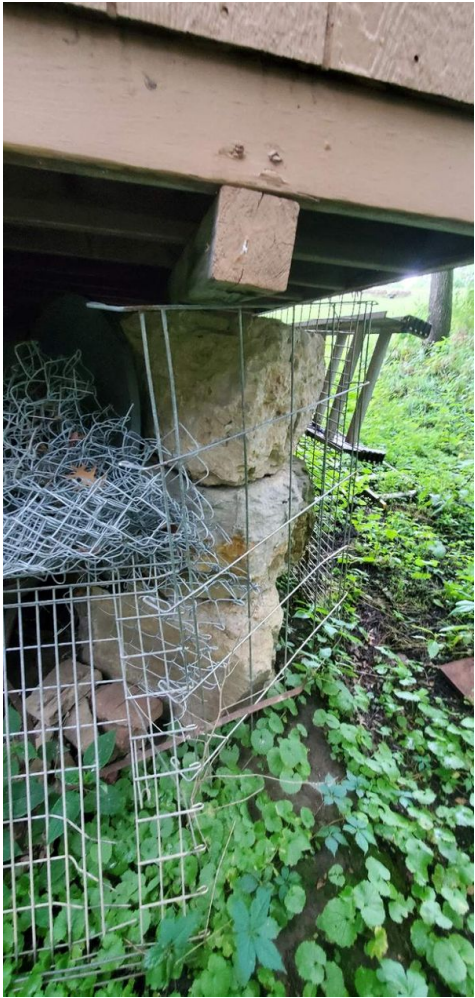
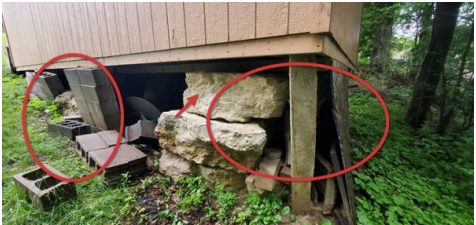
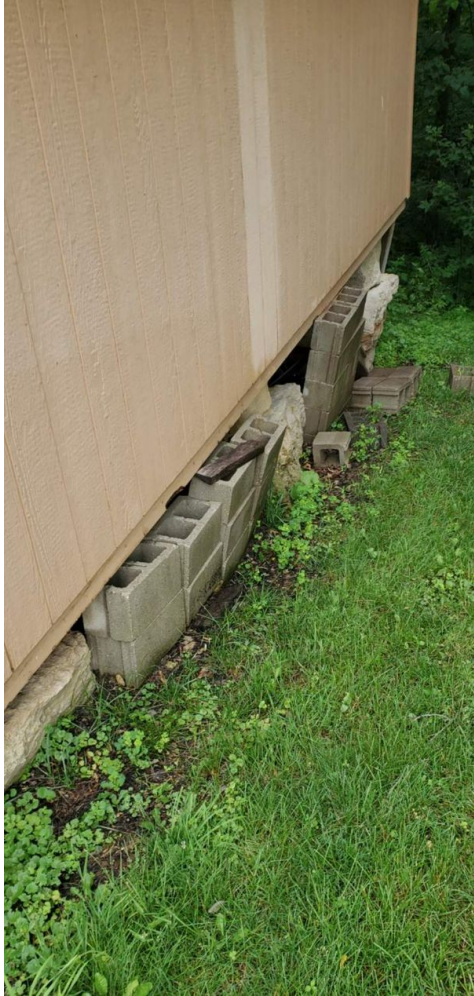
15.1.1 Foundation

Major Material Defect/ Safety Issue

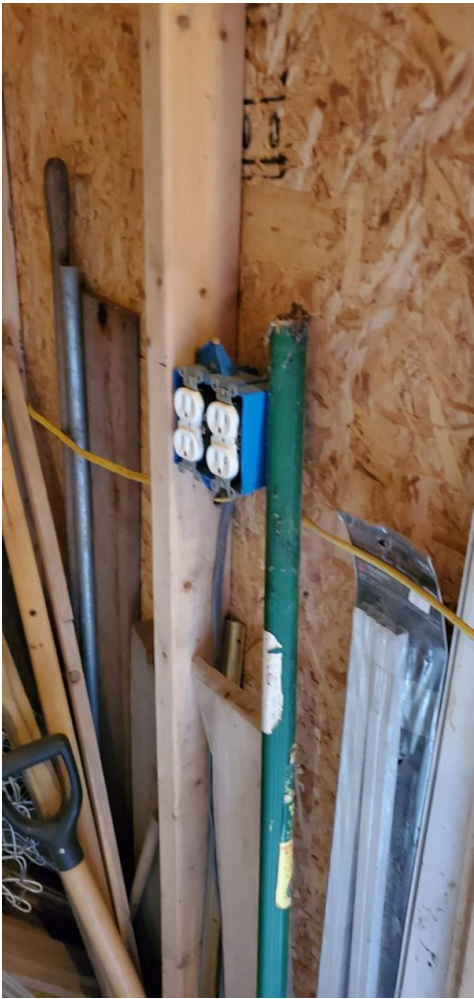
15.2.1 Lighting

COVER PLATES MISSING

Major Material Defect/ Safety Issue

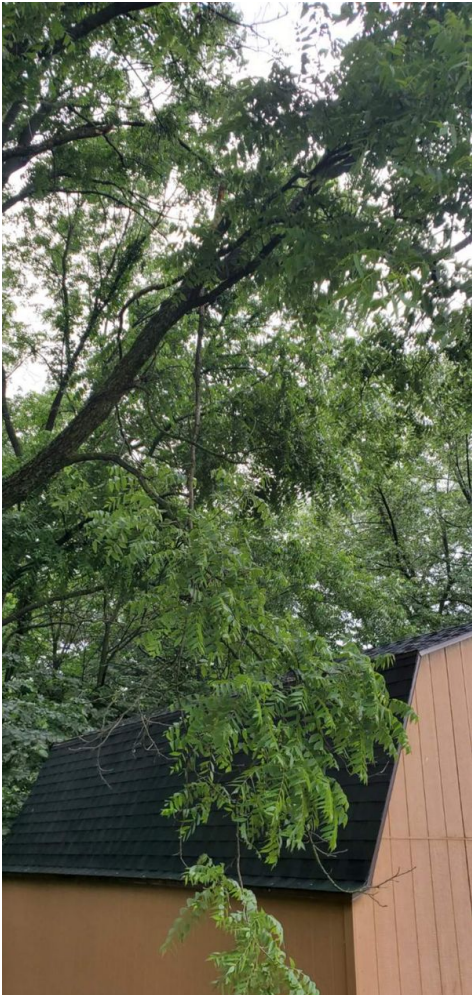
15.4.1 Walls

**TREE LIMBS HANGING
ON OR NEAR STRUCTURE**

Recommendation /Needs Attention
